# DOMED CAP NUT – ZN AL SN CU ALLOY – MODERN TIMES – FRANCE

<b>Artefact name</b>	Domed cap nut
<b>Authors</b>	Christian. Degrigny (HE-Arc CR, Neuchâtel, Neuchâtel, Switzerland) & Mathea. Hovind (University of Oslo, Department of archaeology, conservation and history (IAKH-UiO), Oslo, Oslo, Norway)
<b>Url</b>	/artefacts/714/

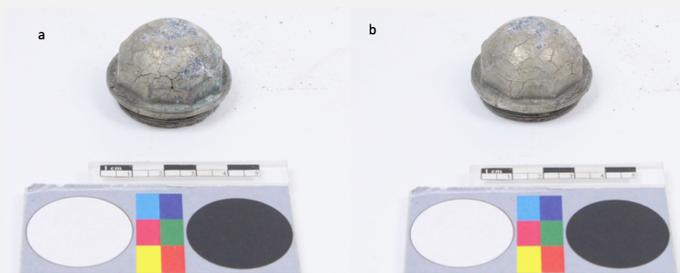
Fig. 1: Octogonal domed cap nut. Profile "a" and "b", to the left and right, respectively,

<b>Description of the artefact</b>	A domed cap nut made of a cast alloy with a metallic plating (Fig. 1). Its shape is octagonal and the inside is hollow. The plating is heavily cracked, leading to surface flaking. The metal appears to be consumed by some kind of internal corrosion. Dimensions: L (∅) = 40mm; H = 28mm; T = 5mm; WT = 49g.
<b>Type of artefact</b>	Cap
<b>Origin</b>	Château de Germolles, Mellecey, Bourgogne, France
<b>Recovering date</b>	Date unknown
<b>Chronology category</b>	Modern Times
<b>chronology tpq</b>	<input type="text" value="1900"/> A.D. ▾
<b>chronology taq</b>	<input type="text" value="2000"/> A.D. ▾
<b>Chronology comment</b>	19th - 20th century
<b>Burial conditions / environment</b>	Outdoor atmosphere
<b>Artefact location</b>	Haute Ecole Arc Conservation-Restauration

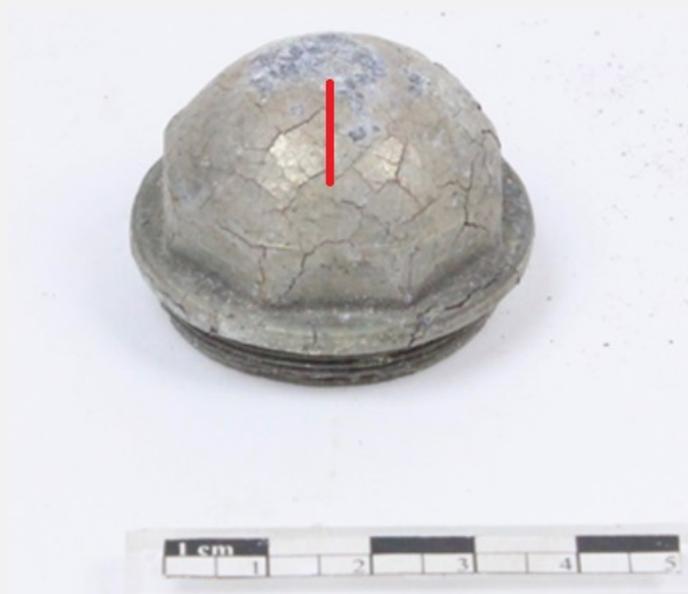
Fig. 2: Zone of the artefact submitted to visual observation and location of sampling area (a cross-section of the metal marked by the red line),

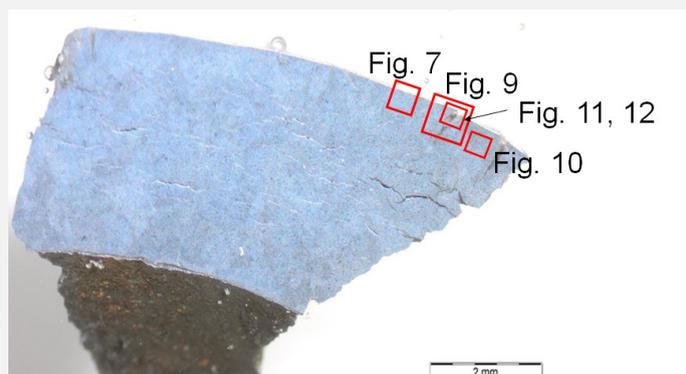
Fig. 4: Micrograph of the cross-section of the sample taken from the domed cap nut showing the locations of Figs. 7 and 9-12,

The sample is a cross section of the metal, representative of the domed cap nut. It shows external cracks extending from the metal surface and into its structure in addition to internal cracks, visible as thin lines along its longitudinal axis (Fig. 4).

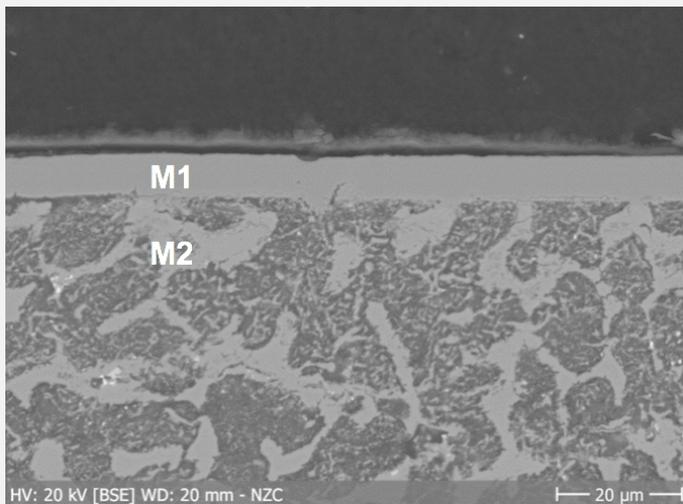
Fig. 7: SEM-image (BSE-mode) of a selected area from Fig. 4 (detail), showing the metal plating (M1) and the bulk metal (M2),

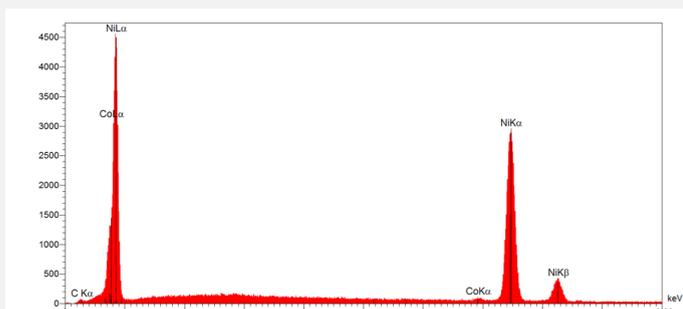
Fig. 8: EDS-spectrum showing the chemical composition of the metal plating (M1). Method of analysis: SEM-EDS. Lab. of Electronic Microscopy and and Microanalysis, Néode, HEI Arc,

The domed cap nut is nickel plated (6-7 micrometers).

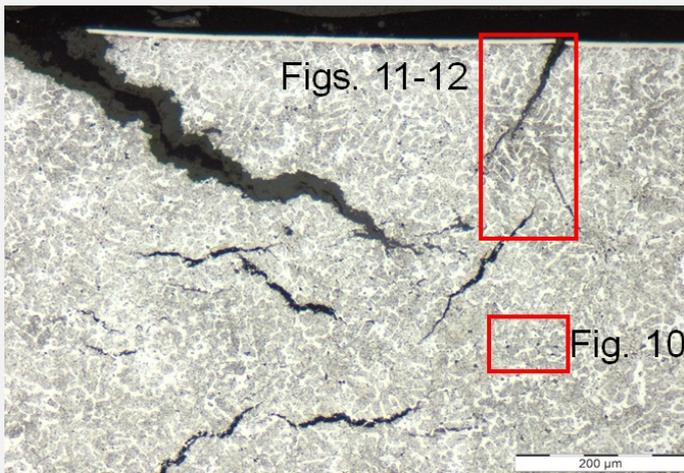
Fig. 9: Micrograph of the metal sample from Fig. 4 (detail), unetched, bright field. The dendrites appear light to dark grey while the interdendritic phase appears white. The metal is characterized by surface cracks as well as internal cracks. The lower red rectangle corresponds to Fig. 10 while the areas selected for elemental chemical distributions (Figs. 11 and 12) are marked by the upper red rectangle,

The dendritic phase is heavily oxidized compared to the interdendritic phase (Table 2 and Fig. 12). The corrosion has developed throughout the entire metal body, generating cracks (Fig. 9). The cracks are Zn and O-rich (Fig. 12) and could be composed of zinc carbonate. It could be a case of zinc pest, an intergranular corrosion phenomenon known to cause disintegration in poor quality alloys (Selwyn 2004, Zhang 2011).

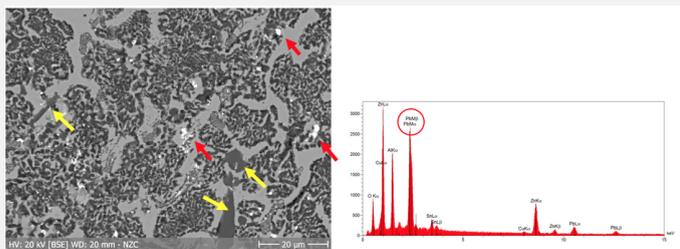
Fig. 10: SEM-image in BSE-mode (left) and EDS-spectrum (right), showing the appearance and the chemical composition of the Pb inclusions (red arrows). The inclusions appear white, the dendrites appear dark grey/black and the interdendritic phase appears grey. Grey opaque patches (yellow arrows) are Fe- and Al-rich phases,

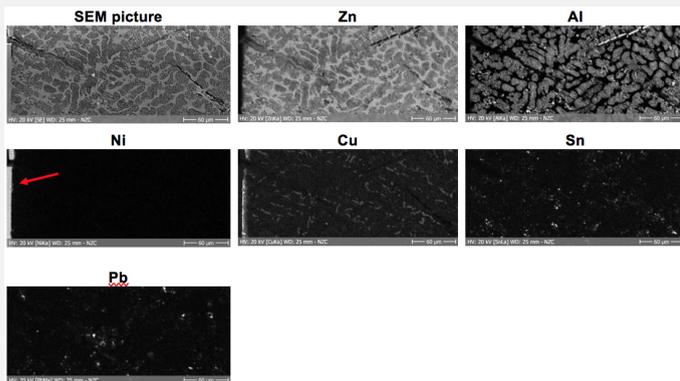
Fig. 11: SEM image and elemental chemical distribution of the selected area from Fig. 9 (rotated 270° and inverted). Method of analysis: SEM-EDS. Lab. of Electronic Microscopy and Microanalysis, Néode, HEI Arc,

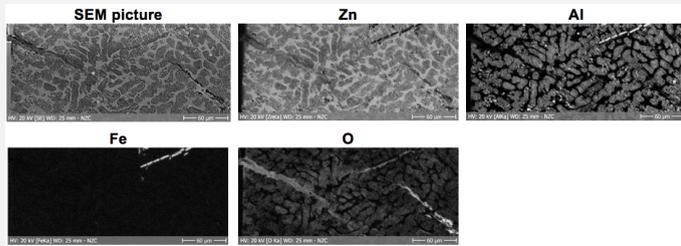
Fig. 12: SEM image and elemental chemical distribution of the selected area from Fig. 9 (rotated 270° and inversed). Method of analysis: SEM-EDS. Lab. of Electronic Microscopy and Microanalysis, Néode, HEI Arc,

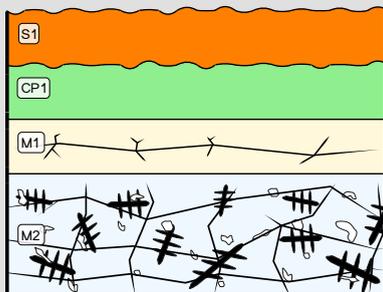
Fig. 5: Stratigraphic representation of the sample taken from the domed cap nut in cross-section (dark field) using the MiCorr application. The characteristics of the strata are only accessible by clicking on the drawing that redirects you to the search tool by stratigraphy representation. Stratigraphy representative of an area with intact metal plating (M1). S1 represents Fe-polluted soil while CP1 is a green translucent corrosion product, Credit UiO-IAKH, M.Hovind.
