# DOMED CAP NUT – ZN AL SN CU ALLOY – MODERN TIMES – FRANCE

| Artefact name | Domed cap nut |
| Authors | Christian. Degrigny (HE-Arc CR, Neuchâtel, Neuchâtel, Switzerland) & Mathea. Hovind (University of Oslo, Department of archaeology, conservation and history (IAKH-UiO), Oslo, Oslo, Norway) |

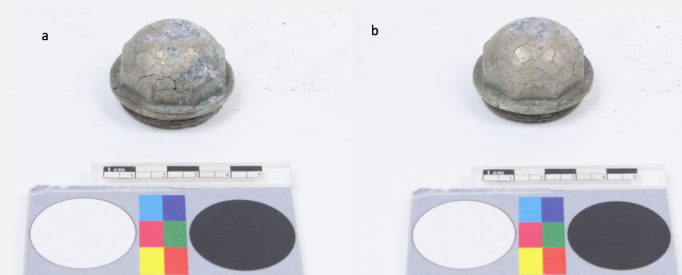
Fig. 1: Octogonal domed cap nut. Profile "a" and "b", to the left and right, respectively,

| Description of the artefact | A domed cap nut made of a cast alloy with a metallic plating (Fig. 1). Its shape is octagonal and the inside is hollow. The plating is heavily cracked, leading to surface flaking. The metal appears to be consumed by some kind of internal corrosion. Dimensions: L (ø) = 40mm; H = 28mm; T = 5mm; WT = 49g. |

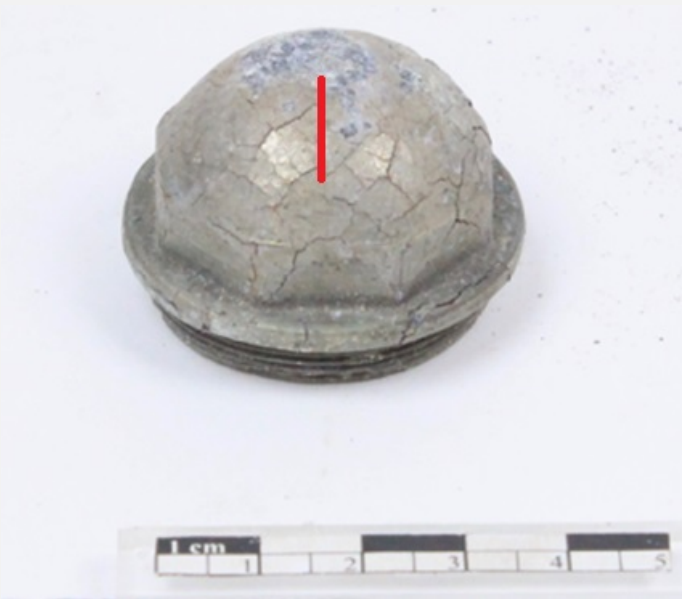
Fig. 2: Zone of the artefact submitted to visual observation and location of sampling area (a cross-section of the metal marked by the red line),

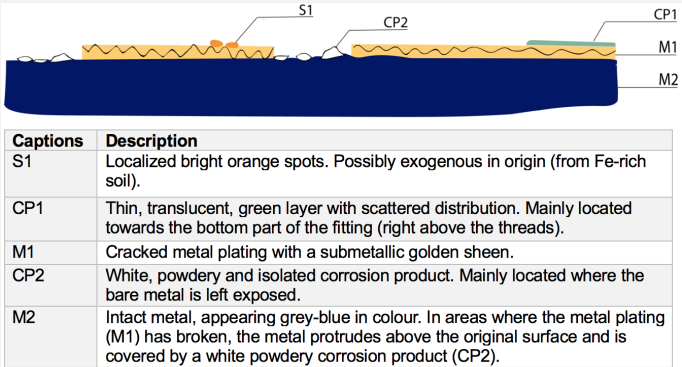
Fig. 3: Preliminary stratigraphy corresponding to the overall surface of the artefact. CP = Corrosion Product, S = Soil, M = Metal,

The external corrosion products and deposits (Fig. 3) were documented but not analyzed as they were considered to be mainly exogenous in origin and not the main reason behind the deterioration of the object. The orange deposit (S1) is probably soil from Fe-rich environment, while the thin green layer (CP1) is most likely consisting of an oxide of Ni from the nickel plating (M1). The white corrosion product (CP2) can either be a salt from the environment, corrosion products of Zn/Al or Zinc carbonate.

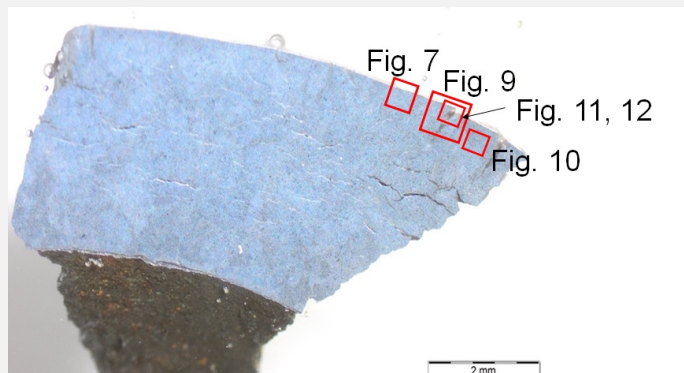
Fig. 4: Micrograph of the cross-section of the sample taken from the domed cap nut showing the locations of Figs. 7 and 9-12,

The sample is a cross section of the metal, representative of the domed cap nut. It shows external cracks extending from the metal surface and into its structure in addition to internal cracks, visible as thin lines along its longitudinal axis (Fig. 4).

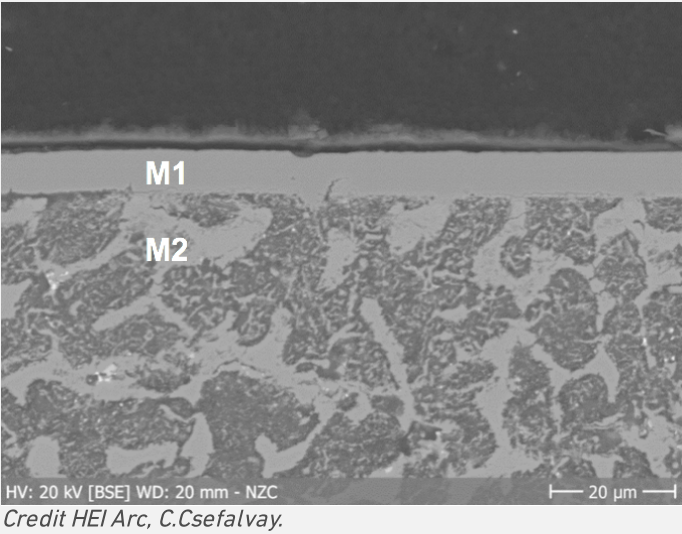
The metal of the domed cap nut (M2) consists of a Zn/Al/Pb/Cu/Sn alloy (Table 1) externally covered by a nickel-based plating (M1) (Figs. 7 and 8) containing some cobalt (Co). The bulk metal (M2) has a dendritic microstructure appearing light grey in bright field, while the interdendritic phase appears white (Fig. 9). The latter is Zn-rich, while the dendritic phase consists of approximately equal amounts of Zn and Al (Table 2, Fig. 11). Observation in SEM (BSE-mode) reveals the presence of Pb-nodules, visible as white irregular spots with a scattered distribution, in addition to opaque grey patches which are rich in Al and Fe (Fig. 10).

Fig. 7: SEM-image (BSE-mode) of a selected area from Fig. 4 (detail), showing the metal plating (M1) and the bulk metal (M2),

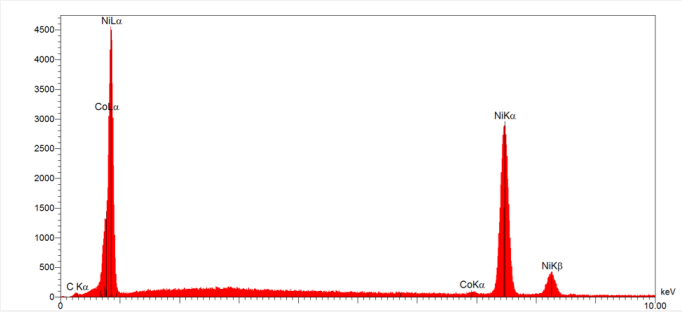
Fig. 8: EDS-spectrum showing the chemical composition of the metal plating (M1). Method of analysis: SEM-EDS. Lab. of Electronic Microscopy and and Microanalysis, Néode, HEI Arc,

The domed cap nut is nickel plated (6-7 micrometers).

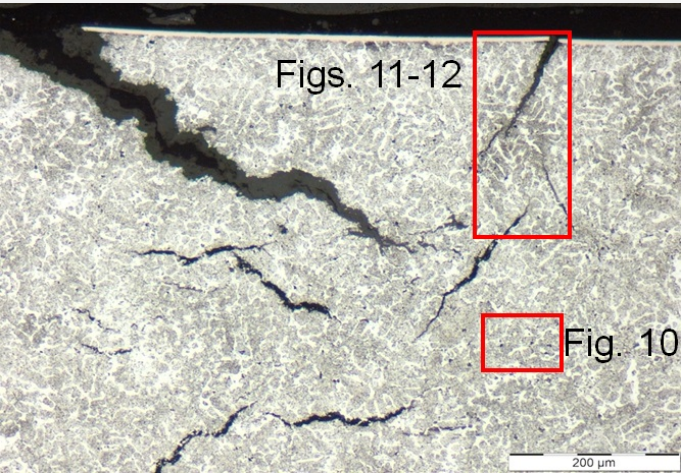
The dendritic phase is heavily oxidized compared to the interdendritic phase (Table 2 and Fig. 12). The corrosion has developed throughout the entire metal body, generating cracks (Fig. 9). The cracks are Zn and O-rich (Fig. 12) and could be composed of zinc carbonate. It could be a case of zinc pest, an intergranular corrosion phenomenon known to cause disintegration in poor quality alloys (Selwyn 2004, Zhang 2011).

Fig. 9: Micrograph of the metal sample from Fig. 4 (detail), unetched, bright field. The dendrites appear light to dark grey while the interdendritic phase appears white. The metal is characterized by surface cracks as well as internal cracks. The lower red rectangle corresponds to Fig. 10 while the areas selected for elemental chemical distributions (Figs. 11 and 12) are marked by the upper red rectangle,

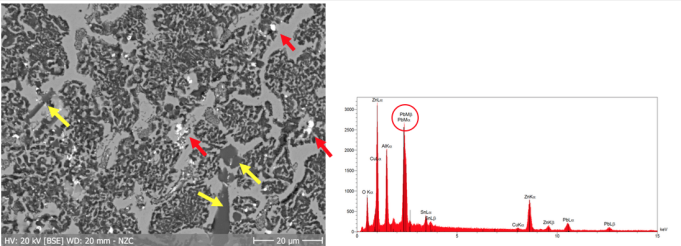
Fig. 10: SEM-image in BSE-mode (left) and EDS-spectrum (right), showing the appearance and the chemical composition of the Pb inclusions (red arrows). The inclusions appear white, the dendrites appear dark grey/black and the interdendritic phase appears grey. Grey opaque patches (yellow arrows) are Fe- and Al-rich phases,

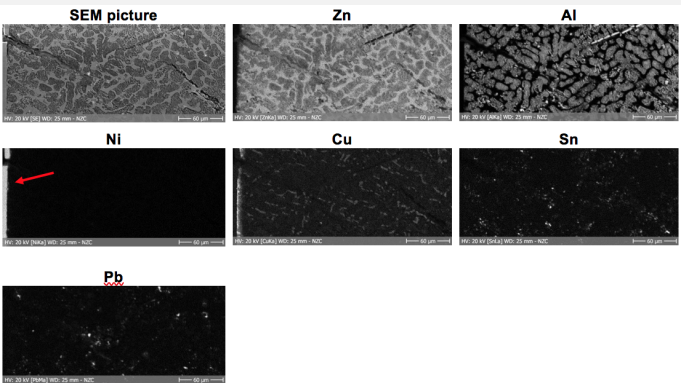
Fig. 11: SEM image and elemental chemical distribution of the selected area from Fig. 9 (rotated 270° and inversed). Method of analysis: SEM-EDS. Lab. of Electronic Microscopy and Microanalysis, Néode, HEI Arc,

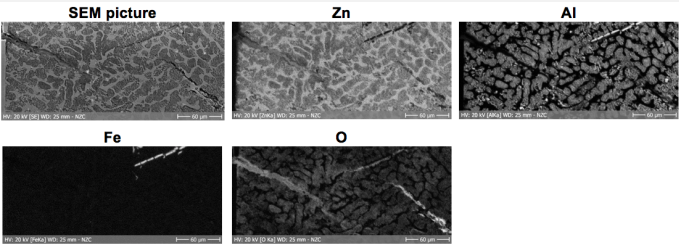
Fig. 12: SEM image and elemental chemical distribution of the selected area from Fig. 9 (rotated 270° and inversed). Method of analysis: SEM-EDS. Lab. of Electronic Microscopy and Microanalysis, Néode, HEI Arc,

The domed cap nut is made of nickel plated Zn/Al/Pb/Cu/Sn alloy. It has a dendritic microstructure, indicative of production by casting (probably a die cast). The deterioration of the metal could be due to absence of cohesion between the different phases which enabled the penetration of oxygen during the manufacture of the alloy and the formation of internal corrosion products, eventually leading to expansion of its internal structure (zinc pest).

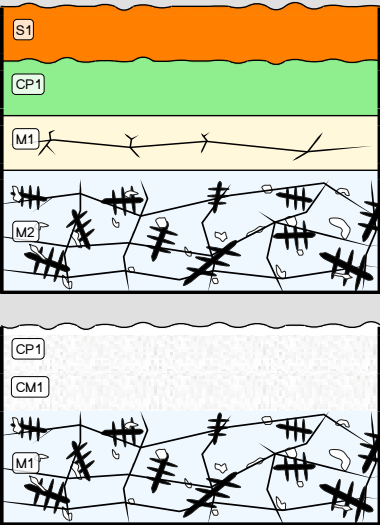
Fig. 5: Stratigraphic representation of the sample taken from the domed cap nut in cross-section (dark field) using the MiCorr application. The characteristics of the strata are only accessible by clicking on the drawing that redirects you to the search tool by stratigraphy representation. Stratigraphy representative of an area with intact metal plating (M1). S1 represents Fe-polluted soil while CP1 is a green translucent corrosion product, Credit UiO-IAKH, M.Hovind.

Fig. 6: Stratigraphic representation of the sample taken from the domed cap nut in cross-section (DF) using the MiCorr application. The characteristics of the strata are only accessible by clicking on the drawing that redirects you to the search tool by stratigraphy representation. Area where the metal plating is missing. CP1 corresponds to CP2 in Fig. 3, CM1 represents the corroded metal phase, while M1 corresponds to the bulk metal (M2 in Fig. 3 and Fig. 5), Credit UiO-IAKH, M.Hovind.
