RAIN GUTTER FRAGMENT – GREY CAST IRON – MODERN TIMES – FRANCE

Artefact name Rain gutter fragment

Authors Christian. Degriigny (HE-Arc CR, Neuchâtel, Neuchâtel, Switzerland) & Mathea. Hovind (University of Oslo, Department of archaeology, conservation and history (IAKH-UiO), Oslo, Oslo, Norway)

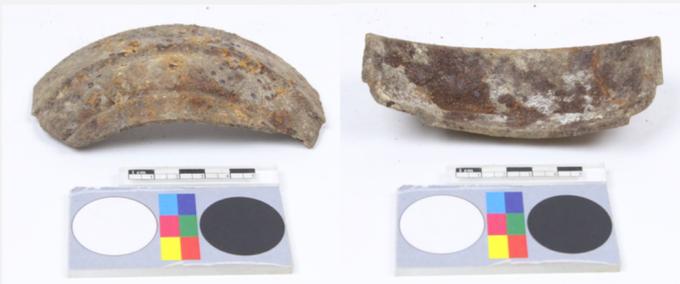
Fig. 1: Rain gutter fragment, exterior and interior faces (to the left and right, respectively),

Description of the artefact	Rain gutter fragment (Fig. 1), possibly part of the extension of a roof drain pipe. Both the exterior and interior surfaces are covered by heterogeneous corrosion crusts. The underlying metal seems however to be well preserved, including features such as a difference in thickness etc. Dimensions: L = 55mm; W (interior) = 120mm; Tmax. = 6mm; WT = 176g.
Type of artefact	Architectural element
Origin	Château de Germolles, Mellecey, Bourgogne, France
Recovering date	Date unknown
Chronology category	Modern Times
chronology tpq	<input type="text" value="1801"/> A.D. ▾
chronology taq	<input type="text" value="2000"/> A.D. ▾
Chronology comment	19th - 20th century
Burial conditions / environment	Outdoor atmosphere
Artefact location	Haute Ecole Arc Conservation-Restoration
Owner	Château de Germolles, Mellecey, Bourgogne

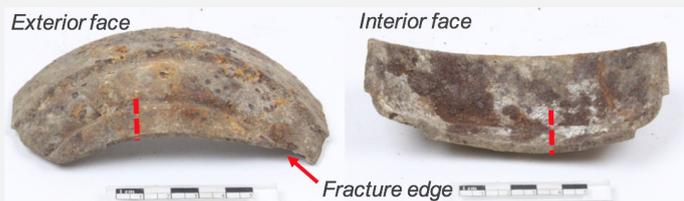
Fig. 2: The exterior and interior faces before sampling. The dotted line represents the sample location (a cross-section of the metal). The fracture edge corresponds to the edge that was formerly attached to the remaining artefact,

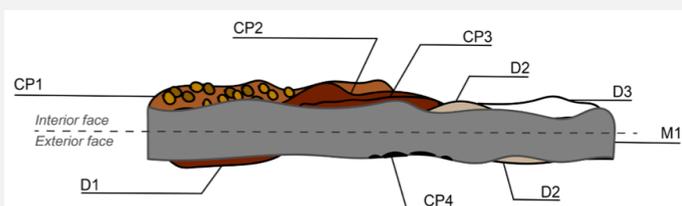
Fig. 3: Preliminary stratigraphy corresponding to the overall surface of the artefact. The interior surface is shown above the stippled line and the exterior surface below. D = Deposit, CP = Corrosion products, M = Metal,

Captions	Description
D1	Scattered, orange to dark red encrustations. Probably corrosion products mixed with soil.
D2	Grey-brown and matte deposit, somewhat powdery - possibly corrosion product mixed with soil. This layer is located both on the interior and exterior surface of the artefact.
D3	Localized, white and strongly adherent deposit.
CP1	Bright orange to dark red corrosion product. Uneven surface with pustules.
CP2	Red-brown corrosion crust. Brittle, but adherent. Flakes off in bits when force is applied perpendicular to the surface with a scalpel.
CP3	Similar to CP2 but appears to be an individual layer.
CP4	Isolated corrosion blisters. Circular and black in colour. Mainly located on the exterior surface.
M1	Intact metal with a dark grey metallic sheen.

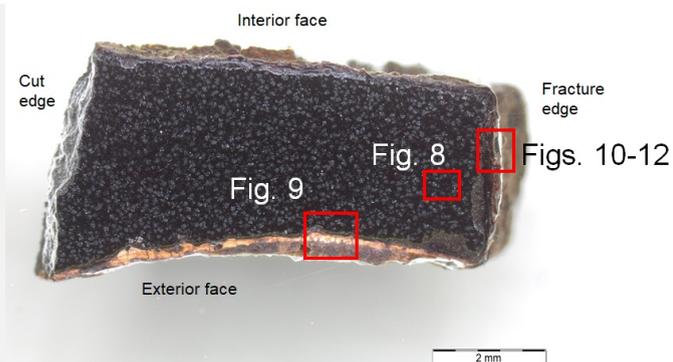
Fig. 4: Micrograph of the sample taken from the rain gutter fragment showing its orientation relative to the artefact and the locations of Figs. 8-12,

Description of sample	The sample consists of a rectangular section (Fig. 4) which was cut out from the fractured edge of the gutter fragment. It is representative of three surfaces: the exterior and interior surface, as well as the fracture edge. Dimensions: L = 7mm; Wmax. = 5mm; Tmax. = 4mm (approx.).
Alloy	Grey cast iron
Technology	Cast
Lab number of sample	CIG2018 (Cast Iron Gutter, sampled in 2018)
Sample location	Haute Ecole Arc Conservation-Restauration
Responsible institution	Haute Ecole Arc Conservation-Restauration
Date and aim of sampling	March 2018, study of corrosion stratigraphy and chemical analyses

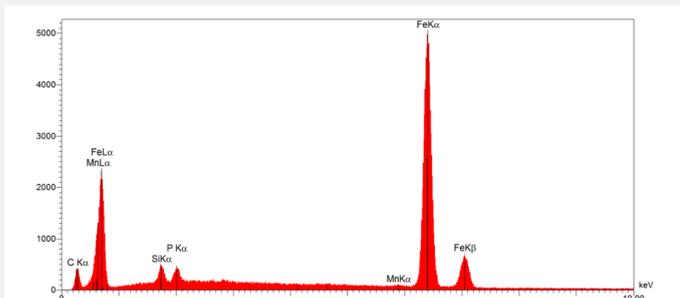
The metal is a P-rich grey cast iron with Si and Mn (Fig. 7). Its microstructure is characterized by evenly distributed graphite flakes in a matrix composed of dendrites and an interdendritic eutectic phase (Fig. 8). What appears to be irregular graphite flakes / porosity is in fact deformed graphite flakes; graphite is soft and prone to destruction by smearing and/or preferential removal during polishing (Scott 1991).

Fig. 7: EDS-spectrum showing the chemical composition of the metal. Method of analysis: SEM-EDS. Lab. of Electronic Microscopy and Microanalysis, Néode, HEI Arc,

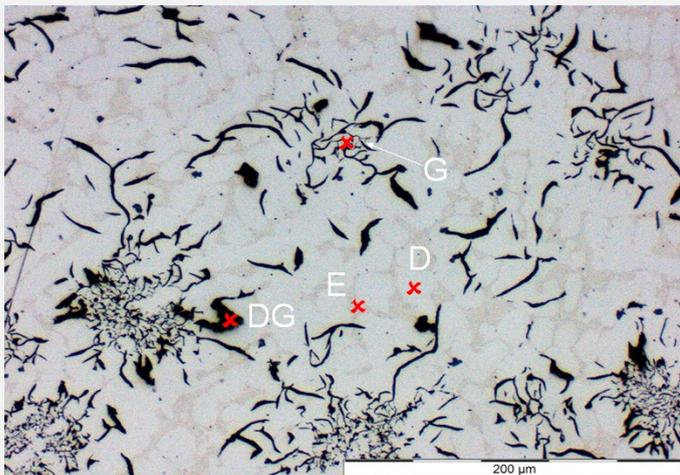
The dendrites appear light grey under polarized light, while the eutectic phase appear light brown (Fig. 8). The eutectic phase is rich in Fe and P and contains small amounts of C and Si, whereas the dendritic phase contains much less P (Table 1).

Fig. 8: Micrograph of the metal sample from Fig. 4 (detail). Unetched, bright field. Graphite flakes (G) in black, the dendrites (D) in light grey and the eutectoid phase (E) in light brown. Deformed graphite (DG) flakes are visible as irregular black inclusions,

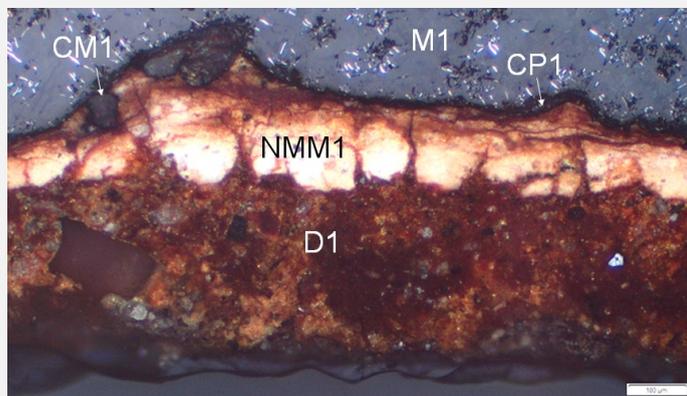
The exterior face (Figs. 2, 4 and 9) consists of a white / light yellow cracked layer (NMM1 in Fig. 5) superimposed by a layer of deposit mixed with orange-red corrosion products (D1 in Fig. 5). Punctual analysis by SEM-EDS (Table 2) revealed that the white / light yellow layer is rich in Ba, O, S, Fe, C and Zn. It has a chemical composition similar to Lithopone (BaSO₄,ZnS), a preparatory paint layer. Fe is probably a contamination from the superimposed porous deposit / corrosion product D1 (Table 2). The latter (D1) is Fe- and O-rich and contains Si, Al and some Ca, in addition to a range of elements (K, P, Na, Cl, S and Ti) present in minor amounts (Table 2). A thin layer of corrosion products (CP1) is located just beneath the paint layer, appearing dark grey under polarized light (Fig. 9). This layer is followed by a corroded metal phase (CM1). Their exact composition was not analyzed but is likely to correspond to the corroded metal phase of the fracture edge, described below.

Fig. 9: Micrograph of the metal sample from Fig. 4 (detail), unetched, polarized light, 5x. The stratigraphy of the exterior surface, from top to bottom: the metal (M1) in grey, a layer of corroded metal (CM1) followed by a thin layer of CP1, and a white cracked layer (NMM1) superimposed by a porous dark-red deposit (D1),

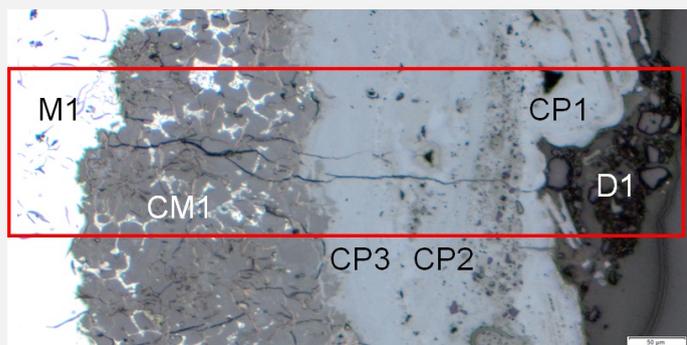
The interior face (Figs. 2 and 4) shows similar characteristics but does not include a white layer similar to NMM1. The fracture edge however (Figs. 2, 4 and 10), shows a more complex stratigraphy consisting of a dense product layer which can be further divided into two individual strata (CP3 and CP2), superimposed by a porous corrosion crust appearing orange under polarized light (CP1) (Fig. 11). The corroded metal (CM1) is located just beneath CP3 and contains remnants of the P-rich eutectic phase (Figs. 10-12). The M/CP ratio (metal to corrosion products) is rather high, implying extensive internal corrosion. Furthermore, a simple crack is traversing the corrosion layers – indicating a fragilization of the structure. As for the composition of the corrosion products CP1, CP2 and CP3, they all contain Fe and O (Fig. 12). A marbling effect within CP2 and CP3 indicates a variation in the concentration of Fe and O (particularly visible in bright field - Fig. 10). The white deposit (D1 in Fig. 6) might originate from exposure to calcareous water (Table 2). The presence of exogenous elements such as Si, Ca, Al, Na and O (Table 2) was confirmed by elemental mapping (Fig. 12).

Fig. 10: Micrograph of the metal sample from Fig. 4 (detail), unetched, bright field. From left to right: intact metal (M1) in white, followed by preferentially corroded metal (CM1) and dense product layers (CP3 and CP2) in various shades of grey. CP1 is slightly porous and covered by grain-like particles (D1). The area selected for elemental chemical distribution (Fig. 12) is marked by a red rectangle. A simple crack is traversing the corrosion layers,

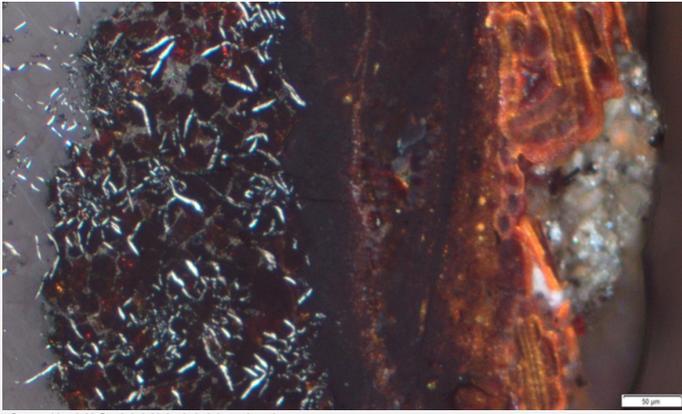
Fig. 11: Micrograph similar to Fig. 10 but under polarized light. The external deposit (D1) appears grey-white, CP1 in bright orange, while CP2 and CP3 appear dark red to brown. The corroded metal (CM1) contains remnants of graphite flakes (in white) and the P-rich eutectic (in grey),

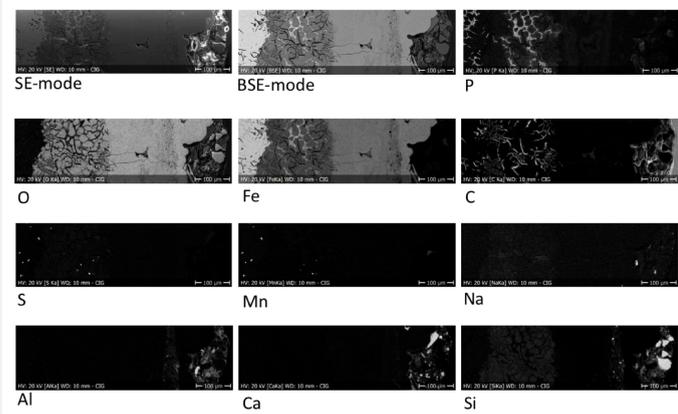
Fig. 12: SEM image and elemental chemical distribution of the selected area from Fig. 10. Method of analysis: SEM-EDS. Lab. of Electronic Microscopy and Microanalysis, Néode, HEI Arc,

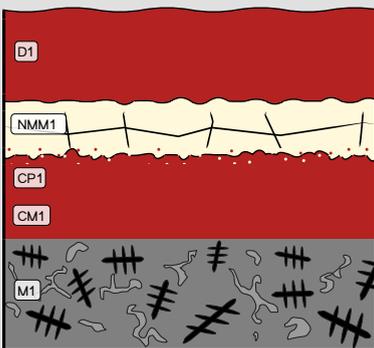
Fig. 5: Stratigraphic representation of the sample taken from the rain gutter fragment in cross-section (dark field) using the MiCorr application. The characteristics of the strata are only accessible by clicking on the drawing that redirects you to the search tool by stratigraphy representation. This representation can be compared to Fig. 9. CP1 corresponds to CP2 in Fig. 3, Credit UiO-IAKH, M.Hovind.

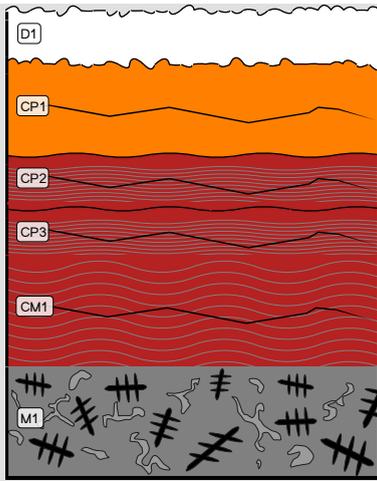
Fig. 6: Stratigraphic representation of the sample taken from the rain gutter fragment in cross-section (dark field) using the MiCorr application. The characteristics of the strata are only accessible by clicking on the drawing that redirects you to the search tool by stratigraphy representation. This representation can be compared to Fig. 11. D1 corresponds to D3 in Fig. 3, Credit UiO-IAKH, M.Hovind.

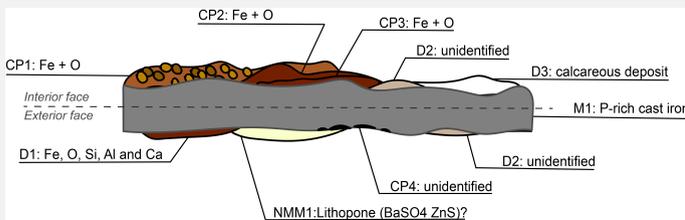
Fig. 13: Improved stratigraphic representation of the rain gutter fragment with results of SEM-EDS analysis and visual microscopic observation,

The rain gutter fragment is a grey cast iron with a microstructure consisting of graphite flakes and a P-rich eutectic phase. The exterior surface contains a preparatory paint layer, located beneath a layer of corrosion products mixed with soil. It seems likely that the cast iron gutter has been covered with a protective paint layer (e.g. Lithopone) to slow down the rate of atmospheric corrosion. The presence of Lithopone reinforces the suggested dating of the artefact (20th century) as this pigment was developed and used from the 1880s and onwards (Lithopone 2007). However, it seems that the protective layer has none or only very limited effect as (pitting) corrosion is present also in these areas.

The corrosion layers consist mainly of Fe and O, indicating atmospheric corrosion with presence of only a very small amount of contaminants/pollution. The scattered white deposit is possibly originating from exposure to calcareous water as it is localized mainly on the interior face of the fragment, where rain water would hit the metal before entering the ground.
