# RAIN GUTTER FRAGMENT – GREY CAST IRON – MODERN TIMES – FRANCE

**Artefact name** Rain gutter fragment

**Authors** Christian. Degriigny (HE-Arc CR, Neuchâtel, Neuchâtel, Switzerland) & Mathea. Hovind (University of Oslo, Department of archaeology, conservation and history (IAKH-UiO), Oslo, Oslo, Norway)

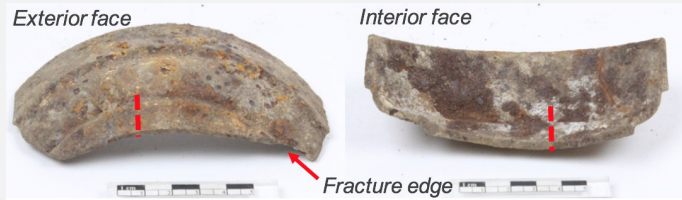
Fig. 2: The exterior and interior faces before sampling. The dotted line represents the sample location (a cross-section of the metal). The fracture edge corresponds to the edge that was formerly attached to the remaining artefact,

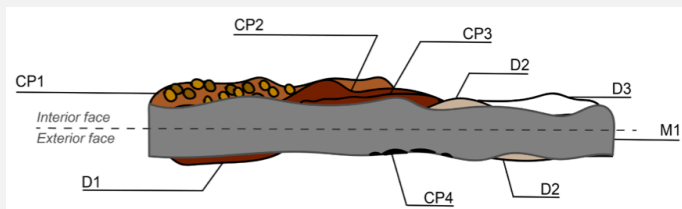
Fig. 3: Preliminary stratigraphy corresponding to the overall surface of the artefact. The interior surface is shown above the stippled line and the exterior surface below. D = Deposit, CP = Corrosion products, M = Metal,

Captions	Description
D1	Scattered, orange to dark red encrustations. Probably corrosion products mixed with soil.
D2	Grey-brown and matte deposit, somewhat powdery - possibly corrosion product mixed with soil. This layer is located both on the interior and exterior surface of the artefact.
D3	Localized, white and strongly adherent deposit.
CP1	Bright orange to dark red corrosion product. Uneven surface with pustules.
CP2	Red-brown corrosion crust. Brittle, but adherent. Flakes off in bits when force is applied perpendicular to the surface with a scalpel.
CP3	Similar to CP2 but appears to be an individual layer.
CP4	Isolated corrosion blisters. Circular and black in colour. Mainly located on the exterior surface.
M1	Intact metal with a dark grey metallic sheen.

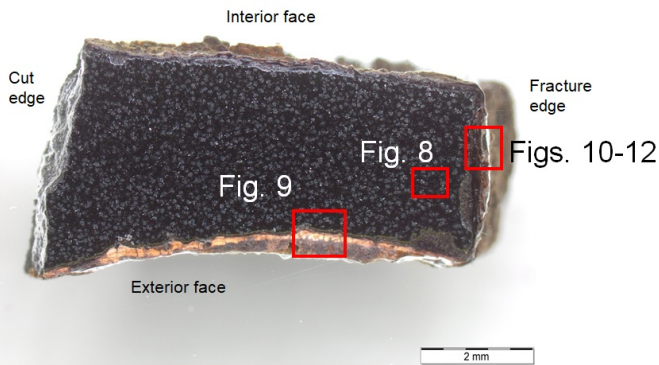
Fig. 4: Micrograph of the sample taken from the rain gutter fragment showing its orientation relative to the artefact and the

locations of Figs. 8-12,

<b>Description of sample</b>	The sample consists of a rectangular section (Fig. 4) which was cut out from the fractured edge of the gutter fragment. It is representative of three surfaces: the exterior and interior surface, as well as the fracture edge. Dimensions: L = 7mm; Wmax. = 5mm; Tmax. = 4mm (approx.).
<b>Alloy</b>	Grey cast iron
<b>Technology</b>	Cast
<b>Lab number of sample</b>	CIG2018 (Cast Iron Gutter, sampled in 2018)
<b>Sample location</b>	Haute Ecole Arc Conservation-Restauration
<b>Responsible institution</b>	Haute Ecole Arc Conservation-Restauration
<b>Date and aim of sampling</b>	March 2018, study of corrosion stratigraphy and chemical analyses

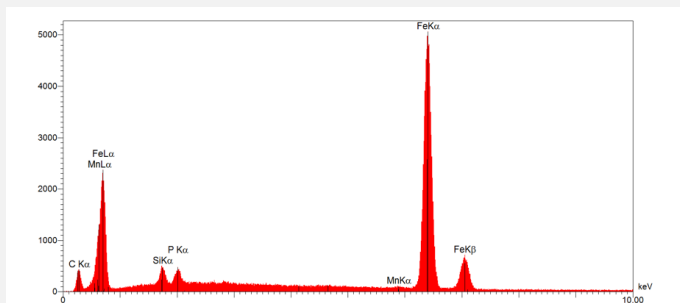
The metal is a P-rich grey cast iron with Si and Mn (Fig. 7). Its microstructure is characterized by evenly distributed graphite flakes in a matrix composed of dendrites and an interdendritic eutectic phase (Fig. 8). What appears to be irregular graphite flakes / porosity is in fact deformed graphite flakes; graphite is soft and prone to destruction by smearing and/or preferential removal during polishing (Scott 1991).

Fig. 7: EDS-spectrum showing the chemical composition of the metal. Method of analysis: SEM-EDS. Lab. of Electronic Microscopy and Microanalysis, Néode, HEI Arc,

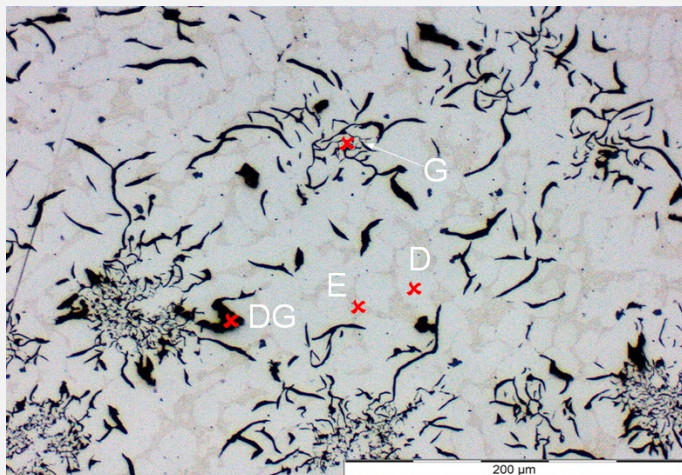
The dendrites appear light grey under polarized light, while the eutectic phase appear light brown (Fig. 8). The eutectic phase is rich in Fe and P and contains small amounts of C and Si, whereas the dendritic phase contains much less P (Table 1).

Fig. 8: Micrograph of the metal sample from Fig. 4 (detail). Unetched, bright field. Graphite flakes (G) in black, the dendrites (D) in light grey and the eutectoid phase (E) in light brown. Deformed graphite (DG) flakes are visible as irregular black inclusions,

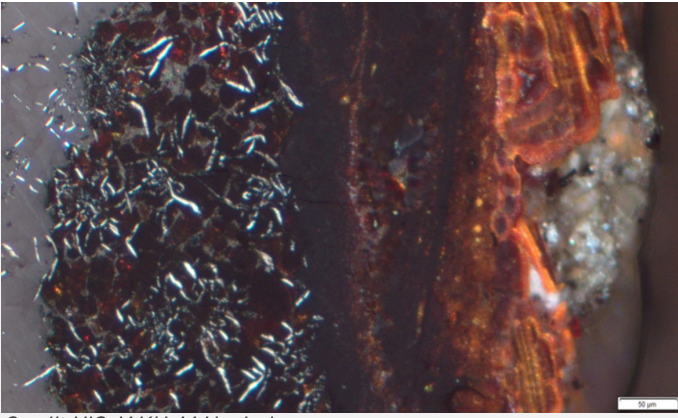
Fig. 11: Micrograph similar to Fig. 10 but under polarized light. The external deposit (D1) appears grey-white, CP1 in bright orange, while CP2 and CP3 appear dark red to brown. The corroded metal (CM1) contains remnants of graphite flakes (in white) and the P-rich eutectic (in grey),

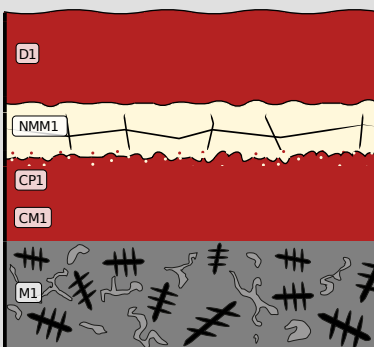
Fig. 5: Stratigraphic representation of the sample taken from the rain gutter fragment in cross-section (dark field) using the MiCorr application. The characteristics of the strata are only accessible by clicking on the drawing that redirects you to the search tool by stratigraphy representation. This representation can be compared to Fig. 9. CP1 corresponds to CP2 in Fig. 3, Credit UiO-IAKH, M.Hovind.

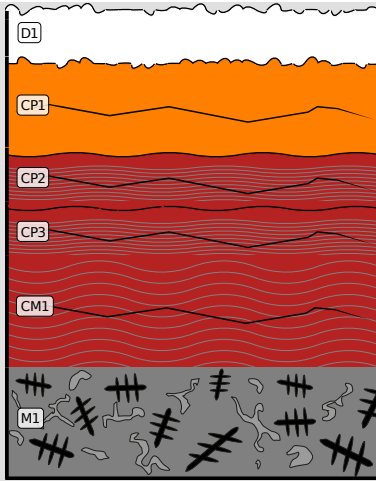
Fig. 6: Stratigraphic representation of the sample taken from the rain gutter fragment in cross-section (dark field) using the MiCorr application. The characteristics of the strata are only accessible by clicking on the drawing that redirects you to the search tool by stratigraphy representation. This representation can be compared to Fig. 11. D1 corresponds to D3 in Fig. 3, Credit UiO-IAKH, M.Hovind.

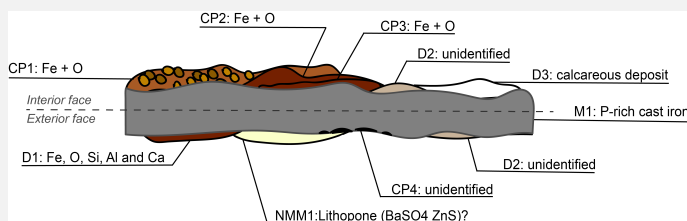
Fig. 13: Improved stratigraphic representation of the rain gutter fragment with results of SEM-EDS analysis and visual microscopic observation,

The rain gutter fragment is a grey cast iron with a microstructure consisting of graphite flakes and a P-rich eutectic phase. The exterior surface contains a preparatory paint layer, located beneath a layer of corrosion products mixed with soil. It seems likely that the cast iron gutter has been covered with a protective paint layer (e.g. Lithopone) to slow down the rate of atmospheric corrosion. The presence of Lithopone reinforces the suggested dating of the artefact (20th century) as this pigment was developed and used from the 1880s and onwards (Lithopone 2007). However, it seems that the protective layer has none or only very limited effect as (pitting) corrosion is present also in these areas.

The corrosion layers consist mainly of Fe and O, indicating atmospheric corrosion with presence of only a very small amount of contaminants/pollution. The scattered white deposit is possibly originating from exposure to calcareous water as it is localized mainly on the interior face of the fragment, where rain water would hit the metal before entering the ground.
