RAIN GUTTER FRAGMENT – GREY CAST IRON – MODERN TIMES – FRANCE

Artefact name Rain gutter fragment

Authors Christian. Degriigny (HE-Arc CR, Neuchâtel, Neuchâtel, Switzerland) & Mathea. Hovind (University of Oslo, Department of archaeology, conservation and history (IAKH-UiO), Oslo, Oslo, Norway)

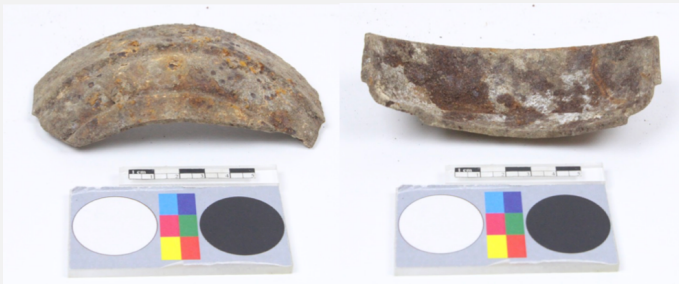
Fig. 1: Rain gutter fragment, exterior and interior faces (to the left and right, respectively),

Description of the artefact	Rain gutter fragment (Fig. 1), possibly part of the extension of a roof drain pipe. Both the exterior and interior surfaces are covered by heterogeneous corrosion crusts. The underlying metal seems however to be well preserved, including features such as a difference in thickness etc. Dimensions: L = 55mm; W (interior) = 120mm; Tmax. = 6mm; WT = 176g.
Type of artefact	Architectural element
Origin	Château de Germolles (14th century), Mellecey, Bourgogne, France
Recovering date	Date unknown
Chronology category	Modern Times
chronology tpq	<input type="text" value="1801"/> A.D. ∨
chronology taq	<input type="text" value="2000"/> A.D. ∨
Chronology comment	19th - 20th century
Burial conditions / environment	Outdoor atmosphere
Artefact location	Haute Ecole Arc Conservation-Restauration
Owner	Château de Germolles, Mellecey, Bourgogne

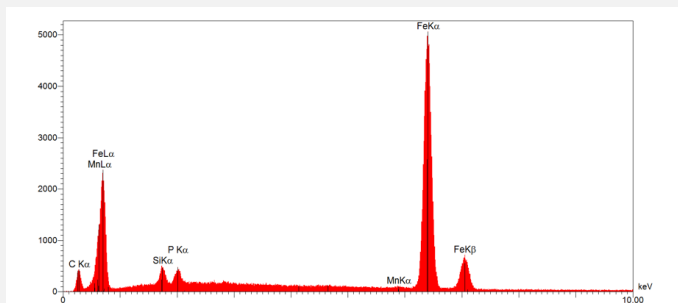
The metal is a P-rich grey cast iron with Si and Mn (Fig. 7). Its microstructure is characterized by evenly distributed graphite flakes in a matrix composed of dendrites and an interdendritic eutectic phase (Fig. 8). What appears to be irregular graphite flakes / porosity is in fact deformed graphite flakes; graphite is soft and prone to destruction by smearing and/or preferential removal during polishing (Scott 1991).

Fig. 7: EDS-spectrum showing the chemical composition of the metal. Method of analysis: SEM-EDS. Lab. of Electronic Microscopy and Microanalysis, Néode, HEI Arc,

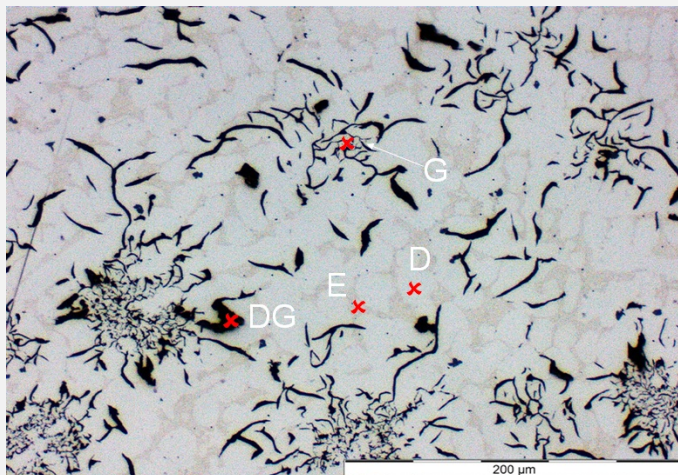
The dendrites appear light grey under polarized light, while the eutectic phase appear light brown (Fig. 8). The eutectic phase is rich in Fe and P and contains small amounts of C and Si, whereas the dendritic phase contains much less P (Table 1).

Fig. 8: Micrograph of the metal sample from Fig. 4 (detail). Unetched, bright field. Graphite flakes (G) in black, the dendrites (D) in light grey and the eutectoid phase (E) in light brown. Deformed graphite (DG) flakes are visible as irregular black inclusions,

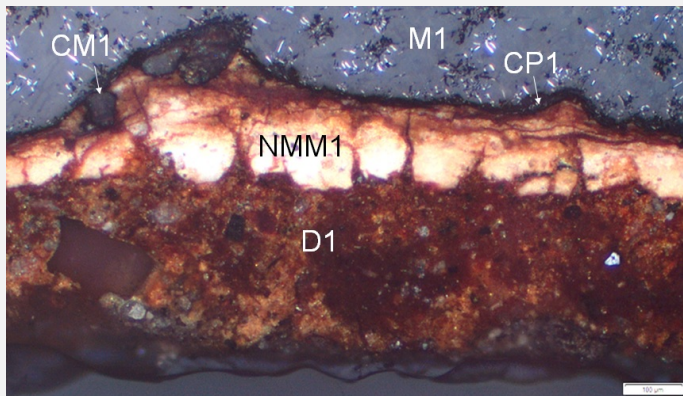
The exterior face (Figs. 2, 4 and 9) consists of a white / light yellow cracked layer (NMM1 in Fig. 5) superimposed by a layer of deposit mixed with orange-red corrosion products (D1 in Fig. 5). Punctual analysis by SEM-EDS (Table 2) revealed that the white / light yellow layer is rich in Ba, O, S, Fe, C and Zn. It has a chemical composition similar to Lithopone (BaSO₄,ZnS), a preparatory paint layer. Fe is probably a contamination from the superimposed porous deposit / corrosion product D1 (Table 2). The latter (D1) is Fe- and O-rich and contains Si, Al and some Ca, in addition to a range of elements (K, P, Na, Cl, S and Ti) present in minor amounts (Table 2). A thin layer of corrosion products (CP1) is located just beneath the paint layer, appearing dark grey under polarized light (Fig. 9). This layer is followed by a corroded metal phase (CM1). Their exact composition was not analyzed but is likely to correspond to the corroded metal phase of the fracture edge, described below.

Table 2: Chemical composition of the strata from Fig. 9. Method of analysis: SEM-EDS. Lab. of Electronic Microscopy and Microanalysis, Néode, HEI Arc, credit MiCorr_HEI Arc, C.Csefalvay. *The value is the calculated average of three analyses of the same feature, but in different areas.

Fig. 9: Micrograph of the metal sample from Fig. 4 (detail), unetched, polarized light, 5x. The stratigraphy of the exterior surface, from top to bottom: the metal (M1) in grey, a layer of corroded metal (CM1) followed by a thin layer of CP1, and a white cracked layer (NMM1) superimposed by a porous dark-red deposit (D1),

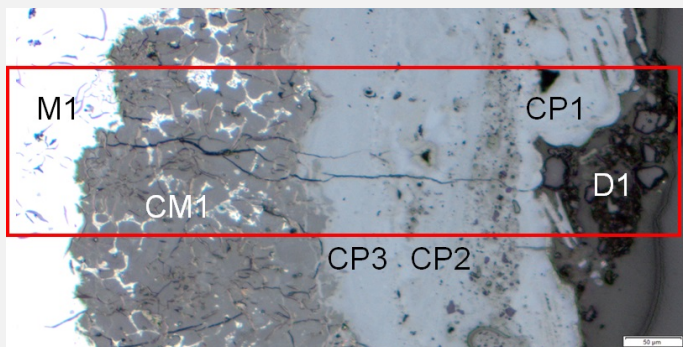
The interior face (Figs. 2 and 4) shows similar characteristics but does not include a white layer similar to NMM1. The fracture edge however (Figs. 2, 4 and 10), shows a more complex stratigraphy consisting of a dense product layer which can be further divided into two individual strata (CP3 and CP2), superimposed by a porous corrosion crust appearing orange under polarized light (CP1) (Fig. 11). The corroded metal (CM1) is located just beneath CP3 and contains remnants of the P-rich eutectic phase (Figs. 10-12). The M/CP ratio (metal to corrosion products) is rather high, implying extensive internal corrosion. Furthermore, a simple crack is traversing the corrosion layers – indicating a fragilization of the structure. As for the composition of the corrosion products CP1, CP2 and CP3, they all contain Fe and O (Fig. 12). A marbling effect within CP2 and CP3 indicates a variation in the concentration of Fe and O (particularly visible in bright field - Fig. 10). The white deposit (D1 in Fig. 6) might originate from exposure to calcareous water (Table 2). The presence of exogenous elements such as Si, Ca, Al, Na and O (Table 2) was confirmed by elemental mapping (Fig. 12).

Fig. 10: Micrograph of the metal sample from Fig. 4 (detail), unetched, bright field. From left to right: intact metal (M1) in white, followed by preferentially corroded metal (CM1) and dense product layers (CP3 and CP2) in various shades of grey. CP1 is slightly porous and covered by grain-like particles (D1). The area selected for elemental chemical distribution (Fig. 12) is marked by a red rectangle. A simple crack is traversing the corrosion layers,

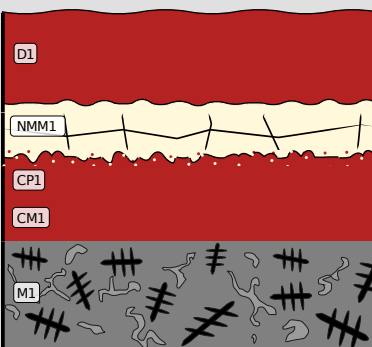
Fig. 5: Stratigraphic representation of the sample taken from the rain gutter fragment in cross-section (dark field) using the MiCorr application. The characteristics of the strata are only accessible by clicking on the drawing that redirects you to the search tool by stratigraphy representation. This representation can be compared to Fig. 9. CP1 corresponds to CP2 in Fig. 3, Credit UiO-IAKH, M.Hovind.

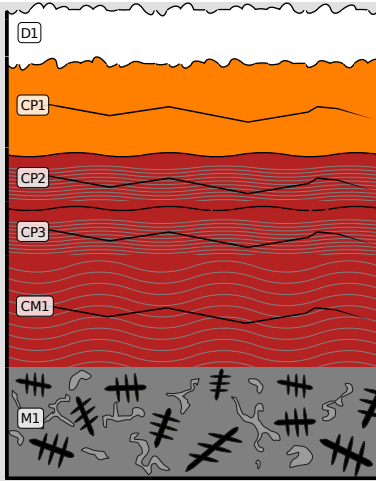
Fig. 6: Stratigraphic representation of the sample taken from the rain gutter fragment in cross-section (dark field) using the MiCorr application. The characteristics of the strata are only accessible by clicking on the drawing that redirects you to the search tool by stratigraphy representation. This representation can be compared to Fig. 11. D1 corresponds to D3 in Fig. 3, Credit UiO-IAKH, M.Hovind.
