# RAIN GUTTER FRAGMENT - GREY CAST IRON - MODERN TIMES - FRANCE

**Artefact name** Rain gutter fragment

**Authors** Christian. Degrigny (HE-Arc CR, Neuchâtel, Neuchâtel, Switzerland) & Mathea. Hovind (University of Oslo, Department of archaeology, conservation and history (IAKH-UoO), Oslo, Oslo, Norway)

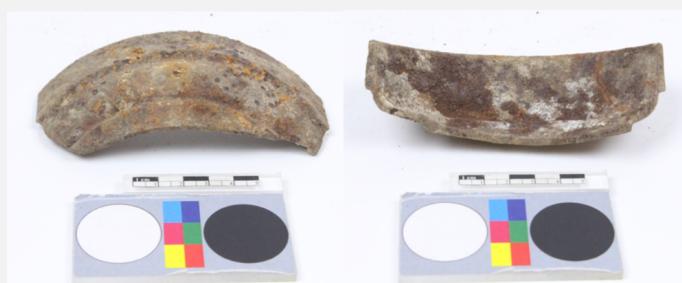
Fig. 1: Rain gutter fragment, exterior and interior faces (to the left and right, respectively).

Rain gutter fragment (Fig. 1), possibly part of the extension of a roof drain pipe. Both the exterior and interior surfaces are covered by heterogeneous corrosion crusts. The underlying metal seems however to be well preserved, including features such as a difference in thickness etc. Dimensions: L = 55mm; W (interior) = 120mm; Tmax. = 6mm; WT = 176g.

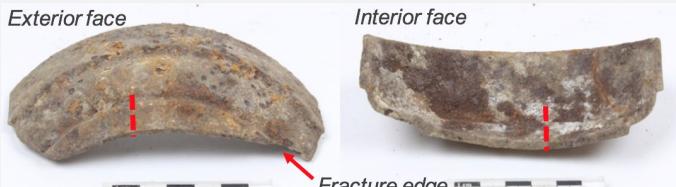
Fig. 2: The exterior and interior faces before sampling. The dotted line represents the sample location (a cross-section of the metal). The fracture edge corresponds to the edge that was formerly attached to the remaining artefact,

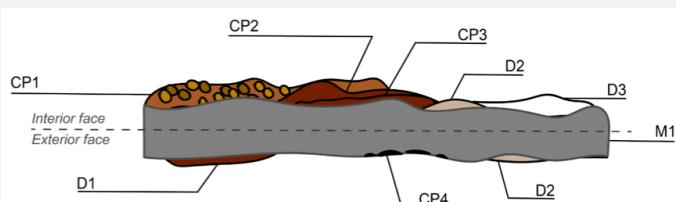
Captions	Description
D1	Scattered, orange to dark red encrustations. Probably corrosion products mixed with soil.
D2	Grey-brown and matte deposit, somewhat powdery - possibly corrosion product mixed with soil. This layer is located both on the interior and exterior surface of the artefact.
D3	Localized, white and strongly adherent deposit.
CP1	Bright orange to dark red corrosion product. Uneven surface with pustules.
CP2	Red-brown corrosion crust. Brittle, but adherent. Flakes off in bits when force is applied perpendicular to the surface with a scalpel.
CP3	Similar to CP2 but appears to be an individual layer.
CP4	Isolated corrosion blisters. Circular and black in colour. Mainly located on the exterior surface.
M1	Intact metal with a dark grey metallic sheen.

Fig. 3: Preliminary stratigraphy corresponding to the overall surface of the artefact. The interior surface is shown above the stippled line and the exterior surface below. D = Deposit, CP = Corrosion products, M = Metal,

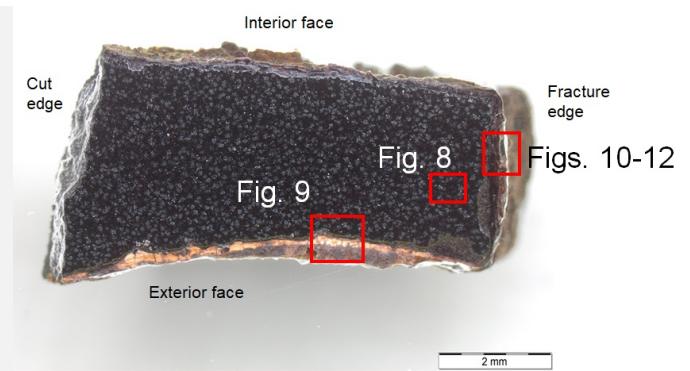
Fig. 4: Micrograph of the sample taken from the rain gutter fragment showing its orientation relative to the artefact and the locations of Figs. 8-12,

The sample consists of a rectangular section (Fig. 4) which was cut out from the fractured edge of the gutter fragment. It is representative of three surfaces: the exterior and interior surface, as well as the fracture edge. Dimensions: L = 7mm; Wmax. = 5mm; Tmax. = 4mm (approx.).

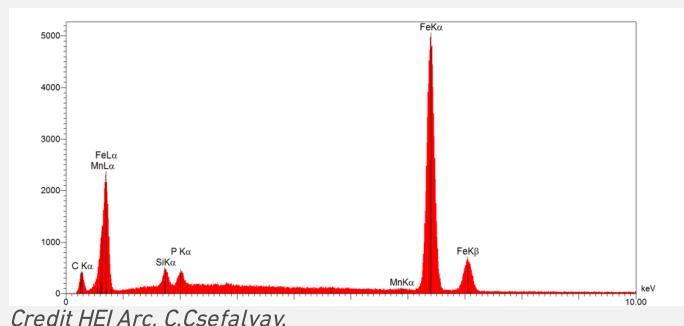
The metal is a P-rich grey cast iron with Si and Mn (Fig. 7). Its microstructure is characterized by evenly distributed graphite flakes in a matrix composed of dendrites and an interdendritic eutectic phase (Fig. 8). What appears to be irregular graphite flakes / porosity is in fact deformed graphite flakes; graphite is soft and prone to destruction by smearing and/or preferential removal during polishing (Scott 1991).

Fig. 7: EDS-spectrum showing the chemical composition of the metal. Method of analysis: SEM-EDS. Lab. of Electronic Microscopy and Microanalysis, Néode, HEI Arc,

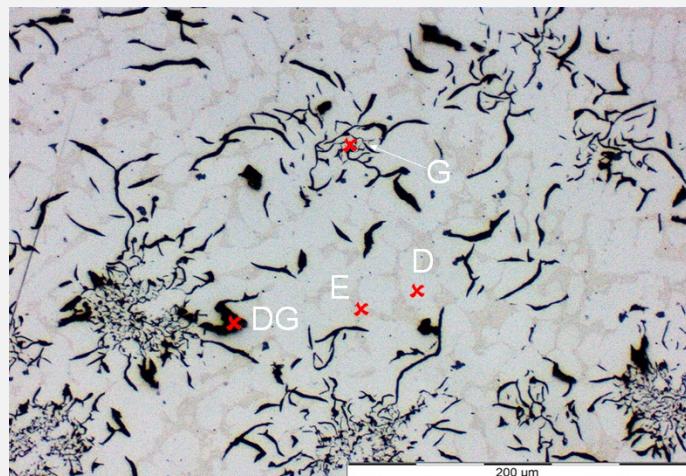
The dendrites appear light grey under polarized light, while the eutectic phase appear light brown (Fig. 8). The eutectic phase is rich in Fe and P and contains small amounts of C and Si, whereas the dendritic phase contains much less P (Table 1).

Fig. 8: Micrograph of the metal sample from Fig. 4 (detail). Unetched, bright field. Graphite flakes (G) in black, the dendrites (D) in light grey and the eutectoid phase (E) in light brown. Deformed graphite (DG) flakes are visible as irregular black inclusions,

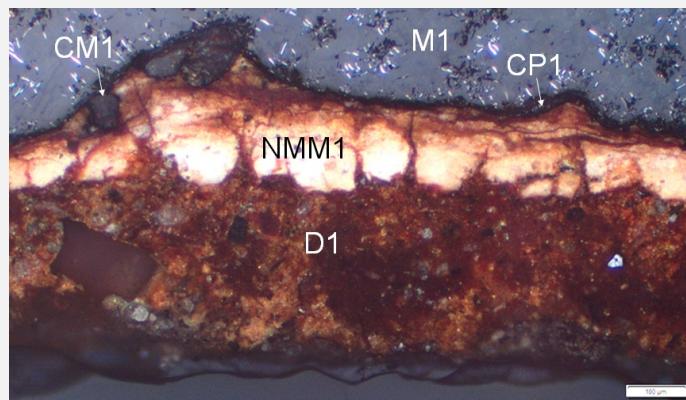
The exterior face (Figs. 2, 4 and 9) consists of a white / light yellow cracked layer (NMM1 in Fig. 5) superimposed by a layer of deposit mixed with orange-red corrosion products (D1 in Fig. 5). Punctual analysis by SEM-EDS (Table 2) revealed that the white / light yellow layer is rich in Ba, O, S, Fe, C and Zn. It has a chemical composition similar to Lithopone (BaSO<sub>4</sub>,ZnS), a preparatory paint layer. Fe is probably a contamination from the superimposed porous deposit / corrosion product D1 (Table 2). The latter (D1) is Fe- and O-rich and contains Si, Al and some Ca, in addition to a range of elements (K, P, Na, Cl, S and Ti) present in minor amounts (Table 2). A thin layer of corrosion products (CP1) is located just beneath the paint layer, appearing dark grey under polarized light (Fig. 9). This layer is followed by a corroded metal phase (CM1). Their exact composition was not analyzed but is likely to correspond to the corroded metal phase of the fracture edge, described below.

Fig. 9: Micrograph of the metal sample from Fig. 4 (detail), unetched, polarized light, 5x. The stratigraphy of the exterior surface, from top to bottom: the metal (M1) in grey, a layer of corroded metal (CM1) followed by a thin layer of CP1, and a white cracked layer (NMM1) superimposed by a porous dark-red deposit (D1),

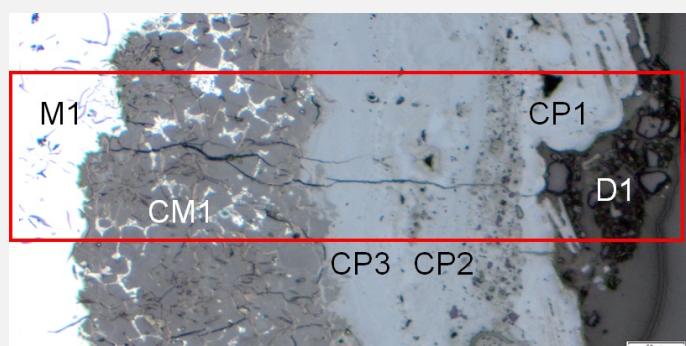
The interior face (Figs. 2 and 4) shows similar characteristics but does not include a white layer similar to NMM1. The fracture edge however (Figs. 2, 4 and 10), shows a more complex stratigraphy consisting of a dense product layer which can be further divided into two individual strata (CP3 and CP2), superimposed by a porous corrosion crust appearing orange under polarized light (CP1) (Fig. 11). The corroded metal (CM1) is located just beneath CP3 and contains remnants of the P-rich eutectic phase (Figs. 10-12). The M/CP ratio (metal to corrosion products) is rather high, implying extensive internal corrosion. Furthermore, a simple crack is traversing the corrosion layers – indicating a fragilization of the structure. As for the composition of the corrosion products CP1, CP2 and CP3, they all contain Fe and O (Fig. 12). A marbling effect within CP2 and CP3 indicates a variation in the concentration of Fe and O (particularly visible in bright field - Fig. 10). The white deposit (D1 in Fig. 6) might originate from exposure to calcareous water (Table 2). The presence of exogenous elements such as Si, Ca, Al, Na and O (Table 2) was confirmed by elemental mapping (Fig. 12).

Fig. 10: Micrograph of the metal sample from Fig. 4 (detail), unetched, bright field. From left to right: intact metal (M1) in white, followed by preferentially corroded metal (CM1) and dense product layers (CP3 and CP2) in various shades of grey. CP1 is slightly porous and covered by grain-like particles (D1). The area selected for elemental chemical distribution (Fig. 12) is marked by a red rectangle. A simple crack is traversing the corrosion layers,

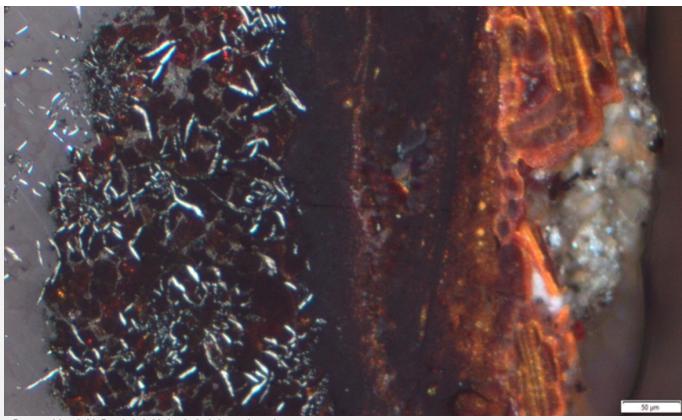
Fig. 11: Micrograph similar to Fig. 10 but under polarized light. The external deposit (D1) appears grey-white, CP1 in bright orange, while CP2 and CP3 appear dark red to brown. The corroded metal (CM1) contains remnants of graphite flakes (in white) and the P-rich eutectic (in grey),

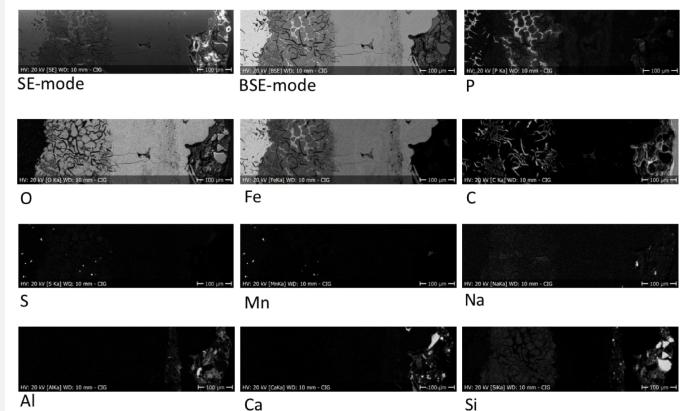
Fig. 12: SEM image and elemental chemical distribution of the selected area from Fig. 10. Method of analysis: SEM-EDS. Lab. of Electronic Microscopy and Microanalysis, Néode, HEI Arc,

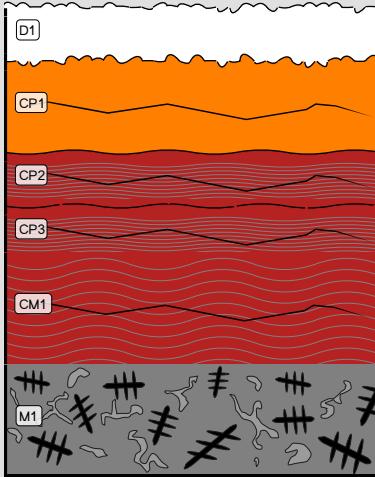
Fig. 6: Stratigraphic representation of the sample taken from the rain gutter fragment in cross-section (dark field) using the MiCorr application. The characteristics of the strata are only accessible by clicking on the drawing that redirects you to the search tool by stratigraphy representation. This representation can be compared to Fig. 11. D1 corresponds to D3 in Fig. 3, Credit UiO-IAKH, M.Hovind.

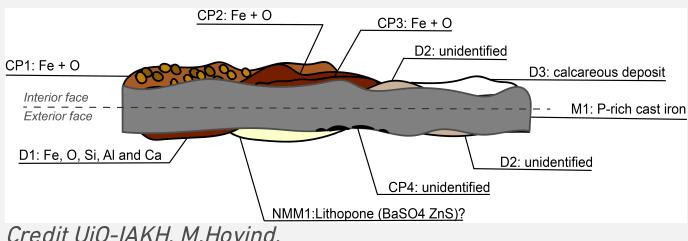
Fig. 13: Improved stratigraphic representation of the rain gutter fragment with results of SEM-EDS analysis and visual microscopic observation,

The rain gutter fragment is a grey cast iron with a microstructure consisting of graphite flakes and a P-rich eutectic phase. The exterior surface contains a preparatory paint layer, located beneath a layer of corrosion products mixed with soil. It seems likely that the cast iron gutter has been covered with a protective paint layer (e.g. Lithopone) to slow down the rate of atmospheric corrosion. The presence of Lithopone reinforces the suggested dating of the artefact (20th century) as this pigment was developed and used from the 1880s and onwards (Lithopone 2007). However, it seems that the protective layer has none or only very limited effect as (pitting) corrosion is present also in these areas.

The corrosion layers consist mainly of Fe and O, indicating atmospheric corrosion with presence of only a very small amount of contaminants/pollution. The scattered white deposit is possibly originating from exposure to calcareous water as it is localized mainly on the interior face of the fragment, where rain water would hit the metal before entering the ground.
