RAIN GUTTER FRAGMENT – GREY CAST IRON – MODERN TIMES – FRANCE

Artefact name	Rain gutter fragment
Authors	Christian. Degriigny (HE-Arc CR, Neuchâtel, Neuchâtel, Switzerland) & Mathea. Hovind (University of Oslo, Department of archaeology, conservation and history (IAKH-UiO), Oslo, Oslo, Norway)
Url	/artefacts/716/

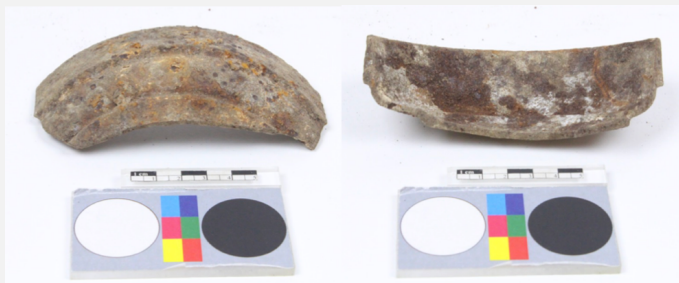
Fig. 1: Rain gutter fragment, exterior and interior faces (to the left and right, respectively),

Description of the artefact	Rain gutter fragment (Fig. 1), possibly part of the extension of a roof drain pipe. Both the exterior and interior surfaces are covered by heterogeneous corrosion crusts. The underlying metal seems however to be well preserved, including features such as a difference in thickness etc. Dimensions: L = 55mm; W (interior) = 120mm; Tmax. = 6mm; WT = 176g.
Type of artefact	Architectural element
Origin	Château de Germolles (14th century), Mellecey, Bourgogne, France
Recovering date	Date unknown
Chronology category	Modern Times
chronology tpq	1801 A.D. ▼
chronology taq	2000 A.D. ▼
Chronology comment	19th - 20th century
Burial conditions / environment	Outdoor atmosphere
Artefact location	Haute Ecole Arc Conservation-Restauration
Owner	Château de Germolles, Mellecey, Bourgogne

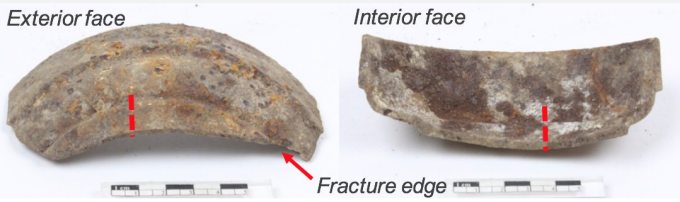
Fig. 2: The exterior and interior faces before sampling. The dotted line represents the sample location (a cross-section of the metal). The fracture edge corresponds to the edge that was formerly attached to the remaining artefact,

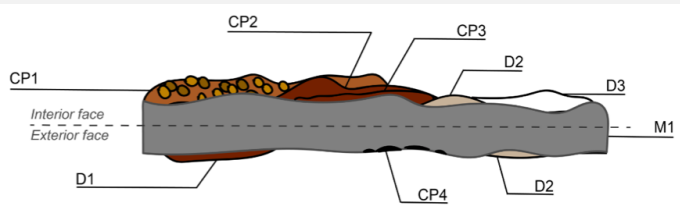
Captions	Description
D1	Scattered, orange to dark red encrustations. Probably corrosion products mixed with soil.
D2	Grey-brown and matte deposit, somewhat powdery - possibly corrosion product mixed with soil. This layer is located both on the interior and exterior surface of the artefact.
D3	Localized, white and strongly adherent deposit.
CP1	Bright orange to dark red corrosion product. Uneven surface with pustules.
CP2	Red-brown corrosion crust. Brittle, but adherent. Flakes off in bits when force is applied perpendicular to the surface with a scalpel.
CP3	Similar to CP2 but appears to be an individual layer.
CP4	Isolated corrosion blisters. Circular and black in colour. Mainly located on the exterior surface.
M1	Intact metal with a dark grey metallic sheen.

Fig. 3: Preliminary stratigraphy corresponding to the overall surface of the artefact. The interior surface is shown above the stippled line and the exterior surface below. D = Deposit, CP = Corrosion products, M = Metal,

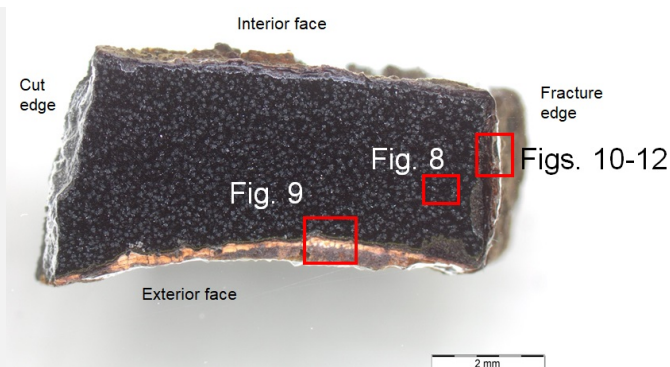
Fig. 4: Micrograph of the sample taken from the rain gutter fragment showing its orientation relative to the artefact and the

locations of Figs. 8-12,

Description of sample	The sample consists of a rectangular section (Fig. 4) which was cut out from the fractured edge of the gutter fragment. It is representative of three surfaces: the exterior and interior surface, as well as the fracture edge. Dimensions: L = 7mm; Wmax. = 5mm; Tmax. = 4mm (approx.).
Alloy	Grey cast iron
Technology	Cast
Lab number of sample	CIG2018 (Cast Iron Gutter, sampled in 2018)
Sample location	Haute Ecole Arc Conservation-Restauration
Responsible institution	Haute Ecole Arc Conservation-Restauration
Date and aim of sampling	March 2018, study of corrosion stratigraphy and chemical analyses

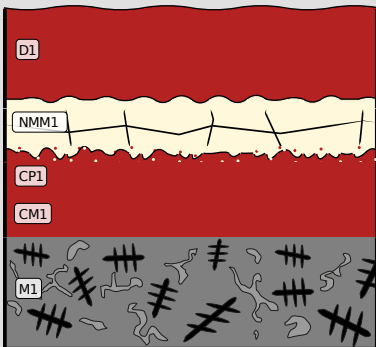
Fig. 5: Stratigraphic representation of the sample taken from the rain gutter fragment in cross-section (dark field) using the MiCorr application. The characteristics of the strata are only accessible by clicking on the drawing that redirects you to the search tool by stratigraphy representation. This representation can be compared to Fig. 9. CP1 corresponds to CP2 in Fig. 3, Credit UiO-IAKH, M.Hovind.

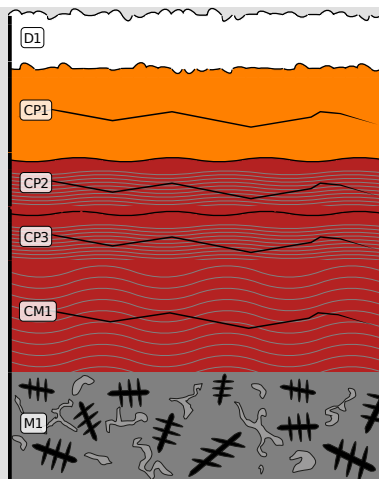
Fig. 6: Stratigraphic representation of the sample taken from the rain gutter fragment in cross-section (dark field) using the MiCorr application. The characteristics of the strata are only accessible by clicking on the drawing that redirects you to the search tool by stratigraphy representation. This representation can be compared to Fig. 11. D1 corresponds to D3 in Fig. 3, Credit UiO-IAKH, M.Hovind.
