VOTIVE FIGURE OF A BAT IVB4168 – GILDED BRASS – MODERN TIMES

Artefact name Votive figure of a bat IVb4168

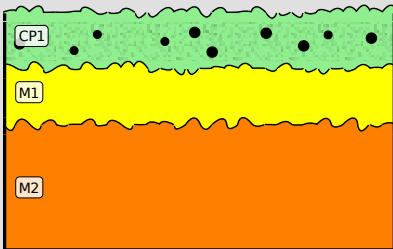
Fig 5: Stratigraphic representation 1 under binocular from Fig. 4 using the MiCorr application. The characteristics of the strata are only accessible by clicking on the drawing that redirects you to the search tool by stratigraphy representation, Credit HE-Arc CR, N.Gutknecht.

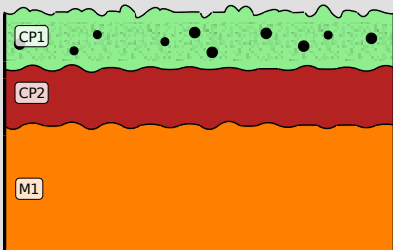
Fig. 6: Stratigraphic representation 2 under binocular from Fig. 4 using the MiCorr application. M1 is M2 in Fig. 5. The characteristics of the strata are only accessible by clicking on the drawing that redirects you to the search tool by stratigraphy representation, Credit HE-Arc CR, N.Gutknecht.

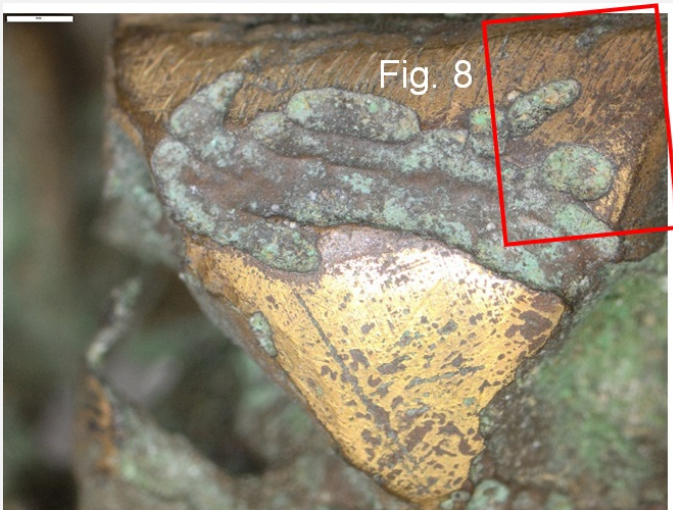
The metal seems to have been heavily attacked (acid dissolution). There are several perforations on the lower part of the object, and where the gold layer is absent the surface is unevenly pitted by corrosion (Figs. 1, 2 and 7). The submetallic core is not visible from the surface.

There are two corrosion products (Figs. 7 and 8). The red one (CP2) has a submetallic brightness and is opaque, non-magnetic, compact, hard and adherent. It is very thin (less than a few microns thick) and only appears where the gold layer has been lost. The EDX spectrum (Fig. 9) shows that it is a Cu- and O rich product, probably cuprite (Cu_2O).

Fig. 7: Binocular image of the nose of the bat showing detail of Fig. 8,

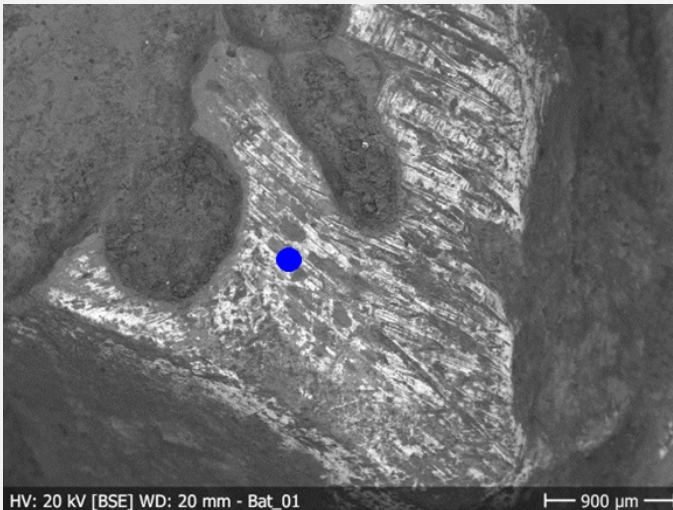
Figs. 8: SEM images of the metal on the nose of the bat. The blue point represents the area for the EDS point analysis (Fig. 9),

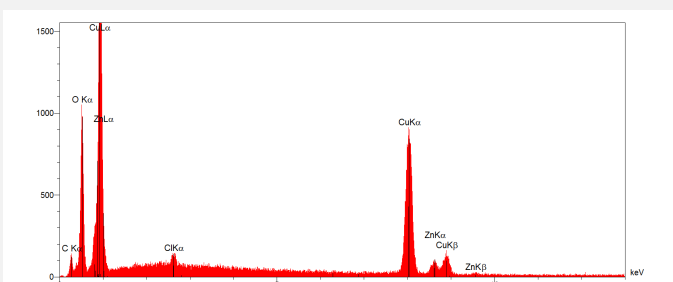
Fig. 9: EDS analysis of the red corrosion product. Method of analysis: SEM-EDS, Lab of Electronic Microscopy and Microanalysis, Néode, HEI Arc,
