VOTIVE FIGURE OF A BAT IVB4168 – GILDED BRASS – MODERN TIMES

Artefact name Votive figure of a bat IVb4168

Authors Christian. Degriigny (HE-Arc CR, Neuchâtel, Neuchâtel, Switzerland) & Naima. Gutknecht (HE-Arc CR, Neuchâtel, Neuchâtel, Switzerland) & Valentin. Boissonnas (HE-Arc CR, Neuchâtel, Neuchâtel, Switzerland)

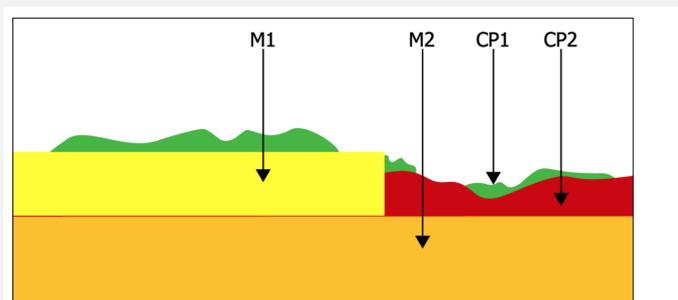
M1: yellow metal plating **M2:** Metal **CP1:** green/white corrosion layer **CP2:** red corrosion layer
Credit HE-Arc CR, N.Gutknecht.

Fig. 3: Stratigraphic representation of the bat by visual macroscopic observation,

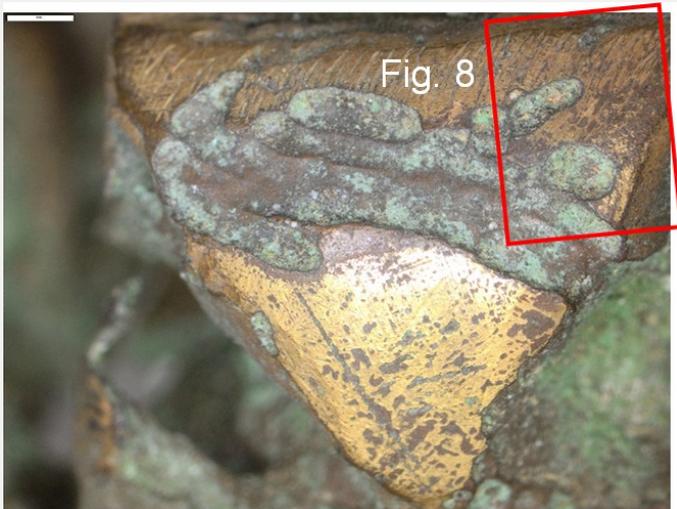
The metal seems to have been heavily attacked (acid dissolution). There are several perforations on the lower part of the object, and where the gold layer is absent the surface is unevenly pitted by corrosion (Figs. 1, 2 and 7). The submetallic core is not visible from the surface.

There are two corrosion products (Figs. 7 and 8). The red one (CP2) has a submetallic brightness and is opaque, non-magnetic, compact, hard and adherent. It is very thin (less than a few microns thick) and only appears where the gold layer has been lost. The EDX spectrum (Fig. 9) shows that it is a Cu- and O rich product, probably cuprite (Cu_2O).

The light green to white corrosion product (CP1) has a waxy consistency and is thin, translucent, non-magnetic, powdery and very soft. It is very loosely bound. It is distributed on the whole object (front and back) as disparate clumps. It is mainly located on the cavities and irregularities of the surface. FTIR analyses (ATR mode) of both green and white areas of CP1 have similar spectra and were identified as copper nitrate (Fig. 10).

Fig. 7: Binocular image of the nose of the bat showing detail of Fig. 8,

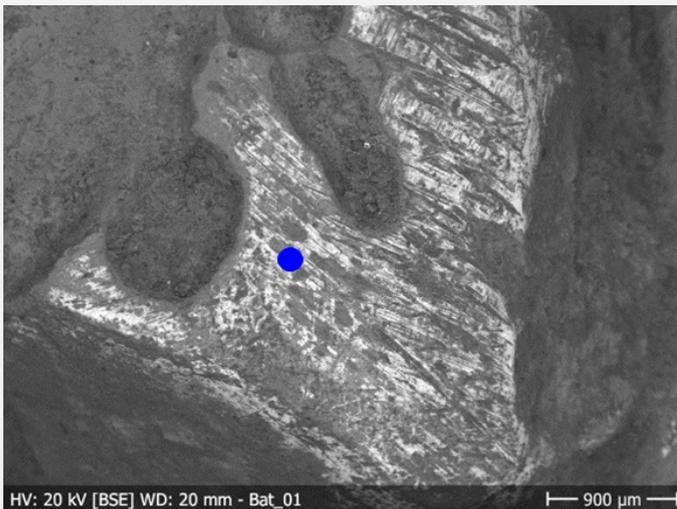
Figs. 8: SEM images of the metal on the nose of the bat. The blue point represents the area for the EDS point analysis (Fig. 9),

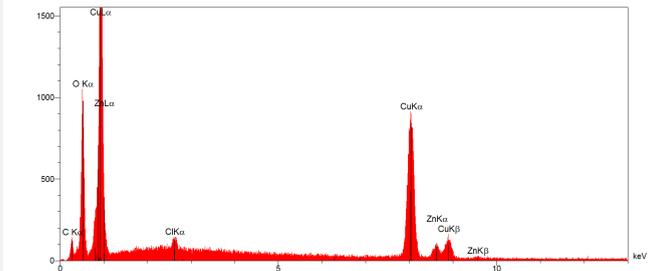
Fig. 9: EDS analysis of the red corrosion product. Method of analysis: SEM-EDS, Lab of Electronic Microscopy and Microanalysis, Néode, HEI Arc,

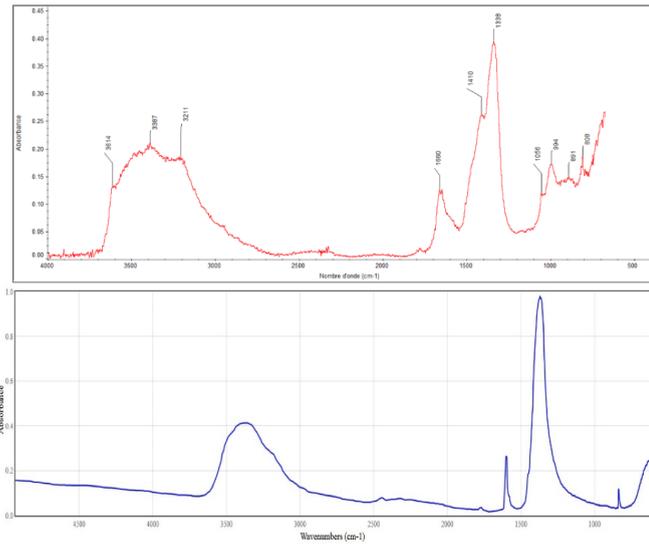
Fig. 10: FTIR spectrum (ATR mode) of the white corrosion product product (top), and of synthesized copper nitrate (Cu(NO3)2 * 3H2O) (bottom),

FTIR analysis of the green/white corrosion product suggests that it is a copper nitrate, a highly water soluble corrosion product that cannot be found in an archaeological context. However, it has been recorded on artificially patinated copper alloys (Scott 2000; Craddock 2009).
