# VOTIVE FIGURE OF A BAT IVB4168 – GILDED BRASS – MODERN TIMES

**Artefact name** Votive figure of a bat IVb4168

**Authors** Christian. Degriigny (HE-Arc CR, Neuchâtel, Neuchâtel, Switzerland) & Naima. Gutknecht (HE-Arc CR, Neuchâtel, Neuchâtel, Switzerland) & Valentin. Boissonnas (HE-Arc CR, Neuchâtel, Neuchâtel, Switzerland)

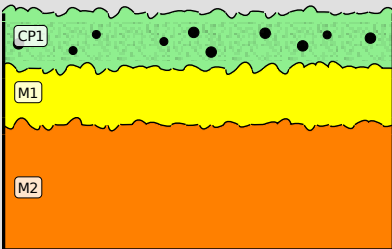
Fig 5: Stratigraphic representation 1 under binocular from Fig. 4 using the MiCorr application. The characteristics of the strata are only accessible by clicking on the drawing that redirects you to the search tool by stratigraphy representation, Credit HE-Arc CR, N.Gutknecht.

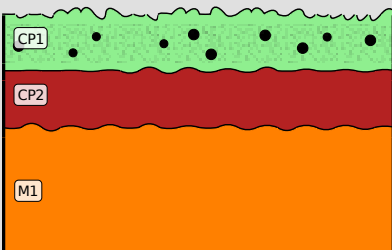
Fig. 6: Stratigraphic representation 2 under binocular from Fig. 4 using the MiCorr application. M1 is M2 in Fig. 5. The characteristics of the strata are only accessible by clicking on the drawing that redirects you to the search tool by stratigraphy representation, Credit HE-Arc CR, N.Gutknecht.
