FUNERAL MASK IVC 11595 - CU/AG, WITH SURFACE ENRICHMENT (AG) - UNKNOWN

Artefact name Funeral mask Ivc 11595

Authors Christian. Degrigny (HE-Arc CR, Neuchâtel, Neuchâtel, Switzerland) & Naima. Gutknecht (HE-Arc CR, Neuchâtel, Neuchâtel, Switzerland) & Valentin. Boissonnas (HE-Arc CR, Neuchâtel, Neuchâtel, Switzerland)

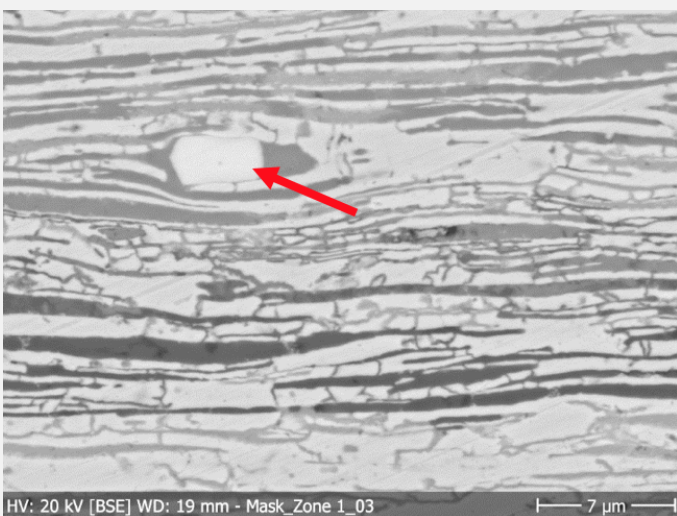
The SEM/EDS analysis of the core metal shows that there are Cu-rich phases alternating with Ag-rich phases. There are inclusions of Pb and As (Fig. 5). The surface of the metal has been decuprified (Fig. 6) according to the tumbaga making process (Scott 2000 and McEwan 2000). This pre-Columbian repeatedly hammered and annealed the metal, which would create a copper oxide scale on the surface. The latter was then dissolved in acidic plant juices (Scott 2000). This process was repeated until the surface was enriched with silver, giving it the appearance of a silver artefact.

Fig. 5: SEM image (BSE-mode) of the metal sample from Fig. 4 (detail), the elongated grains are the result of repeated hammering. Absence of strain lines indicates that the metal is annealed. The darker areas are Cu-rich phases and the lighter areas are Ag-rich phases. The arrow shows an As- and Pb inclusion,

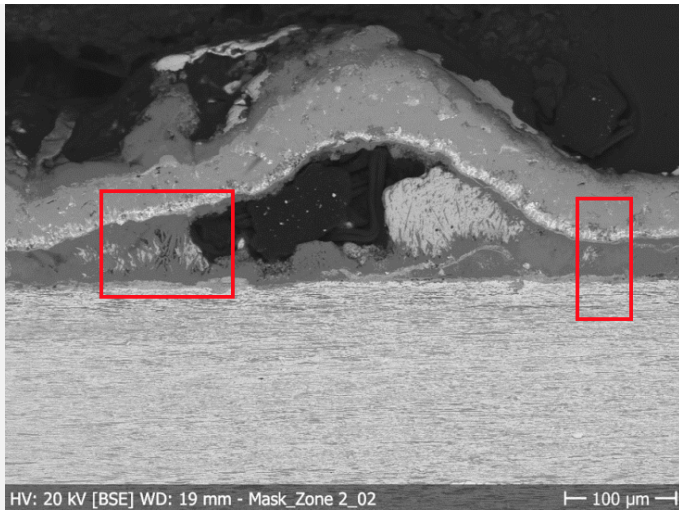
Fig. 6: SEM image (BSE-mode) of the metal sample from Fig. 4 with detail (Fig. 7) indicated by the left red rectangle. The

selected area for elemental chemical distribution (Fig. 8) is marked by the right red rectangle,
