FUNERAL MASK IVC 11595 – CU/AG, WITH SURFACE ENRICHMENT (AG) – UNKNOWN

Artefact name Funeral mask IVC 11595

Authors Christian. Degriigny (HE-Arc CR, Neuchâtel, Neuchâtel, Switzerland) & Naima. Gutknecht (HE-Arc CR, Neuchâtel, Neuchâtel, Switzerland) & Valentin. Boissonnas (HE-Arc CR, Neuchâtel, Neuchâtel, Switzerland)

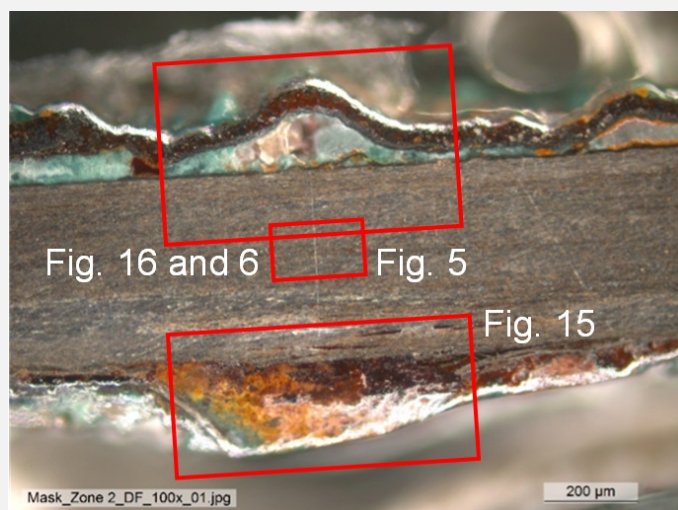
Fig. 4: Micrograph of the cross-section of the sample temporarily taken from the detached fragment of Fig. 2 showing the locations of Figs. 15 (corresponding to the front of the funeral mask), 16 (back of the funeral mask), 5 and 6,

A polished section was made from an already detached fragment that was temporarily embedded in resin (Fig. 2). On Fig. 4 the upper part of the sample corresponds to the back face of the funeral mask while the lower part corresponds to its front face. Both sides have developed subsequent layers of corrosion. In areas, these have buckled and become detached.

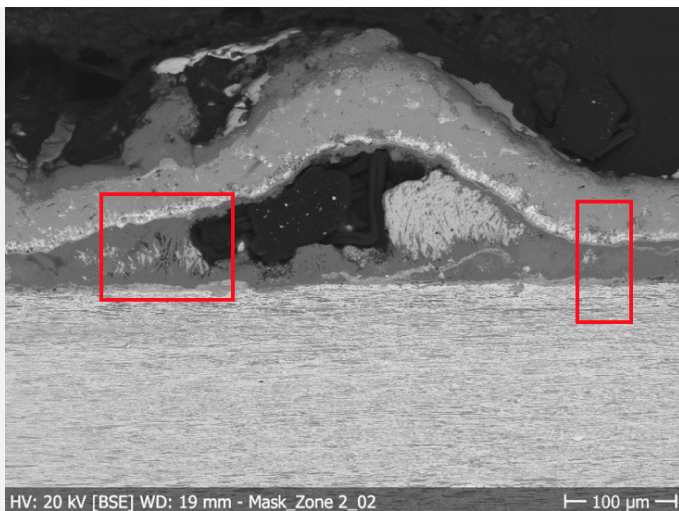
The SEM/EDS analysis of the core metal shows that there are Cu-rich phases alternating with Ag-rich phases. There are inclusions of Pb and As (Fig. 5). The surface of the metal has been decuprified (Fig. 6) according to the tumbaga making process (Scott 2000 and McEwan 2000). This pre-Columbian repeatedly hammered and annealed the metal, which would create a copper oxide scale on the surface. The latter was then dissolved in acidic plant juices (Scott 2000). This process was repeated until the surface was enriched with silver, giving it the appearance of a silver artefact.

A layer of mercury can be seen with EDS (Figs. 6 and 7). Mercury was not used by the pre-Columbians in metallic form (Scott 2000 and McEwan 2000) but was common as a pigment in form of mercury sulfide (cinnabar).

Fig. 6: SEM image (BSE-mode) of the metal sample from Fig. 4 with detail (Fig. 7) indicated by the left red rectangle. The

selected area for elemental chemical distribution (Fig. 8) is marked by the right red rectangle,

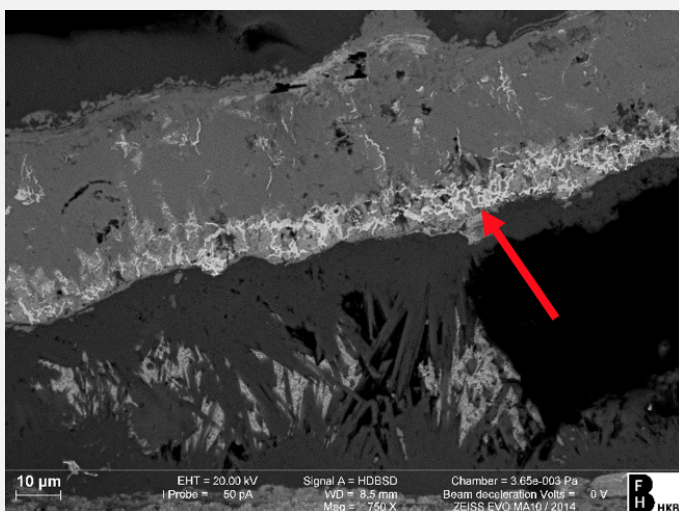
Fig. 7: SEM image of a partially refilled structural void with a silver-, copper- and mercury-rich layer (red arrow),

The silver sulphide (HgS, cinnabar, Fig. 13), present as a red pigment on the silver surface, could have been reduced through an electrochemical process in the presence of chlorides (Keune 2005). The released sulfur recombined with the silver to form black silver sulphide. Above that layer a porous mercury- and silver rich stratum has formed (see Hg & Ag on cartography Fig. 8). It remains unclear if the limitos is located in the silver enriched surface or within this silver-mercury compound (Fig. 7).

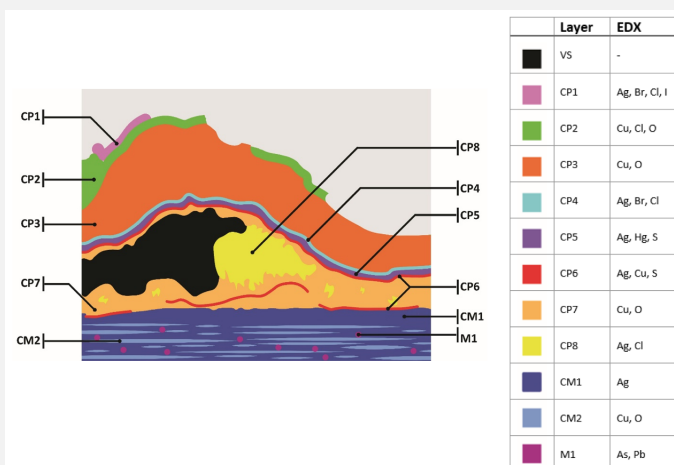
Fig. 17: Improved stratigraphic representation of the funeral mask (Fig. 3) based on the results from the SEM-EDS analyses,

The artefact is a repeatedly hammered, annealed and pickled Cu-Ag tumbaga. The cuprite and hydroxycarbonate layers and the presence of chlorides are typical for the corrosion of tumbaga alloys in an archaeological context. Cinnabar has been identified as pigment applied to the surface before burial. Over the centuries, it was partially incorporated into the growing copper corrosion layers. Close to the enriched silver surface and below the cuprite layer a silver- and mercury-rich stratum has formed. Only one publication mentions the reaction of cinnabar with a gold-enriched tumbaga surface but does not go into details about the possible mechanism involved (Masuda 1997).

The presence of a silver-sulphur compound below this silver-mercury stratum could indicate that the cinnabar was reduced by electrochemical processes to mercury, releasing sulphur that reacted with the silver enriched surface. The mercury itself formed a silver-mercury layer above the latter. More research is needed to fully comprehend this phenomenon.
