FRAGMENT OF AN AEGIS OF NEÏTH 1886.305.0096 – LEADED BRONZE

Artefact name Fragment of an Aegis of Neïth 1886.305.0096

Authors Line. Pedersen (HE-Arc, Neuchâtel, Neuchâtel, Switzerland) & Christian. Degrigny (HE-Arc CR, Neuchâtel, Neuchâtel, Switzerland) & Valentin. Boissonnas (HE-Arc CR, Neuchâtel, Neuchâtel, Switzerland)

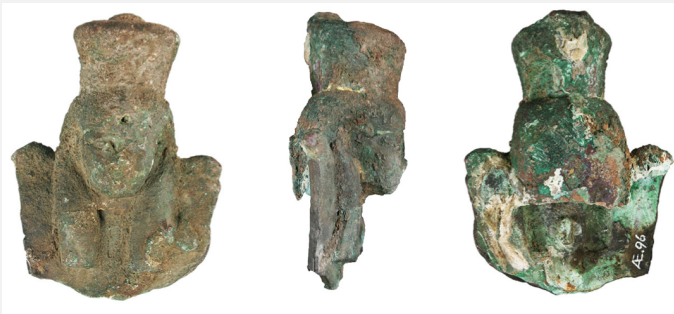
Fig. 1: Fragment of an Aegis of Neïth. From left to right: front, side view and back respectively,

Description of the artefact Fragment of an aegis surmounted by the head of Neith, the Egyptian goddess of war (Fig. 1). Traces of leaf gilding is still present in certain areas (Fig. 3). The lower part of the collar and the upper part of the crown are broken (Fig. 2 and 4). The surface is covered with a thick and hard, green-brown corrosion crust (Fig. 2, 3 and 4). A cross-section was studied on the lower edge that was broken after excavation. Dimensions: L = 96mm; W = 72mm; T = 40mm; WT = 216g.

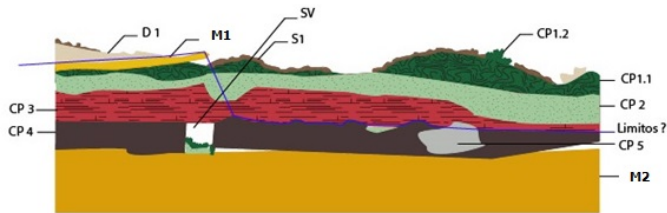
Captions	Colour, aspect, hardness and cohesion
S1	Brown, matte, can be scratched with scalpel blade but remains cohesive.
D1	White deposit: shiny, powdery when shaved with scalpel.
M1	Thin gold leaf trapped in corrosion products, brittle, yellow and not adherent.
CP1.1	Dark green corrosion layer, lumpy and matte, thick, hardly scratched by a scalpel blade, cohesive and compact.
CP1.2	Minor stratum of CP1.1. Dark green crystals appearing on the surface of the artefact. Easily scratched under the action a scalpel blade.
CP2	Light green corrosion layer, matte, thick in some places, powdery under the action of a scalpel blade. In some areas it is located directly on CP4.
CP3	Red corrosion layer, lumpy and matte, thick, sometimes hard and sometimes powdery under the action of a scalpel blade.
Limitos	Interface of the limit of the original surface. Shiny, straight and black with manufacturing traces.
CP4	Dark grey with red or green reflection. Shiny, hard, straight, dense and with traces of engraving and possible inlays.

CP5	Isolated white corrosion products: waxy and very soft.
SV	Void in CP4 resulting in loss of the limitos.
M2	Yellow stratum with metallic sheen, dense and hardly scratched by scalpel blade.

Fig. 6: Preliminary stratigraphy 1, corresponding to the front face of the aegis. S = soil, D = deposit, M = metal, CP = corrosion products, SV = structural void,

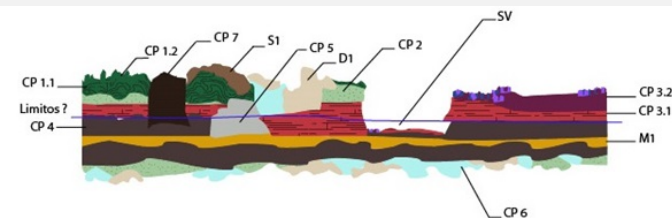
Captions	Colour, aspect, hardness and cohesion
S1	Brown, matte, can be scratched with scalpel blade but remains cohesive.
D1	White shiny deposit, powdery when shaved with scalpel.
CP1.1	Dark green corrosion layer, lumpy and matte, thick, hardly scratched by a scalpel blade, cohesive and compact.
CP1.2	Minor stratum of CP1.1. Dark green crystals appearing on the surface of the artefact. Easily scratched by a scalpel blade.
CP2	Light green corrosion layer, matte and thick in some places, powdery under the action of a scalpel blade. Sometimes located directly on CP4.
CP3.1	Red corrosion layer, lumpy and matte, thick, sometimes hard and sometimes powdery under the action of a scalpel blade.
CP3.2	Minor stratum of CP3.1. Purple with blue-purple crystals, hard and cohesive.
Limitos	Interface of the limit of the original surface. Shiny, straight, black, manufacturing traces.
CP4	Dark grey with red or green reflection. Shiny, hard, straight, dense and with traces of engraving and possible inlays.

CP5	Isolated white stratum: waxy and very soft.
CP6	Light blue stratum, chalky. Isolated on the exterior surface and extends on the interior surface.
CP7	Isolated black stratum, very hard, straight and shiny.
SV:	Void in CP4, resulting in loss of the limitos. Presence of CP1.2 crystals inside the void.
Structural Void	
M1	Yellow stratum with metallic sheen, dense and hardly scratched by scalpel blade.

Fig. 7: Preliminary stratigraphy 2, corresponding to the back face of the aegis and interior (below part). S = soil, D = deposit, M = metal, CP = corrosion products, SV = structural void,

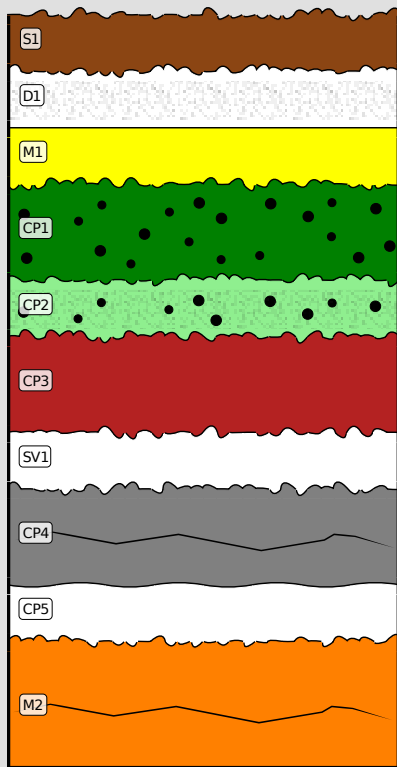
Fig.9: Schematic representation combining stratigraphies 1 and 2 under binocular and using the MiCorr application. The characteristics of the strata are only accessible by clicking on the drawing that redirects you to the search tool by stratigraphy representation, Credit He-Arc CR, L.Pedersen.

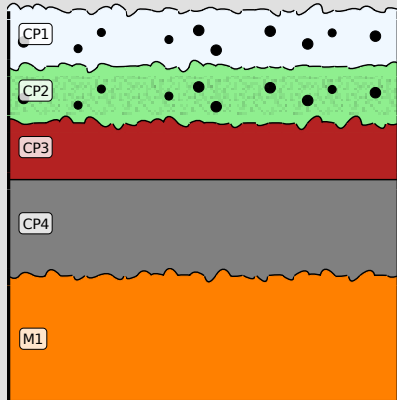
Fig.10: Schematic representation of stratigraphy 3 under binocular and using the MiCorr application. CP1 is CP6 in Fig. 8. The characteristics of the strata are only accessible by clicking on the drawing that redirects you to the search tool by stratigraphy representation, Credit He-Arc CR, L. Pedersen.

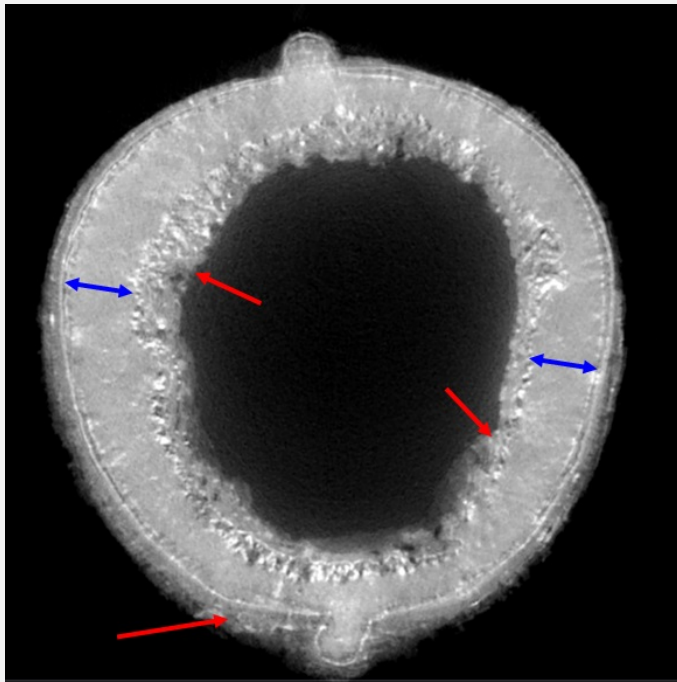
Fig. 11: X-ray tomography by cross section of the crown showing a dense and non-porous metal core (blue arrows). The corrosion products however are porous (red arrows). The external limit is visible as a fine line preserved under corrosion layers,

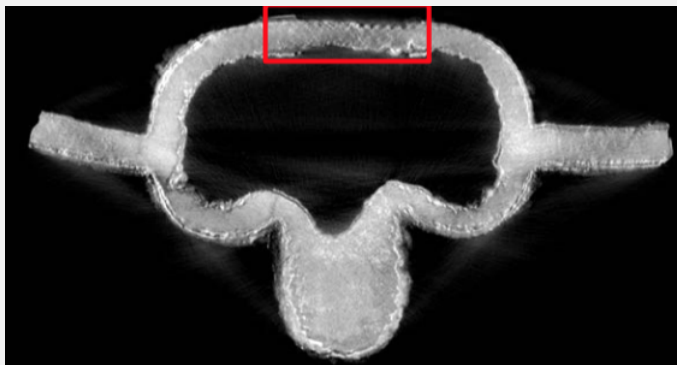
Fig. 12: X-ray tomography by cross section of the lower part showing that there are losses of the original surface (red square),

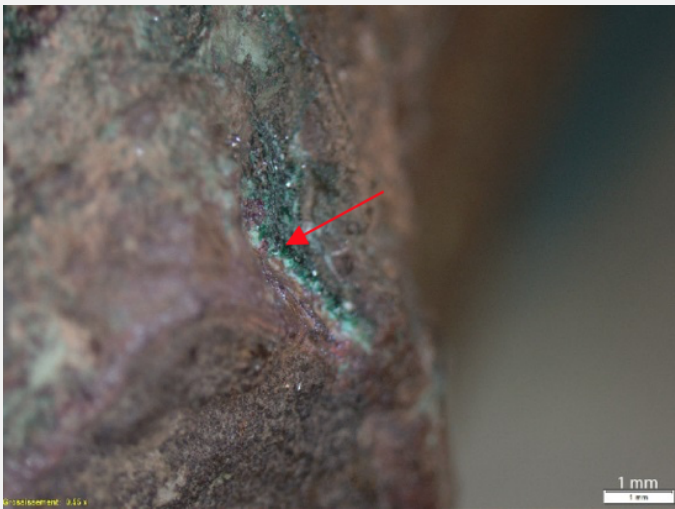
Fig. 13: Observation of the dark green corrosion product,

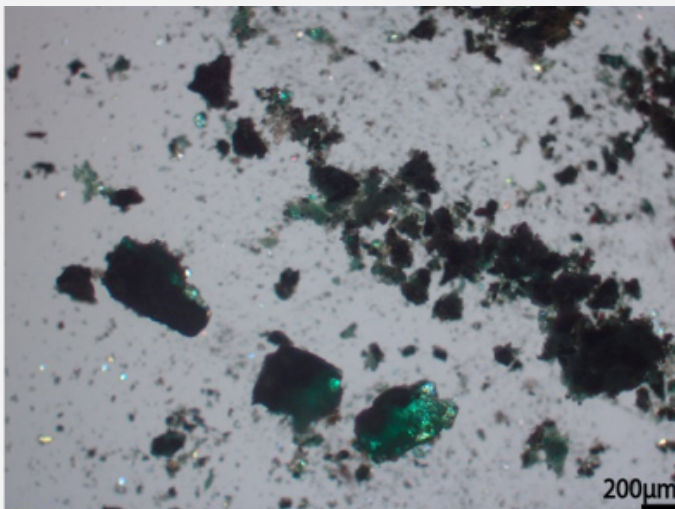
Fig. 14: Dark green corrosion product identified as paratacamite, atacamite $\text{Cu}_2\text{Cl}(\text{OH})_3$ by XRD. Microscopic examination under polarized light,
