FRAGMENT OF AN AEGIS OF NEÏTH 1886.305.0096 – LEADED BRONZE

Artefact name Fragment of an Aegis of Neïth 1886.305.0096

Authors Line. Pedersen (HE-Arc, Neuchâtel, Neuchâtel, Switzerland) & Christian. Degrigny (HE-Arc CR, Neuchâtel, Neuchâtel, Switzerland) & Valentin. Boissonnas (HE-Arc CR, Neuchâtel, Neuchâtel, Switzerland)

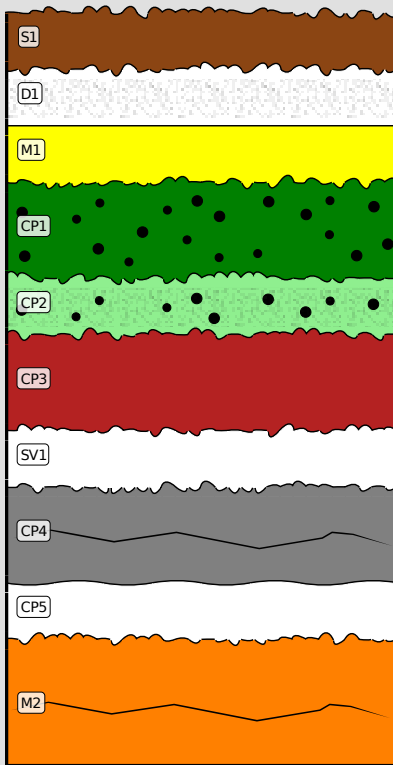
Fig.9: Schematic representation combining stratigraphies 1 and 2 under binocular and using the MiCorr application. The characteristics of the strata are only accessible by clicking on the drawing that redirects you to the search tool by stratigraphy representation, Credit He-Arc CR, L.Pedersen.

The metal (M2 in Fig.9 and M1 in Fig. 10) was analysed on the broken edge of the bottom of the artefact where despite a highly corroded surface, the metal seems to be the best preserved. The XRF analyses revealed that the metal is a leaded bronze with remains of gold leaf on the surface (Table 1, Au was detected in the measurement spots 4,5 and 6) (Scott 2002; Gouda 2012; Mohammed 2012).

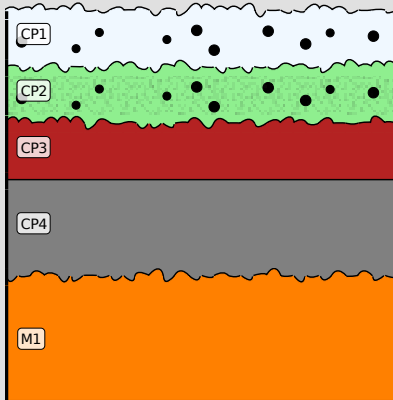
Fig.10: Schematic representation of stratigraphy 3 under binocular and using the MiCorr application. CP1 is CP6 in Fig. 8. The characteristics of the strata are only accessible by clicking on the drawing that redirects you to the search tool by stratigraphy representation, Credit He-Arc CR, L. Pedersen.

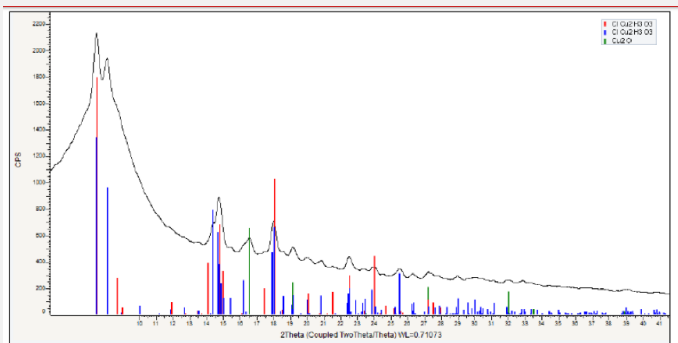
Fig. 21: XRD spectrum of the sample of the dark green corrosion product showing the presence of atacamite and paratacamite ($\text{Cu}_2\text{Cl}(\text{OH})_3$) as major compound and cuprite (Cu_2O) as minor compound,
