## RAIN GUTTER FRAGMENT – GREY CAST IRON – MODERN TIMES – FRANCE

Artefact name	Rain gutter fragment
Authors	Christian. Degriigny (HE-Arc CR, Neuchâtel, Neuchâtel, Switzerland) & Mathea. Hovind (University of Oslo, Department of archaeology, conservation and history (IAKH-UiO), Oslo, Oslo, Norway)
Url	/artefacts/879/

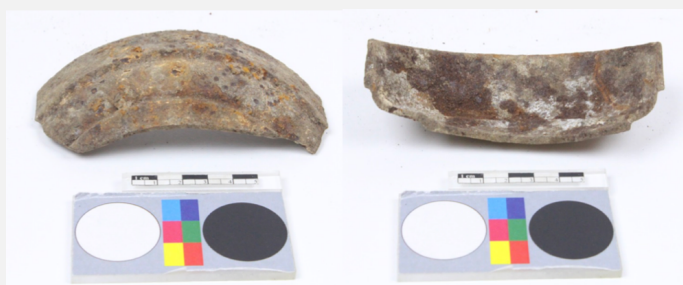
Fig. 1: Rain gutter fragment, exterior and interior faces (to the left and right, respectively),

Description of the artefact	Rain gutter fragment (Fig. 1), possibly part of the extension of a roof drain pipe. Both the exterior and interior surfaces are covered by heterogeneous corrosion crusts. The underlying metal seems however to be well preserved, including features such as a difference in thickness etc. Dimensions: L = 55mm; W (interior) = 120mm; Tmax. = 6mm; WT = 176g.
Type of artefact	Architectural element
Origin	Château de Germolles (14th century), Mellecey, Bourgogne, France
Recovering date	Unknown
Chronology category	Modern Times
chronology tpq	1801 A.D. ▼
chronology taq	2000 A.D. ▼
Chronology comment	19th - 20th century
Burial conditions / environment	Outdoor atmosphere
Artefact location	HE-Arc CR, Neuchâtel, Neuchâtel
Owner	Château de Germolles, Mellecey, Bourgogne

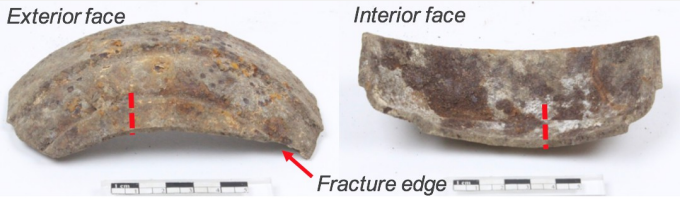
Fig. 2: The exterior and interior faces before sampling. The dotted line represents the sample location (a cross-section of the metal). The fracture edge corresponds to the edge that was formerly attached to the remaining artefact,

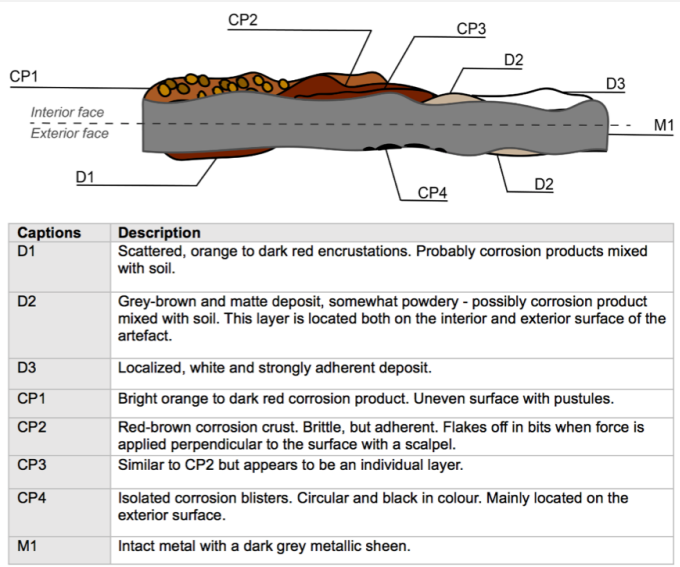
The schematic representation below (Fig. 3) gives an overview of the strata encountered by visual macroscopic observation.

Fig. 3: Preliminary stratigraphy of the corrosion structure based on visual microscopic observation,

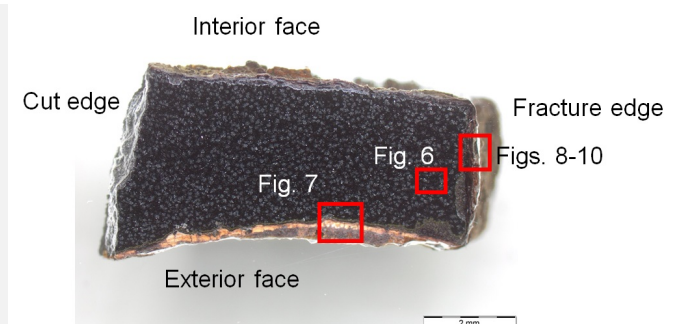
Fig. 4: Micrograph of the sample taken from the rain gutter fragment showing its orientation relative to the artefact and the

locations of Figs. 6-10,

<b>Description of sample</b>	The sample consists of a rectangular section (Fig. 4) which was cut out from the fractured edge of the gutter fragment. It is representative of three surfaces: the exterior and interior surface, as well as the fracture edge. Dimensions: L = 7mm; Wmax. = 5mm; Tmax. = 4mm (approx.).
<b>Alloy</b>	Grey cast iron
<b>Technology</b>	Cast
<b>Lab number of sample</b>	CIG2018 (Cast Iron Gutter, sampled in 2018)
<b>Sample location</b>	HE-Arc CR, Neuchâtel, Neuchâtel
<b>Responsible institution</b>	HE-Arc CR, Neuchâtel, Neuchâtel
<b>Date and aim of sampling</b>	March 2018, study of corrosion stratigraphy and chemical analyses

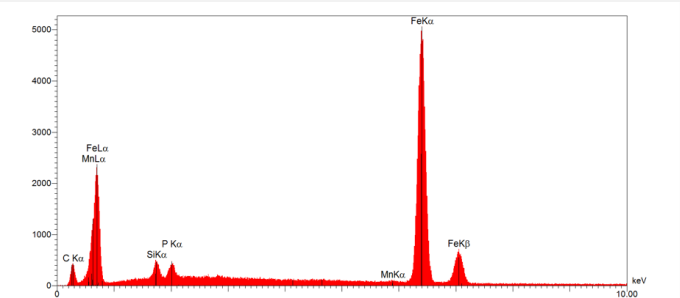
The metal is a P-rich grey cast iron with Si and Mn (Fig. 5). Its microstructure is characterized by evenly distributed graphite flakes in a matrix composed of dendrites and an interdendritic eutectic phase (Fig. 6). What appears to be irregular graphite flakes / porosity is in fact deformed graphite flakes; graphite is soft and prone to destruction by smearing and/or preferential removal during polishing (Scott 1991).

Fig. 5: EDS-spectrum showing the chemical composition of the metal. Method of analysis: SEM-EDS. Lab. of Electronic Microscopy and Microanalysis, Néode, HEI Arc,

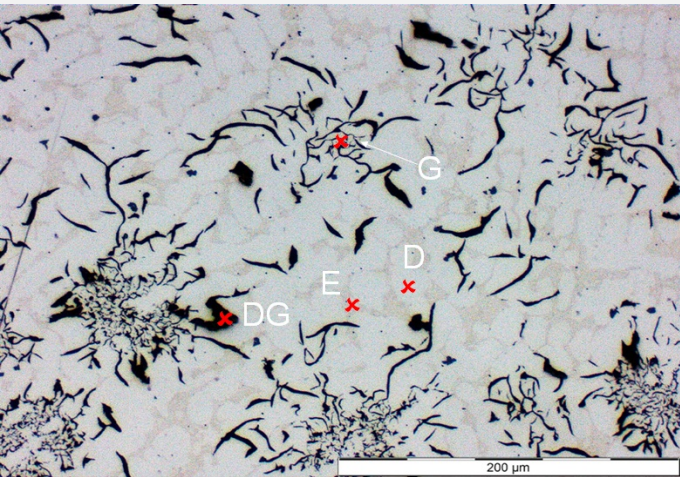
The dendrites appear light grey under polarized light, while the eutectic phase appear light brown (Fig. 6). The eutectic phase is rich in Fe and P and contains small amounts of C and Si, whereas the dendritic phase contains much less P (Table 1).

Fig. 6: Micrograph of the metal sample from Fig. 4 (detail). Unetched, bright field. Graphite flakes (G) in black, the dendrites (D) in light grey and the eutectoid phase (E) in light brown. Deformed graphite (DG) flakes are visible as irregular black inclusions,

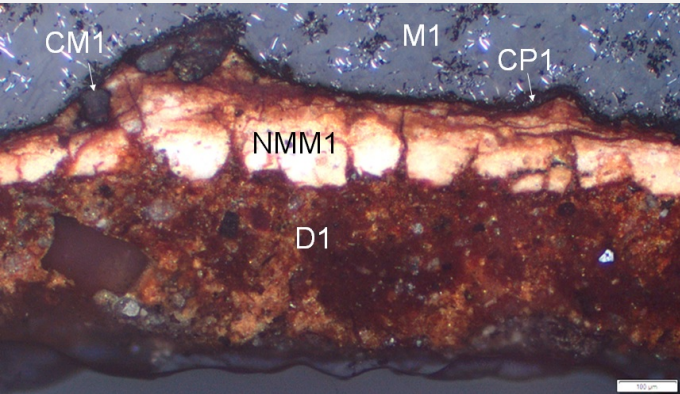
The exterior face (Figs. 2, 4 and 7) consists of a white / light yellow cracked layer (NMM1 in Fig. 7) superimposed by a layer of deposit mixed with orange-red corrosion products (D1 in Fig. 7). Local analysis by SEM-EDS (Table 2) revealed that the

white / light yellow layer is rich in Ba, O, S, Fe, C and Zn. It has a chemical composition similar to Lithopone (BaSO<sub>4</sub>,ZnS), a preparatory paint layer. Fe is probably a contamination from the superimposed porous deposit / corrosion product D1 (Table 2). The latter (D1) is Fe- and O-rich and contains Si, Al and some Ca, in addition to a range of elements (K, P, Na, Cl, S and Ti) present in minor amounts (Table 2). A thin layer of corrosion products (CP1) is located just beneath the paint layer, appearing dark grey under polarized light (Fig. 7). This layer is followed by a corroded metal phase (CM1). Their exact composition was not analyzed but is likely to correspond to the corroded metal phase of the fracture edge, described below.

Fig. 7: Micrograph of the metal sample from Fig. 4 (detail), unetched, polarized light, 5x. Stratigraphy of the exterior surface, to be compared to Fig. 11 and from top to bottom: the metal (M1) in grey, a layer of corroded metal (CM1) followed by a thin layer of CP1, and a white cracked layer (NMM1) superimposed by a porous dark-red deposit (D1),

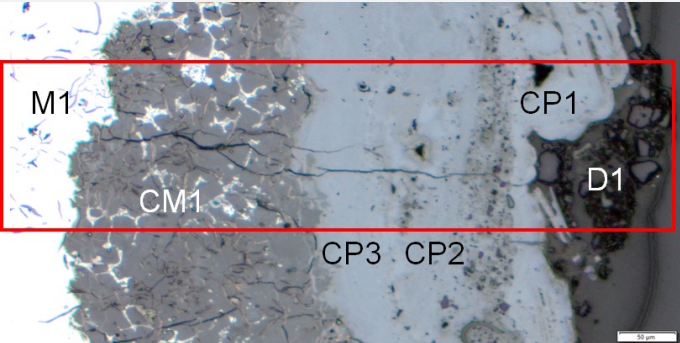
The interior face (Figs. 2 and 4) shows similar characteristics but does not include a white layer similar to NMM1. The fracture edge however (Figs. 2, 4 and 8), shows a more complex stratigraphy consisting of a dense product layer which can be further divided into two individual strata (CP3 and CP2), superimposed by a porous corrosion crust appearing orange under polarized light (CP1) (Fig. 9). The corroded metal (CM1) is located just beneath CP3 and contains remnants of the P-rich eutectic phase (Figs. 8-10). The M/CP ratio (metal to corrosion products) is rather high, implying extensive internal corrosion. Furthermore, cracks are traversing the whole corrosion layers – indicating a fragilization of the structure. As for the composition of the corrosion products CP1, CP2 and CP3, they all contain Fe and O (Fig. 10). A marbling effect within CP2 and CP3 indicates a variation in the concentration of Fe and O (particularly visible in bright field - Fig. 8). The white deposit (D1 in Figs. 8 and 9) might originate from exposure to calcareous water (Table 2). The presence of exogenous elements such as Si, Ca, Al, Na and O (Table 2) was confirmed by elemental mapping (Fig. 10).

Fig. 8: Micrograph of the metal sample from Fig. 4 (detail), unetched, bright field. Stratigraphy of the fracture edge, to be compared to Fig. 12 and from left to right: intact metal (M1) in white, followed by preferentially corroded metal (CM1) and dense product layers (CP3 and CP2) in various shades of grey. CP1 is slightly porous and covered by grain-like particles (D1). The area selected for elemental chemical distribution (Fig. 12) is marked by a red rectangle,

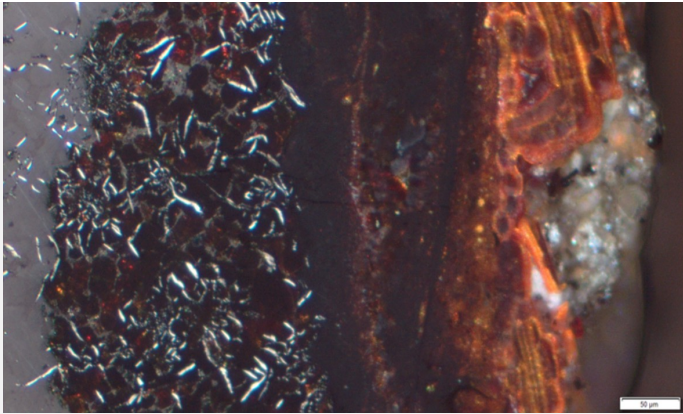
Fig. 9: Micrograph similar to Fig. 8 but under polarized light. The external deposit (D1) appears grey-white, CP1 in bright orange, while CP2 and CP3 appear dark red to brown. The corroded metal (CM1) contains remnants of graphite flakes (in white) and the P-rich eutectic (in grey),

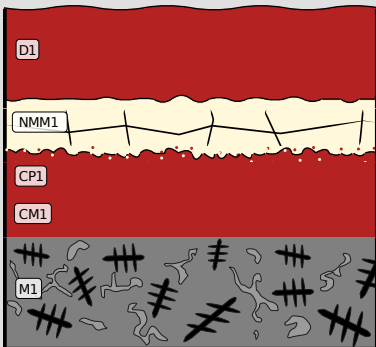
Fig. 11: Stratigraphic representation of the sample taken from the rain gutter fragment in cross-section (dark field) using the MiCorr application. The characteristics of the strata are only accessible by clicking on the drawing that redirects you to the search tool by stratigraphy representation. This representation can be compared to Fig. 7 (exterior surface). CP1 corresponds to CP2 in Fig. 3, Credit UiO-IAKH, M.Hovind.

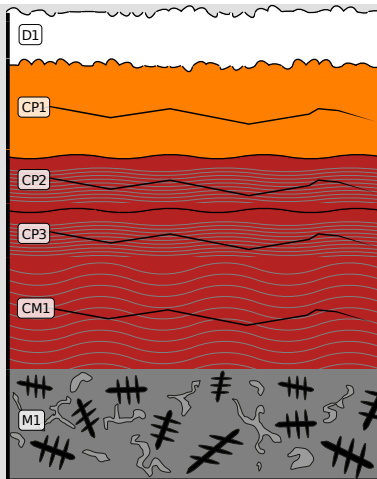
Fig. 12: Stratigraphic representation of the sample taken from the rain gutter fragment in cross-section (dark field) using the MiCorr application. The characteristics of the strata are only accessible by clicking on the drawing that redirects you to the search tool by stratigraphy representation. This representation can be compared to Figs. 8 and 9 (fracture edge). D1 corresponds to D3 in Fig. 3, Credit UiO-IAKH, M.Hovind.

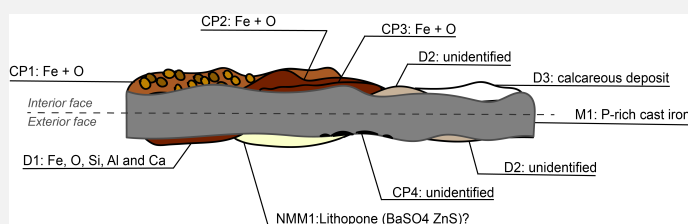
Fig. 13: Improved stratigraphic representation of the rain gutter fragment based on analysis from cross-section and visual microscopic observation,

The rain gutter fragment is a grey cast iron with a microstructure consisting of graphite flakes and a P-rich eutectic phase. The corrosion layers of the exterior surface contains a preparatory paint layer, located beneath a layer of iron corrosion products mixed with soil. It seems likely that the cast iron gutter has been covered with a protective paint layer (e.g. Lithopone) to slow down the rate of atmospheric corrosion. The presence of Lithopone reinforces the suggested dating of the artefact (20th century) as this pigment was developed and used from the 1880s and onwards (Lithopone 2007). However, it seems that the protective layer has none or only very limited effect as (pitting) corrosion is present also in these areas.

The corrosion layers consist mainly of Fe and O, indicating atmospheric corrosion with presence of only a very small amount of contaminants/pollution. The scattered white deposit is possibly originating from exposure to calcareous water as it is localized mainly on the interior face of the fragment, where rain water would hit the metal before entering the ground.
