RAIN GUTTER FRAGMENT – GREY CAST IRON – MODERN TIMES – FRANCE

Artefact name Rain gutter fragment

Authors Christian. Degriigny (HE-Arc CR, Neuchâtel, Neuchâtel, Switzerland) & Mathea. Hovind (University of Oslo, Department of archaeology, conservation and history (IAKH-UiO), Oslo, Oslo, Norway)

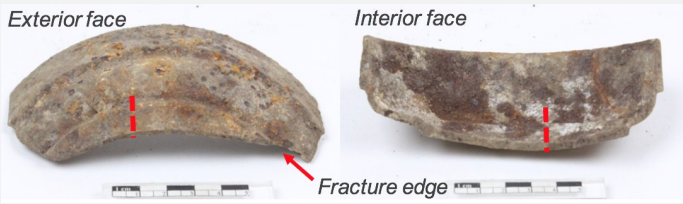
Fig. 2: The exterior and interior faces before sampling. The dotted line represents the sample location (a cross-section of the metal). The fracture edge corresponds to the edge that was formerly attached to the remaining artefact,

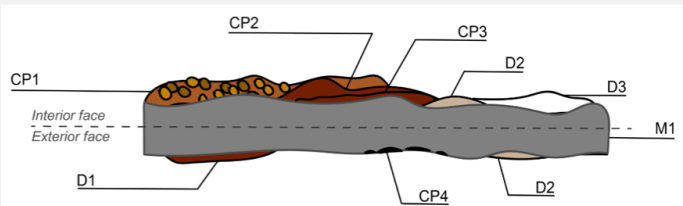
Fig. 3: Preliminary stratigraphy of the corrosion structure based on visual microscopic observation,

Captions	Description
D1	Scattered, orange to dark red encrustations. Probably corrosion products mixed with soil.
D2	Grey-brown and matte deposit, somewhat powdery - possibly corrosion product mixed with soil. This layer is located both on the interior and exterior surface of the artefact.
D3	Localized, white and strongly adherent deposit.
CP1	Bright orange to dark red corrosion product. Uneven surface with pustules.
CP2	Red-brown corrosion crust. Brittle, but adherent. Flakes off in bits when force is applied perpendicular to the surface with a scalpel.
CP3	Similar to CP2 but appears to be an individual layer.
CP4	Isolated corrosion blisters. Circular and black in colour. Mainly located on the exterior surface.
M1	Intact metal with a dark grey metallic sheen.

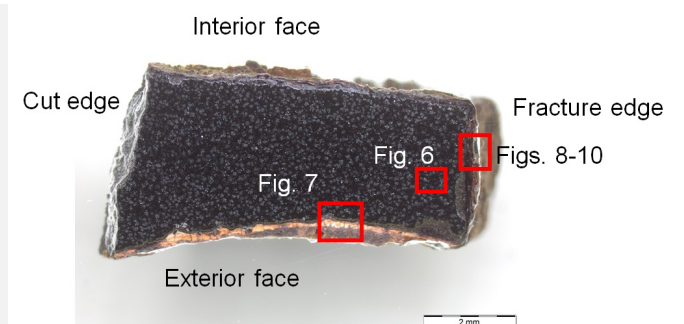
Fig. 4: Micrograph of the sample taken from the rain gutter fragment showing its orientation relative to the artefact and the locations of Figs. 6-10,

Description of sample	The sample consists of a rectangular section (Fig. 4) which was cut out from the fractured edge of the gutter fragment. It is representative of three surfaces: the exterior and interior surface, as well as the fracture edge. Dimensions: L = 7mm; Wmax. = 5mm; Tmax. = 4mm (approx.).
Alloy	Grey cast iron
Technology	Cast
Lab number of sample	CIG2018 (Cast Iron Gutter, sampled in 2018)
Sample location	HE-Arc CR, Neuchâtel, Neuchâtel
Responsible institution	HE-Arc CR, Neuchâtel, Neuchâtel
Date and aim of sampling	March 2018, study of corrosion stratigraphy and chemical analyses

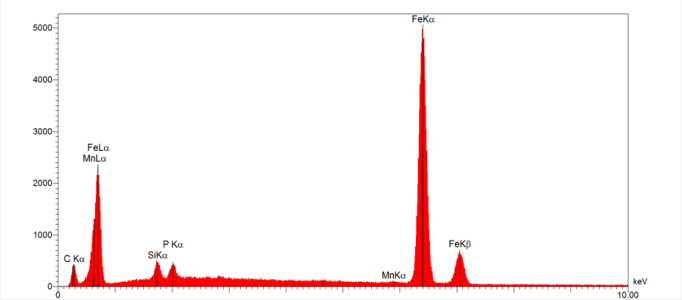
The metal is a P-rich grey cast iron with Si and Mn (Fig. 5). Its microstructure is characterized by evenly distributed graphite flakes in a matrix composed of dendrites and an interdendritic eutectic phase (Fig. 6). What appears to be irregular graphite flakes / porosity is in fact deformed graphite flakes; graphite is soft and prone to destruction by smearing and/or preferential removal during polishing (Scott 1991).

Fig. 5: EDS-spectrum showing the chemical composition of the metal. Method of analysis: SEM-EDS. Lab. of Electronic Microscopy and Microanalysis, Néode, HEI Arc,

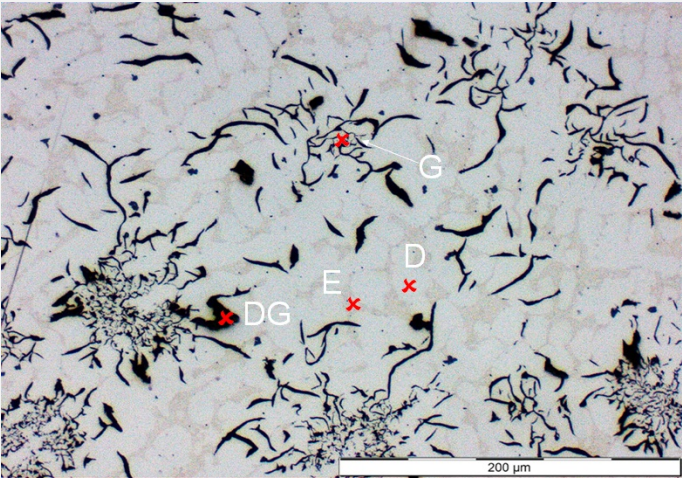
The dendrites appear light grey under polarized light, while the eutectic phase appear light brown (Fig. 6). The eutectic phase is rich in Fe and P and contains small amounts of C and Si, whereas the dendritic phase contains much less P (Table 1).

Fig. 6: Micrograph of the metal sample from Fig. 4 (detail). Unetched, bright field. Graphite flakes (G) in black, the dendrites (D) in light grey and the eutectoid phase (E) in light brown. Deformed graphite (DG) flakes are visible as irregular black inclusions,

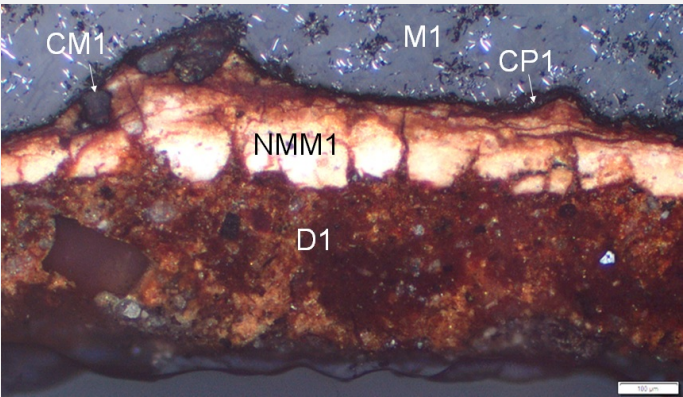
The exterior face (Figs. 2, 4 and 7) consists of a white / light yellow cracked layer (NMM1 in Fig. 7) superimposed by a layer of deposit mixed with orange-red corrosion products (D1 in Fig. 7). Local analysis by SEM-EDS (Table 2) revealed that the

white / light yellow layer is rich in Ba, O, S, Fe, C and Zn. It has a chemical composition similar to Lithopone (BaSO₄,ZnS), a preparatory paint layer. Fe is probably a contamination from the superimposed porous deposit / corrosion product D1 (Table 2). The latter (D1) is Fe- and O-rich and contains Si, Al and some Ca, in addition to a range of elements (K, P, Na, Cl, S and Ti) present in minor amounts (Table 2). A thin layer of corrosion products (CP1) is located just beneath the paint layer, appearing dark grey under polarized light (Fig. 7). This layer is followed by a corroded metal phase (CM1). Their exact composition was not analyzed but is likely to correspond to the corroded metal phase of the fracture edge, described below.

Fig. 7: Micrograph of the metal sample from Fig. 4 (detail), unetched, polarized light, 5x. Stratigraphy of the exterior surface, to be compared to Fig. 11 and from top to bottom: the metal (M1) in grey, a layer of corroded metal (CM1) followed by a thin layer of CP1, and a white cracked layer (NMM1) superimposed by a porous dark-red deposit (D1),

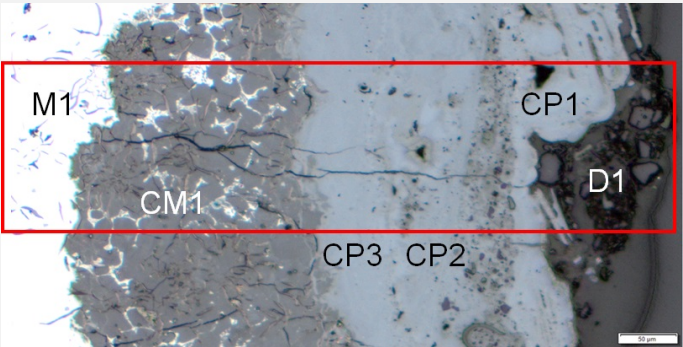
The interior face (Figs. 2 and 4) shows similar characteristics but does not include a white layer similar to NMM1. The fracture edge however (Figs. 2, 4 and 8), shows a more complex stratigraphy consisting of a dense product layer which can be further divided into two individual strata (CP3 and CP2), superimposed by a porous corrosion crust appearing orange under polarized light (CP1) (Fig. 9). The corroded metal (CM1) is located just beneath CP3 and contains remnants of the P-rich eutectic phase (Figs. 8-10). The M/CP ratio (metal to corrosion products) is rather high, implying extensive internal corrosion. Furthermore, cracks are traversing the whole corrosion layers – indicating a fragilization of the structure. As for the composition of the corrosion products CP1, CP2 and CP3, they all contain Fe and O (Fig. 10). A marbling effect within CP2 and CP3 indicates a variation in the concentration of Fe and O (particularly visible in bright field - Fig. 8). The white deposit (D1 in Figs. 8 and 9) might originate from exposure to calcareous water (Table 2). The presence of exogenous elements such as Si, Ca, Al, Na and O (Table 2) was confirmed by elemental mapping (Fig. 10).

Fig. 8: Micrograph of the metal sample from Fig. 4 (detail), unetched, bright field. Stratigraphy of the fracture edge, to be compared to Fig. 12 and from left to right: intact metal (M1) in white, followed by preferentially corroded metal (CM1) and dense product layers (CP3 and CP2) in various shades of grey. CP1 is slightly porous and covered by grain-like particles (D1). The area selected for elemental chemical distribution (Fig. 12) is marked by a red rectangle,

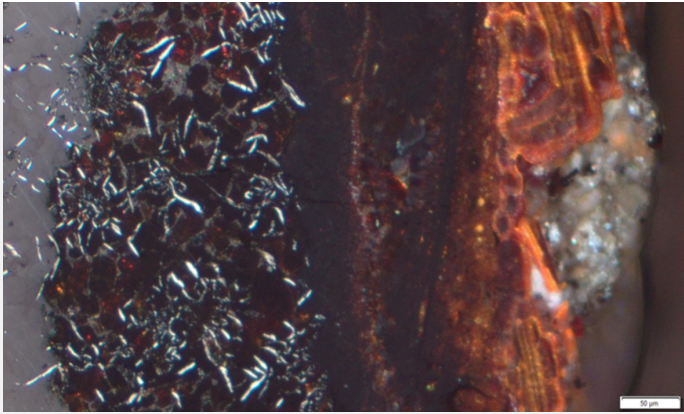
Fig. 9: Micrograph similar to Fig. 8 but under polarized light. The external deposit (D1) appears grey-white, CP1 in bright orange, while CP2 and CP3 appear dark red to brown. The corroded metal (CM1) contains remnants of graphite flakes (in white) and the P-rich eutectic (in grey),

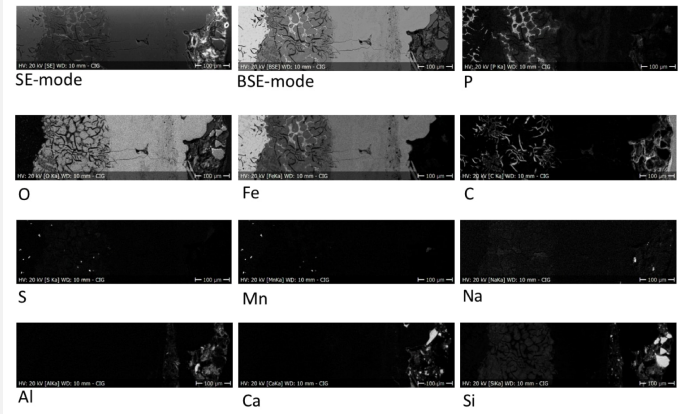
Fig. 10: SEM image and elemental chemical distribution of the selected area from Fig. 8. Method of analysis: SEM-EDS. Lab. of Electronic Microscopy and Microanalysis, Néode, HEI Arc,

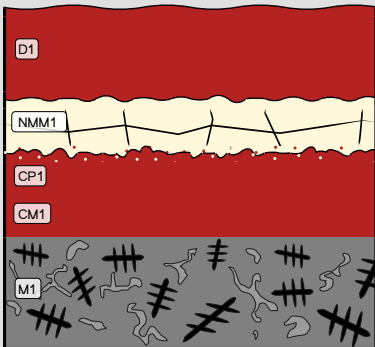
Fig. 11: Stratigraphic representation of the sample taken from the rain gutter fragment in cross-section (dark field) using the MiCorr application. The characteristics of the strata are only accessible by clicking on the drawing that redirects you to the search tool by stratigraphy representation. This representation can be compared to Fig. 7 (exterior surface). CP1 corresponds to CP2 in Fig. 3, Credit UiO-IAKH, M.Hovind.

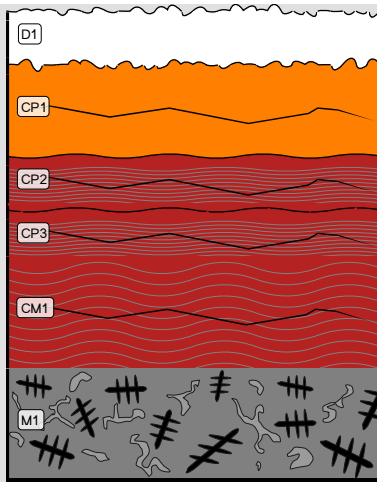
Fig. 12: Stratigraphic representation of the sample taken from the rain gutter fragment in cross-section (dark field) using the MiCorr application. The characteristics of the strata are only accessible by clicking on the drawing that redirects you to the search tool by stratigraphy representation. This representation can be compared to Figs. 8 and 9 (fracture edge). D1 corresponds to D3 in Fig. 3, Credit UiO-IAKH, M.Hovind.

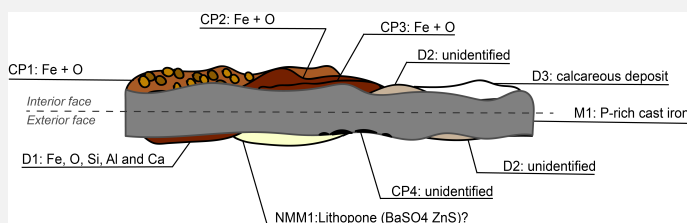
Fig. 13: Improved stratigraphic representation of the rain gutter fragment based on analysis from cross-section and visual microscopic observation,

The rain gutter fragment is a grey cast iron with a microstructure consisting of graphite flakes and a P-rich eutectic phase. The corrosion layers of the exterior surface contains a preparatory paint layer, located beneath a layer of iron corrosion products mixed with soil. It seems likely that the cast iron gutter has been covered with a protective paint layer (e.g. Lithopone) to slow down the rate of atmospheric corrosion. The presence of Lithopone reinforces the suggested dating of the artefact (20th century) as this pigment was developed and used from the 1880s and onwards (Lithopone 2007). However, it seems that the protective layer has none or only very limited effect as (pitting) corrosion is present also in these areas.

The corrosion layers consist mainly of Fe and O, indicating atmospheric corrosion with presence of only a very small amount of contaminants/pollution. The scattered white deposit is possibly originating from exposure to calcareous water as it is localized mainly on the interior face of the fragment, where rain water would hit the metal before entering the ground.
