# RAIN GUTTER FRAGMENT – GREY CAST IRON – MODERN TIMES – FRANCE

**Artefact name** Rain gutter fragment

**Authors** Christian. Degriigny (HE-Arc CR, Neuchâtel, Neuchâtel, Switzerland) & Mathea. Hovind (University of Oslo, Department of archaeology, conservation and history (IAKH-UiO), Oslo, Oslo, Norway)

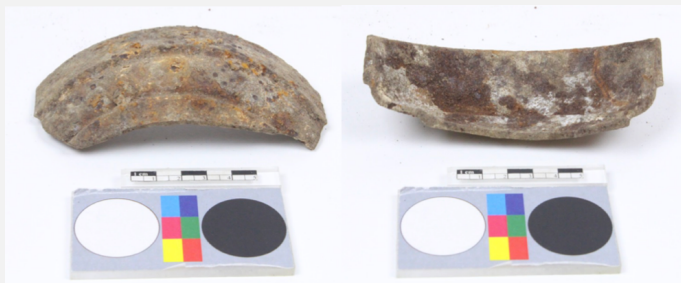
Fig. 1: Rain gutter fragment, exterior and interior faces (to the left and right, respectively),

<b>Description of the artefact</b>	Rain gutter fragment (Fig. 1), possibly part of the extension of a roof drain pipe. Both the exterior and interior surfaces are covered by heterogeneous corrosion crusts. The underlying metal seems however to be well preserved, including features such as a difference in thickness etc. Dimensions: L = 55mm; W (interior) = 120mm; Tmax. = 6mm; WT = 176g.
<b>Type of artefact</b>	Architectural element
<b>Origin</b>	Château de Germolles (14th century), Mellecey, Bourgogne, France
<b>Recovering date</b>	Unknown
<b>Chronology category</b>	Modern Times
<b>chronology tpq</b>	<input type="text" value="1801"/> A.D. ▾
<b>chronology taq</b>	<input type="text" value="2000"/> A.D. ▾
<b>Chronology comment</b>	19th - 20th century
<b>Burial conditions / environment</b>	Outdoor atmosphere
<b>Artefact location</b>	HE-Arc CR, Neuchâtel, Neuchâtel
<b>Owner</b>	Château de Germolles, Mellecey, Bourgogne

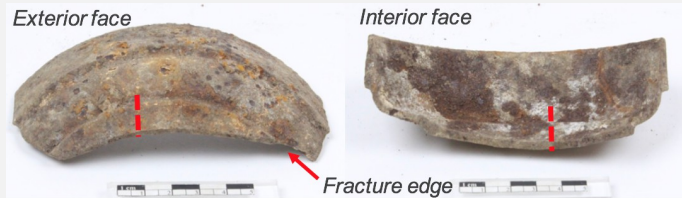
Fig. 2: The exterior and interior faces before sampling. The dotted line represents the sample location (a cross-section of the metal). The fracture edge corresponds to the edge that was formerly attached to the remaining artefact,

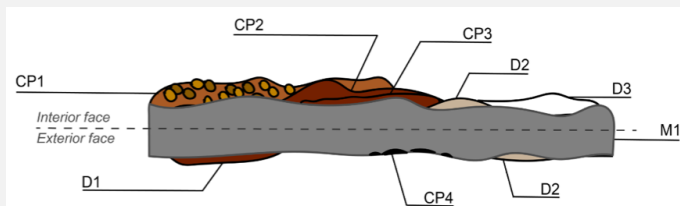
Fig. 3: Preliminary stratigraphy of the corrosion structure based on visual microscopic observation,

Captions	Description
D1	Scattered, orange to dark red encrustations. Probably corrosion products mixed with soil.
D2	Grey-brown and matte deposit, somewhat powdery - possibly corrosion product mixed with soil. This layer is located both on the interior and exterior surface of the artefact.
D3	Localized, white and strongly adherent deposit.
CP1	Bright orange to dark red corrosion product. Uneven surface with pustules.
CP2	Red-brown corrosion crust. Brittle, but adherent. Flakes off in bits when force is applied perpendicular to the surface with a scalpel.
CP3	Similar to CP2 but appears to be an individual layer.
CP4	Isolated corrosion blisters. Circular and black in colour. Mainly located on the exterior surface.
M1	Intact metal with a dark grey metallic sheen.

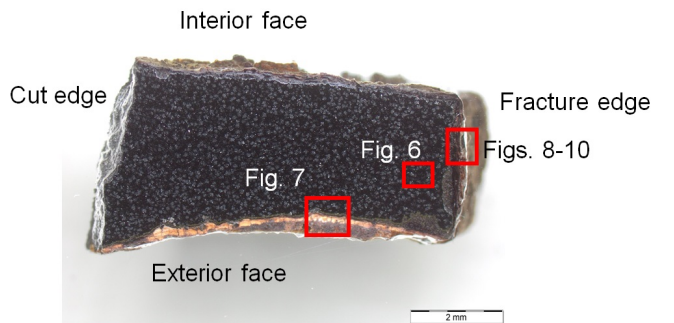
Fig. 4: Micrograph of the sample taken from the rain gutter fragment showing its orientation relative to the artefact and the

locations of Figs. 6-10,

<b>Description of sample</b>	The sample consists of a rectangular section (Fig. 4) which was cut out from the fractured edge of the gutter fragment. It is representative of three surfaces: the exterior and interior surface, as well as the fracture edge. Dimensions: L = 7mm; Wmax. = 5mm; Tmax. = 4mm (approx.).
<b>Alloy</b>	Grey cast iron
<b>Technology</b>	Cast
<b>Lab number of sample</b>	CIG2018 (Cast Iron Gutter, sampled in 2018)
<b>Sample location</b>	HE-Arc CR, Neuchâtel, Neuchâtel
<b>Responsible institution</b>	HE-Arc CR, Neuchâtel, Neuchâtel
<b>Date and aim of sampling</b>	March 2018, study of corrosion stratigraphy and chemical analyses

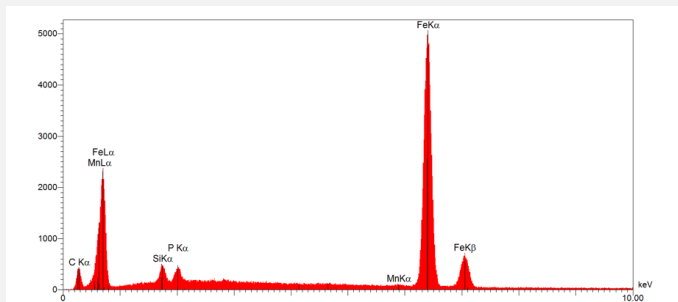
The metal is a P-rich grey cast iron with Si and Mn (Fig. 5). Its microstructure is characterized by evenly distributed graphite flakes in a matrix composed of dendrites and an interdendritic eutectic phase (Fig. 6). What appears to be irregular graphite flakes / porosity is in fact deformed graphite flakes; graphite is soft and prone to destruction by smearing and/or preferential removal during polishing (Scott 1991).

Fig. 5: EDS-spectrum showing the chemical composition of the metal. Method of analysis: SEM-EDS. Lab. of Electronic Microscopy and Microanalysis, Néode, HEI Arc,

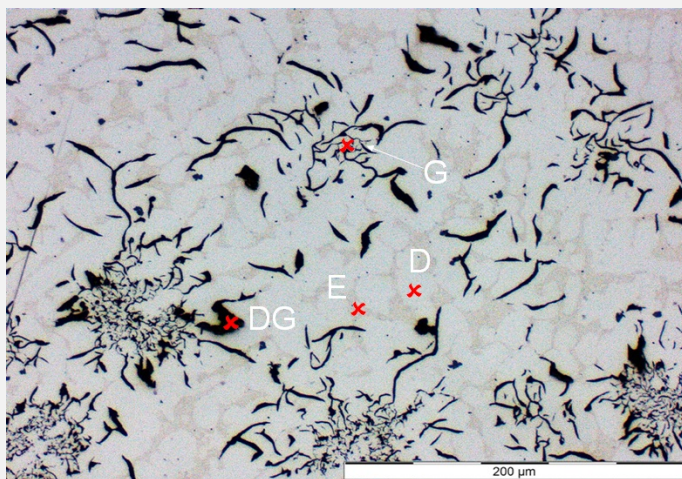
The dendrites appear light grey under polarized light, while the eutectic phase appear light brown (Fig. 6). The eutectic phase is rich in Fe and P and contains small amounts of C and Si, whereas the dendritic phase contains much less P (Table 1).

Fig. 6: Micrograph of the metal sample from Fig. 4 (detail). Unetched, bright field. Graphite flakes (G) in black, the dendrites (D) in light grey and the eutectoid phase (E) in light brown. Deformed graphite (DG) flakes are visible as irregular black inclusions,

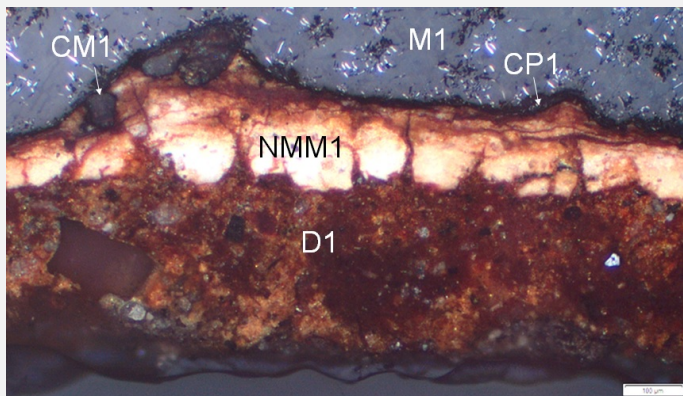
The exterior face (Figs. 2, 4 and 7) consists of a white / light yellow cracked layer (NMM1 in Fig. 7) superimposed by a layer of deposit mixed with orange-red corrosion products (D1 in Fig. 7). Local analysis by SEM-EDS (Table 2) revealed that the

white / light yellow layer is rich in Ba, O, S, Fe, C and Zn. It has a chemical composition similar to Lithopone (BaSO<sub>4</sub>,ZnS), a preparatory paint layer. Fe is probably a contamination from the superimposed porous deposit / corrosion product D1 (Table 2). The latter (D1) is Fe- and O-rich and contains Si, Al and some Ca, in addition to a range of elements (K, P, Na, Cl, S and Ti) present in minor amounts (Table 2). A thin layer of corrosion products (CP1) is located just beneath the paint layer, appearing dark grey under polarized light (Fig. 7). This layer is followed by a corroded metal phase (CM1). Their exact composition was not analyzed but is likely to correspond to the corroded metal phase of the fracture edge, described below.

Fig. 7: Micrograph of the metal sample from Fig. 4 (detail), unetched, polarized light, 5x. Stratigraphy of the exterior surface, to be compared to Fig. 11 and from top to bottom: the metal (M1) in grey, a layer of corroded metal (CM1) followed by a thin layer of CP1, and a white cracked layer (NMM1) superimposed by a porous dark-red deposit (D1),

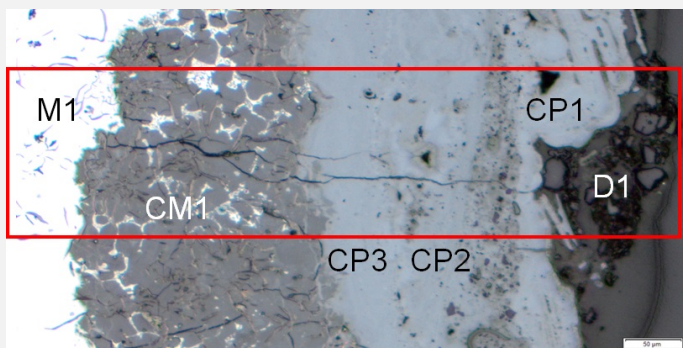
The interior face (Figs. 2 and 4) shows similar characteristics but does not include a white layer similar to NMM1. The fracture edge however (Figs. 2, 4 and 8), shows a more complex stratigraphy consisting of a dense product layer which can be further divided into two individual strata (CP3 and CP2), superimposed by a porous corrosion crust appearing orange under polarized light (CP1) (Fig. 9). The corroded metal (CM1) is located just beneath CP3 and contains remnants of the P-rich eutectic phase (Figs. 8-10). The M/CP ratio (metal to corrosion products) is rather high, implying extensive internal corrosion. Furthermore, cracks are traversing the whole corrosion layers – indicating a fragilization of the structure. As for the composition of the corrosion products CP1, CP2 and CP3, they all contain Fe and O (Fig. 10). A marbling effect within CP2 and CP3 indicates a variation in the concentration of Fe and O (particularly visible in bright field - Fig. 8). The white deposit (D1 in Figs. 8 and 9) might originate from exposure to calcareous water (Table 2). The presence of exogenous elements such as Si, Ca, Al, Na and O (Table 2) was confirmed by elemental mapping (Fig. 10).

Fig. 8: Micrograph of the metal sample from Fig. 4 (detail), unetched, bright field. Stratigraphy of the fracture edge, to be compared to Fig. 12 and from left to right: intact metal (M1) in white, followed by preferentially corroded metal (CM1) and dense product layers (CP3 and CP2) in various shades of grey. CP1 is slightly porous and covered by grain-like particles (D1). The area selected for elemental chemical distribution (Fig. 12) is marked by a red rectangle,

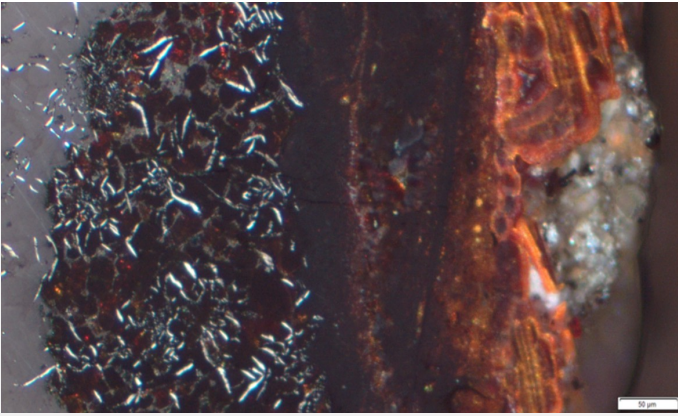
Fig. 9: Micrograph similar to Fig. 8 but under polarized light. The external deposit (D1) appears grey-white, CP1 in bright orange, while CP2 and CP3 appear dark red to brown. The corroded metal (CM1) contains remnants of graphite flakes (in white) and the P-rich eutectic (in grey),

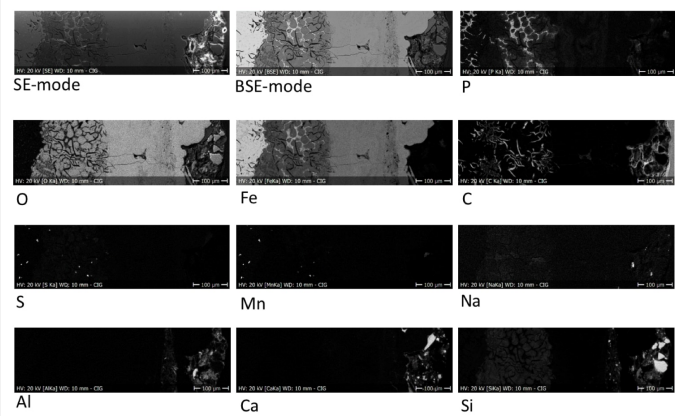
Fig. 10: SEM image and elemental chemical distribution of the selected area from Fig. 8. Method of analysis: SEM-EDS. Lab. of Electronic Microscopy and Microanalysis, Néode, HEI Arc,

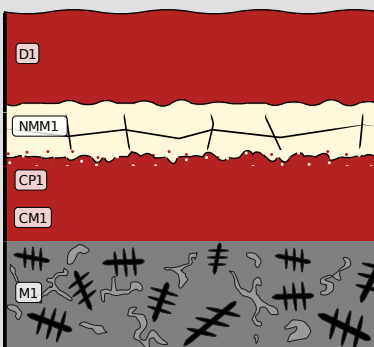
Fig. 11: Stratigraphic representation of the sample taken from the rain gutter fragment in cross-section (dark field) using the MiCorr application. The characteristics of the strata are only accessible by clicking on the drawing that redirects you to the search tool by stratigraphy representation. This representation can be compared to Fig. 7 (exterior surface). CP1 corresponds to CP2 in Fig. 3. Credit UiO-IAKH, M.Hovind.

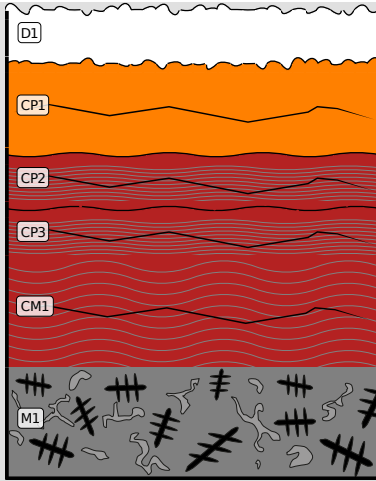
Fig. 12: Stratigraphic representation of the sample taken from the rain gutter fragment in cross-section (dark field) using the MiCorr application. The characteristics of the strata are only accessible by clicking on the drawing that redirects you to the search tool by stratigraphy representation. This representation can be compared to Figs. 8 and 9 (fracture edge). D1 corresponds to D3 in Fig. 3. Credit UiO-IAKH, M.Hovind.

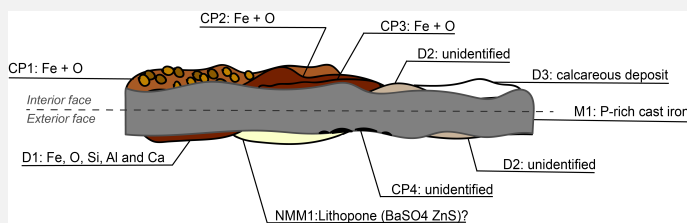
Fig. 13: Improved stratigraphic representation of the rain gutter fragment based on analysis from cross-section and visual microscopic observation,

The rain gutter fragment is a grey cast iron with a microstructure consisting of graphite flakes and a P-rich eutectic phase. The corrosion layers of the exterior surface contains a preparatory paint layer, located beneath a layer of iron corrosion products mixed with soil. It seems likely that the cast iron gutter has been covered with a protective paint layer (e.g. Lithopone) to slow down the rate of atmospheric corrosion. The presence of Lithopone reinforces the suggested dating of the artefact (20th century) as this pigment was developed and used from the 1880s and onwards (Lithopone 2007). However, it seems that the protective layer has none or only very limited effect as (pitting) corrosion is present also in these areas.

The corrosion layers consist mainly of Fe and O, indicating atmospheric corrosion with presence of only a very small amount of contaminants/pollution. The scattered white deposit is possibly originating from exposure to calcareous water as it is localized mainly on the interior face of the fragment, where rain water would hit the metal before entering the ground.
