RAIN GUTTER FRAGMENT – GREY CAST IRON – MODERN TIMES – FRANCE

Artefact name Rain gutter fragment

Authors Christian. Degriigny (HE-Arc CR, Neuchâtel, Neuchâtel, Switzerland) & Mathea. Hovind (University of Oslo, Department of archaeology, conservation and history (IAKH-UiO), Oslo, Oslo, Norway)

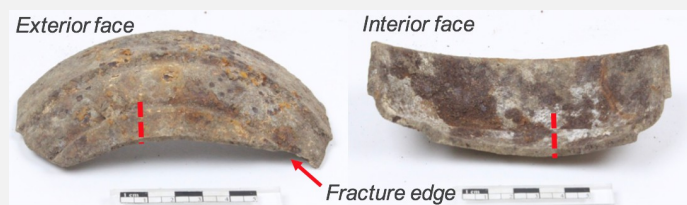
Fig. 2: The exterior and interior faces before sampling. The dotted line represents the sample location (a cross-section of the metal). The fracture edge corresponds to the edge that was formerly attached to the remaining artefact,

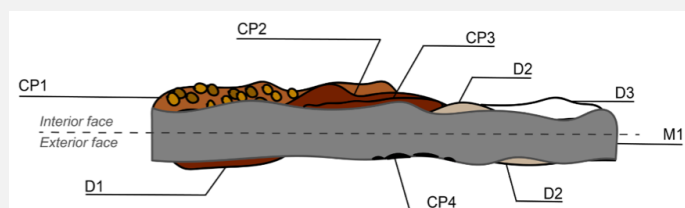
Fig. 3: Preliminary stratigraphy of the corrosion structure based on visual microscopic observation,

Captions	Description
D1	Scattered, orange to dark red encrustations. Probably corrosion products mixed with soil.
D2	Grey-brown and matte deposit, somewhat powdery - possibly corrosion product mixed with soil. This layer is located both on the interior and exterior surface of the artefact.
D3	Localized, white and strongly adherent deposit.
CP1	Bright orange to dark red corrosion product. Uneven surface with pustules.
CP2	Red-brown corrosion crust. Brittle, but adherent. Flakes off in bits when force is applied perpendicular to the surface with a scalpel.
CP3	Similar to CP2 but appears to be an individual layer.
CP4	Isolated corrosion blisters. Circular and black in colour. Mainly located on the exterior surface.
M1	Intact metal with a dark grey metallic sheen.

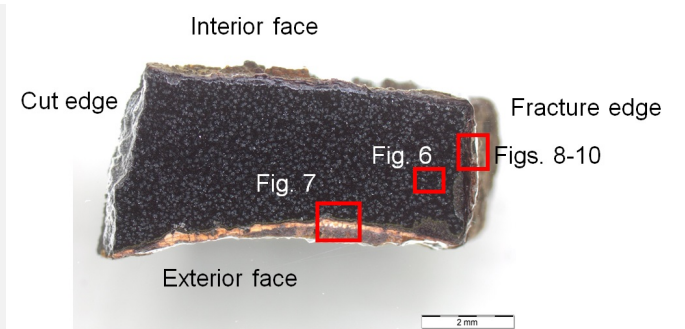
Fig. 4: Micrograph of the sample taken from the rain gutter fragment showing its orientation relative to the artefact and the locations of Figs. 6-10,

Description of sample	The sample consists of a rectangular section (Fig. 4) which was cut out from the fractured edge of the gutter fragment. It is representative of three surfaces: the exterior and interior surface, as well as the fracture edge. Dimensions: L = 7mm; Wmax. = 5mm; Tmax. = 4mm (approx.).
Alloy	Grey cast iron
Technology	Cast
Lab number of sample	CIG2018 (Cast Iron Gutter, sampled in 2018)
Sample location	HE-Arc CR, Neuchâtel, Neuchâtel
Responsible institution	HE-Arc CR, Neuchâtel, Neuchâtel
Date and aim of sampling	March 2018, study of corrosion stratigraphy and chemical analyses

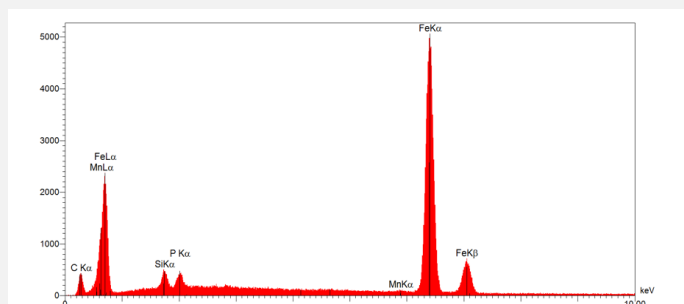
The metal is a P-rich grey cast iron with Si and Mn (Fig. 5). Its microstructure is characterized by evenly distributed graphite flakes in a matrix composed of dendrites and an interdendritic eutectic phase (Fig. 6). What appears to be irregular graphite flakes / porosity is in fact deformed graphite flakes; graphite is soft and prone to destruction by smearing and/or preferential removal during polishing (Scott 1991).

Fig. 5: EDS-spectrum showing the chemical composition of the metal. Method of analysis: SEM-EDS. Lab. of Electronic Microscopy and Microanalysis, Néode, HEI Arc,

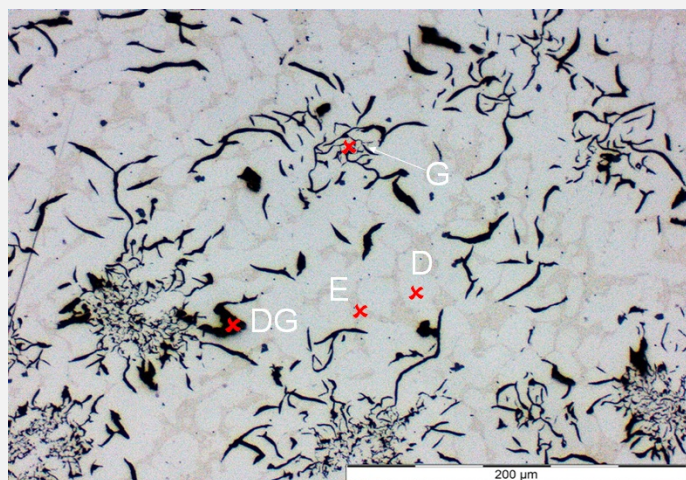
The dendrites appear light grey under polarized light, while the eutectic phase appear light brown (Fig. 6). The eutectic phase is rich in Fe and P and contains small amounts of C and Si, whereas the dendritic phase contains much less P (Table 1).

Fig. 6: Micrograph of the metal sample from Fig. 4 (detail). Unetched, bright field. Graphite flakes (G) in black, the dendrites (D) in light grey and the eutectoid phase (E) in light brown. Deformed graphite (DG) flakes are visible as irregular black inclusions,

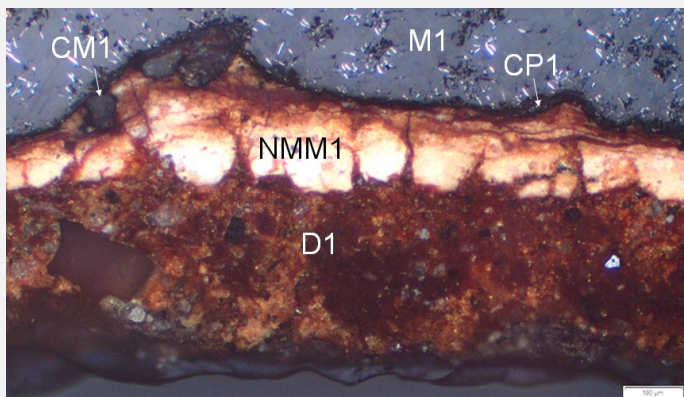
The exterior face (Figs. 2, 4 and 7) consists of a white / light yellow cracked layer (NMM1 in Fig. 7) superimposed by a layer of deposit mixed with orange-red corrosion products (D1 in Fig. 7). Local analysis by SEM-EDS (Table 2) revealed that the

white / light yellow layer is rich in Ba, O, S, Fe, C and Zn. It has a chemical composition similar to Lithopone (BaSO₄,ZnS), a preparatory paint layer. Fe is probably a contamination from the superimposed porous deposit / corrosion product D1 (Table 2). The latter (D1) is Fe- and O-rich and contains Si, Al and some Ca, in addition to a range of elements (K, P, Na, Cl, S and Ti) present in minor amounts (Table 2). A thin layer of corrosion products (CP1) is located just beneath the paint layer, appearing dark grey under polarized light (Fig. 7). This layer is followed by a corroded metal phase (CM1). Their exact composition was not analyzed but is likely to correspond to the corroded metal phase of the fracture edge, described below.

Fig. 7: Micrograph of the metal sample from Fig. 4 (detail), unetched, polarized light, 5x. Stratigraphy of the exterior surface, to be compared to Fig. 11 and from top to bottom: the metal (M1) in grey, a layer of corroded metal (CM1) followed by a thin layer of CP1, and a white cracked layer (NMM1) superimposed by a porous dark-red deposit (D1),

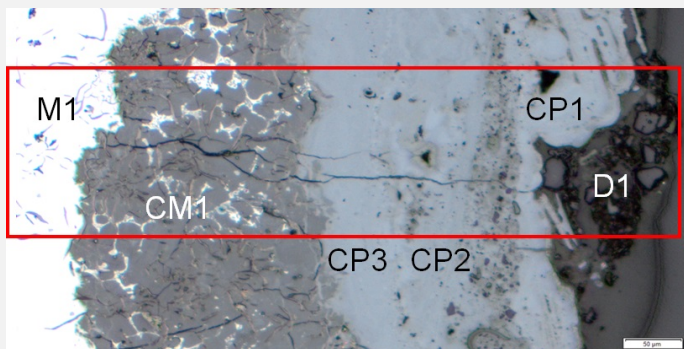
The interior face (Figs. 2 and 4) shows similar characteristics but does not include a white layer similar to NMM1. The fracture edge however (Figs. 2, 4 and 8), shows a more complex stratigraphy consisting of a dense product layer which can be further divided into two individual strata (CP3 and CP2), superimposed by a porous corrosion crust appearing orange under polarized light (CP1) (Fig. 9). The corroded metal (CM1) is located just beneath CP3 and contains remnants of the P-rich eutectic phase (Figs. 8-10). The M/CP ratio (metal to corrosion products) is rather high, implying extensive internal corrosion. Furthermore, cracks are traversing the whole corrosion layers – indicating a fragilization of the structure. As for the composition of the corrosion products CP1, CP2 and CP3, they all contain Fe and O (Fig. 10). A marbling effect within CP2 and CP3 indicates a variation in the concentration of Fe and O (particularly visible in bright field - Fig. 8). The white deposit (D1 in Figs. 8 and 9) might originate from exposure to calcareous water (Table 2). The presence of exogenous elements such as Si, Ca, Al, Na and O (Table 2) was confirmed by elemental mapping (Fig. 10).

Fig. 8: Micrograph of the metal sample from Fig. 4 (detail), unetched, bright field. Stratigraphy of the fracture edge, to be compared to Fig. 12 and from left to right: intact metal (M1) in white, followed by preferentially corroded metal (CM1) and dense product layers (CP3 and CP2) in various shades of grey. CP1 is slightly porous and covered by grain-like particles (D1). The area selected for elemental chemical distribution (Fig. 12) is marked by a red rectangle,

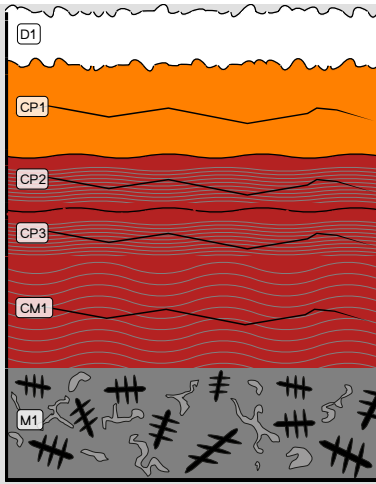
Fig. 12: Stratigraphic representation of the sample taken from the rain gutter fragment in cross-section (dark field) using the MiCorr application. The characteristics of the strata are only accessible by clicking on the drawing that redirects you to the search tool by stratigraphy representation. This representation can be compared to Figs. 8 and 9 (fracture edge). D1 corresponds to D3 in Fig. 3, Credit UiO-IAKH, M.Hovind.

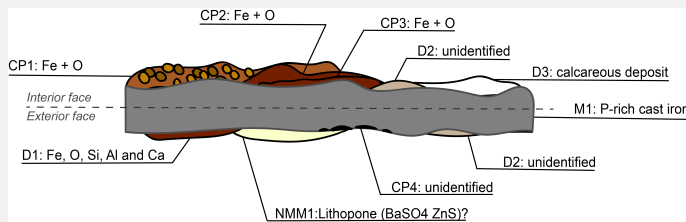
Fig. 13: Improved stratigraphic representation of the rain gutter fragment based on analysis from cross-section and visual microscopic observation,

The rain gutter fragment is a grey cast iron with a microstructure consisting of graphite flakes and a P-rich eutectic phase. The corrosion layers of the exterior surface contains a preparatory paint layer, located beneath a layer of iron corrosion products mixed with soil. It seems likely that the cast iron gutter has been covered with a protective paint layer (e.g. Lithopone) to slow down the rate of atmospheric corrosion. The presence of Lithopone reinforces the suggested dating of the artefact (20th century) as this pigment was developed and used from the 1880s and onwards (Lithopone 2007). However, it seems that the protective layer has none or only very limited effect as (pitting) corrosion is present also in these areas.

The corrosion layers consist mainly of Fe and O, indicating atmospheric corrosion with presence of only a very small amount of contaminants/pollution. The scattered white deposit is possibly originating from exposure to calcareous water as it is localized mainly on the interior face of the fragment, where rain water would hit the metal before entering the ground.
