ROOF GUTTER ELEMENT – ZN ALLOY – MODERN TIMES – FRANCE

Artefact name	Roof gutter element
Authors	Christian. Degriigny (HE-Arc CR, Neuchâtel, Neuchâtel, Switzerland) & Mathea. Hovind (University of Oslo, Department of archaeology, conservation and history (IAKH-UiO), Oslo, Oslo, Norway)
Url	/artefacts/880/

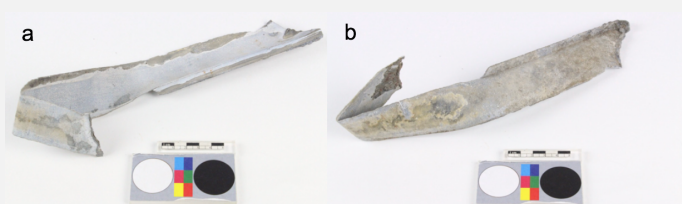
Fig. 1: Roof gutter element having different appearances on each of its surfaces: "a" on the left and "b" on the right,

Description of the artefact	A roof gutter element with remains of lead solder (Fig. 1). Its surfaces are covered by a white, strongly adherent oxide layer. Surface "b" is slightly darker in colour than surface "a" due to the presence of soil particles. Dimensions: L = 265mm; W = 47mm; T = 1mm; WT = 93g.		
Type of artefact	Architectural element		
Origin	Château de Germolles, Mellecey, Bourgogne, France		
Recovering date	Unknown		
Chronology category	Modern Times		
chronology tpq	1900	A.D.	▼
chronology taq	2000	A.D.	▼
Chronology comment	19th-20th century		
Burial conditions / environment	Outdoor atmosphere		
Artefact location	HE-Arc CR, Neuchâtel, Neuchâtel		
Owner	Château de Germolles, Mellecey, Bourgogne		
Inv. number	None		
Recorded conservation data	N/A

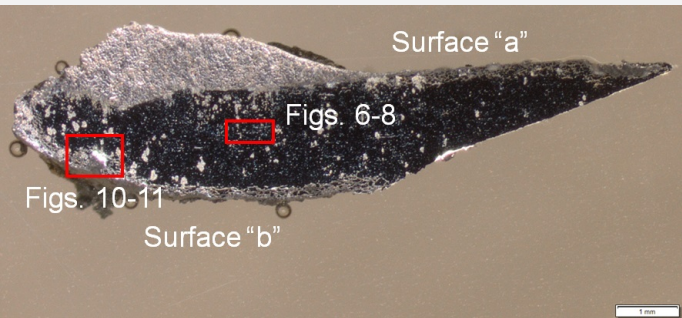
Fig. 4: Micrograph of the sample taken from the roof gutter showing the locations of Figs. 6-8 and 10-11. The uppermost area (in white) is remains of solder, while the zinc metal appears dark grey to black (the white patches are due to secondary oxidation of the sample),

A cross-section (Fig. 4) was cut out where the metal is at an angle of approximately 90° to the flat surface. Its upper edge corresponds to surface "a" and contains remains of solder, while the lower edge corresponds to surface "b".

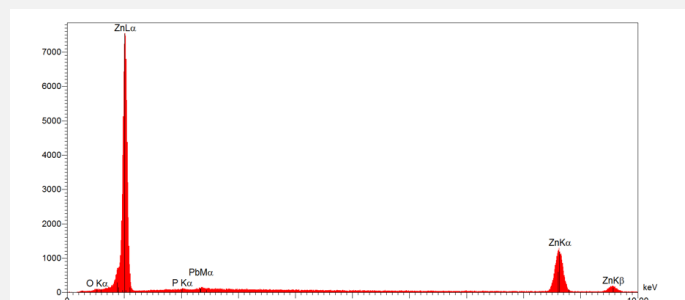
The roof gutter element is composed of Zn with P and Pb at lower concentrations (Fig. 5). The latter is probably originating from the solder that was applied to adjoin several metal sheets for the roof gutter.

Fig. 5: Chemical composition of the metal. Method of analysis: SEM-EDS. Lab. of Electronic Microscopy and Microanalysis, Néode, HEI Arc,

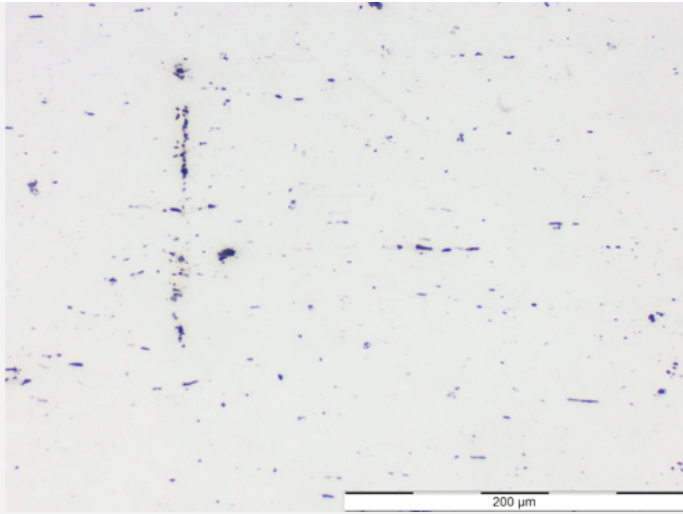
Fig. 6: Micrograph of the metal sample from Fig. 4 (detail). Unetched, bright field,

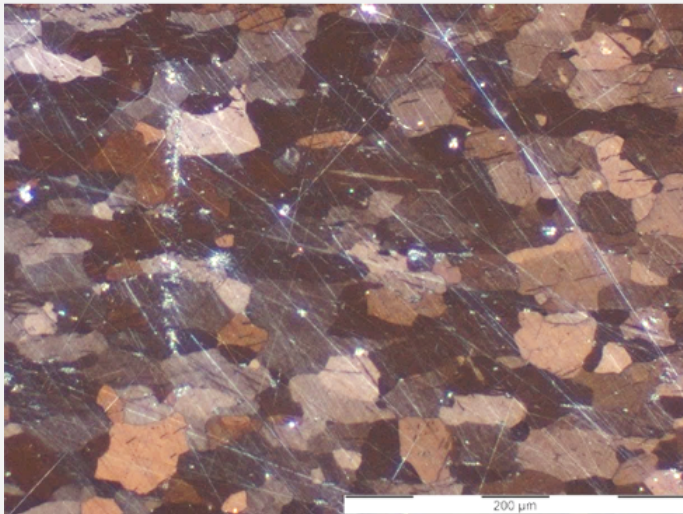
The metal appears white to light grey under bright field (Fig. 6). Under polarized light however (Fig. 78), the microstructure of the metal is visible as small polygonal grains appearing in various shades of brown, a coloured effect due to the anisotropic properties of the metal (Scott 1991: 49). In the SEM-image, white elongated inclusions are visible (Fig. 8) consisting mainly of Zn and Pb with some O (Fig. 90).

Fig. 7: Micrograph similar to Fig. 6, but under polarized light. The microstructure of the metal shows the presence of small and polygonal grains in shape,

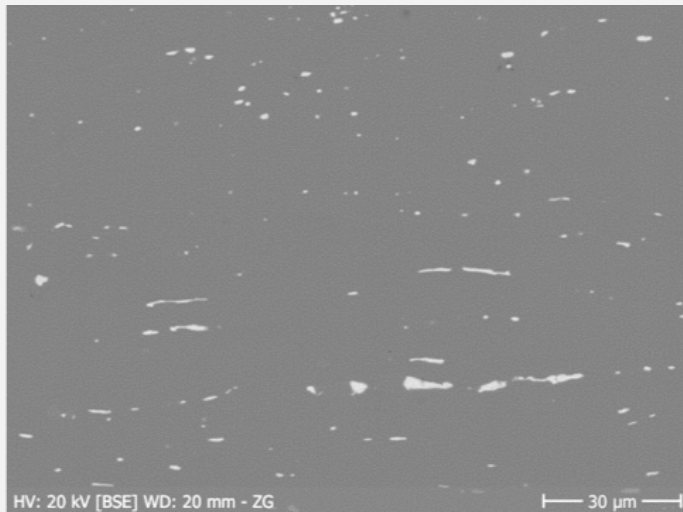
Fig. 8: SEM-image (BSE-mode) of the metal sample from Fig. 4 (detail) showing the white elongated inclusions,

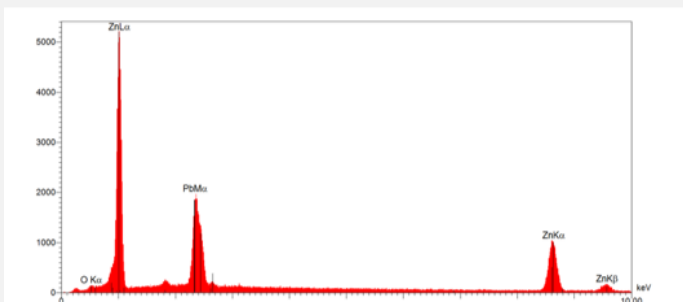
Fig. 9: SEM-EDS spectrum showing the composition of the elongated inclusions from Fig. 8. Method of analysis: SEM-EDS. Lab. of Electronic Microscopy and Microanalysis, Néode, HEI Arc,

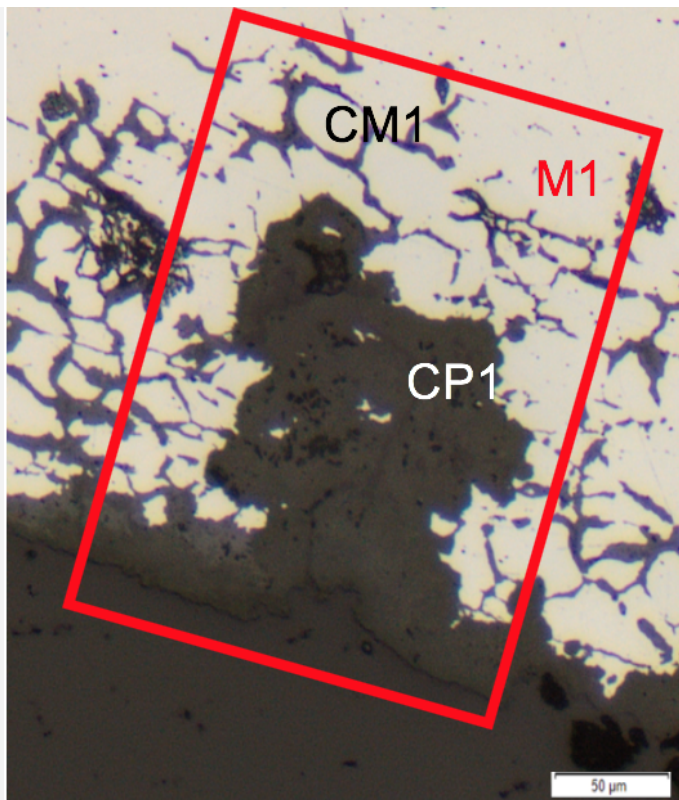
The metal is suffering from intergranular corrosion visible as a white corrosion product (CP1) located within crevices and along the grain boundaries (Figs. 10 and 11). The porous and powdery corrosion product (CP1) appears dark grey in bright field (Fig. 10) and white-grey under polarized light (Fig. 11). It consists of Zn and O (Table 1). The external corrosion product (CP1) contains some S (and not Pb as suggested by Table 1 and Fig. 13) which is probably due to atmospheric pollution. The structural composition of the corrosion product was determined by crystallographic analysis (XRD) to consist of a mixture of zincite (ZnO) and pure zinc (Zn) (Table 2, Fig 12). Mapping of the corroded area by SEM-EDS displays a similar composition but shows additionally the presence of Cl in some of the veins of the corroded metal (Fig. 13). S1 (soil material) is found on the very top of CP1.

Table 1: Chemical composition of the corrosion layers from Fig. 10. Method of analysis: SEM-EDS. Lab. of Electronic Microscopy and Microanalysis, Néode, HEI Arc, credit MiCorr_HEI Arc, C.Csefalvay. *The sum is the calculated average of three analyses of the same feature, but in different areas.

Fig. 10: Micrograph of the metal sample from Fig. 4 (detail). Unetched, bright field. The corrosion product (CP1) is located at the surface of the metal and in its crevices. Intergranular corrosion (CM1) is visible as thin grey lines in between the metal grains (M1). The corrosion structure is to compare to the stratigraphy representation of Fig. 14. The area selected for elemental chemical distribution (Fig. 13) is marked by a red rectangle,

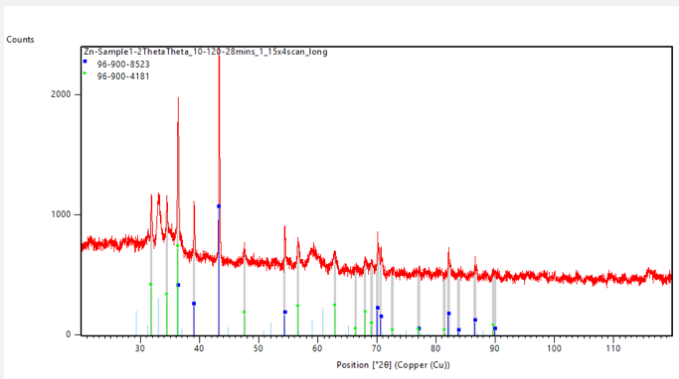
Table 2: Summary of the results from the crystallographic analysis of the white corrosion product (CP1). A representative spectrum is given in Fig. 12. Method of analysis: XRD. Center of X-ray Analytics, Empa-Swiss Federal Laboratories for Materials Science and Technology (Dübendorf), credit MiCorr_Empa, Z.Balogh-Michels. *The results are based on the analysis of two powder samples from different areas (see Fig. 2 for sample locations).

Fig. 12: XRD-spectrum for the analysis of powder sample 1. Ref. 96-900-8523 (in blue) corresponds to pure zinc and 96-900-4181 (in green) to zincite (ZnO),

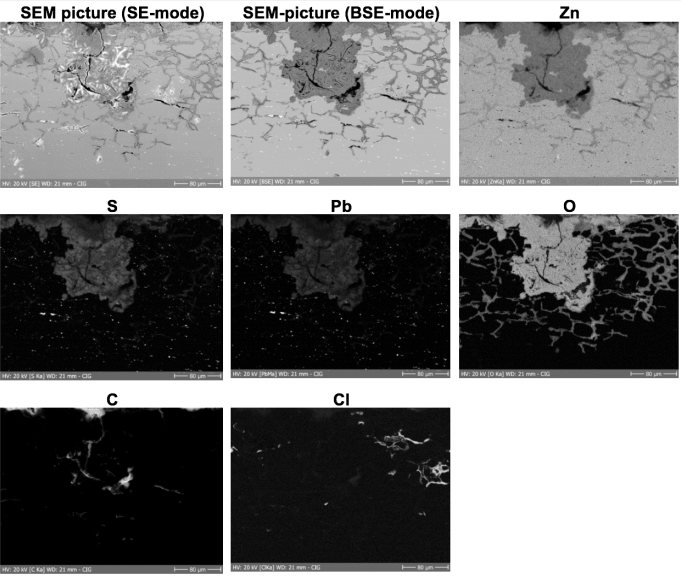
Fig. 13: SEM image and elemental chemical distribution of a selected area of Fig. 10 (rotated almost 180° and reversed). Method of analysis: SEM-EDS. Lab. of Electronic Microscopy and Microanalysis, Néode, HEI Arc,

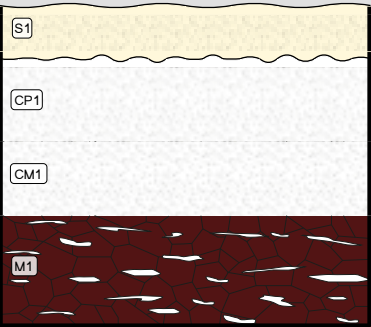
Fig. 14: Stratigraphic representation of the sample taken from the roof gutter (surface "b") in cross-section (dark field) using the MiCorr application. The characteristics of the strata are only accessible by clicking on the drawing that redirects you to the search tool by stratigraphy representation. This representation can be compared to Figs. 10 and 11, Credit UiO-IAKH, M.Hovind.
