ROOF GUTTER ELEMENT – ZN ALLOY – MODERN TIMES – FRANCE

Artefact name	Roof gutter element
Authors	Christian. Degrigny (HE-Arc CR, Neuchâtel, Neuchâtel, Switzerland) & Mathea. Hovind (University of Oslo, Department of archaeology, conservation and history (IAKH-UiO), Oslo, Oslo, Norway)
Url	/artefacts/880/

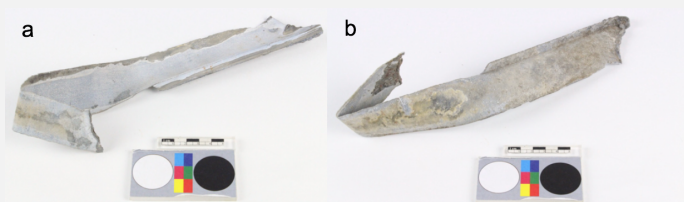
Fig. 1: Roof gutter element having different appearances on each of its surfaces: "a" on the left and "b" on the right,

Description of the artefact	A roof gutter element with remains of lead solder (Fig. 1). Its surfaces are covered by a white, strongly adherent oxide layer. Surface "b" is slightly darker in colour than surface "a" due to the presence of soil particles. Dimensions: L = 265mm; W = 47mm; T = 1mm; WT = 93g.
Type of artefact	Architectural element
Origin	Château de Germolles (14th century), Mellecey, Bourgogne, France
Recovering date	Unknown
Chronology category	Modern Times
chronology tpq	<input type="text" value="1900"/> A.D. ▼
chronology taq	<input type="text" value="2000"/> A.D. ▼
Chronology comment	19th-20th century
Burial conditions / environment	Outdoor atmosphere
Artefact location	HE-Arc CR, Neuchâtel, Neuchâtel
Owner	Château de Germolles, Mellecey, Bourgogne
Inv. number	None
Recorded conservation data	N/A

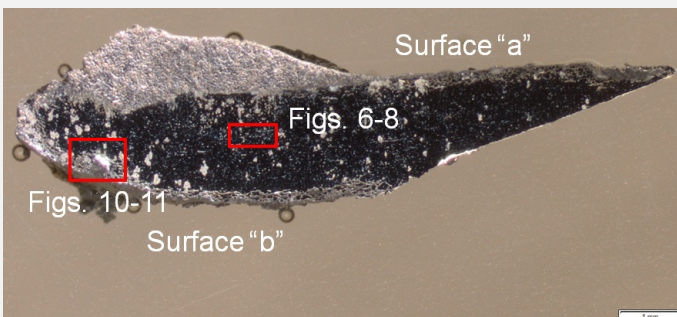
Fig. 4: Micrograph of the sample taken from the roof gutter showing the locations of Figs. 6-8 and 10-11. The uppermost area (in white) is remains of solder, while the zinc metal appears dark grey to black (the white patches are due to secondary oxidation of the sample),

A cross-section (Fig. 4) was cut out where the metal is at an angle of approximately 90° to the flat surface. Its upper edge corresponds to surface "a" and contains remains of solder, while the lower edge corresponds to surface "b".

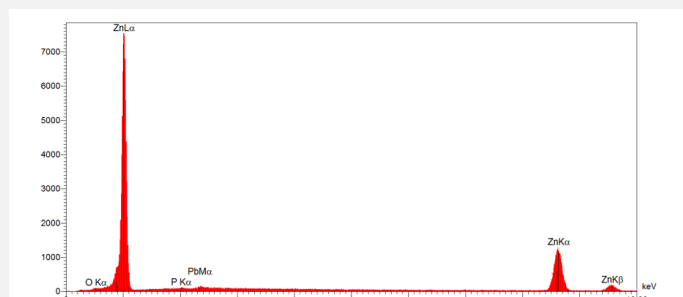
The roof gutter element is composed of Zn with P and Pb at lower concentrations (Fig. 5). The latter is probably originating from the solder that was applied to adjoin several metal sheets for the roof gutter.

Fig. 5: Chemical composition of the metal. Method of analysis: SEM-EDS. Lab. of Electronic Microscopy and Microanalysis, Néode, HEI Arc,

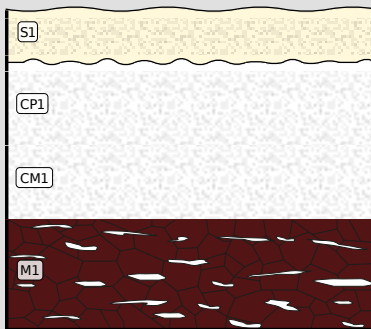
Fig. 14: Stratigraphic representation of the sample taken from the roof gutter (surface "b") in cross-section (dark field) using the MiCorr application. The characteristics of the strata are only accessible by clicking on the drawing that redirects you to the search tool by stratigraphy representation. This representation can be compared to Figs. 10 and 11, Credit UiO-IAKH, M.Hovind.
