ROOF GUTTER ELEMENT – ZN ALLOY – MODERN TIMES – FRANCE

Artefact name	Roof gutter element
Authors	Christian. Degriigny (HE-Arc CR, Neuchâtel, Neuchâtel, Switzerland) & Mathea. Hovind (University of Oslo, Department of archaeology, conservation and history (IAKH-UiO), Oslo, Oslo, Norway)
Url	/artefacts/880/

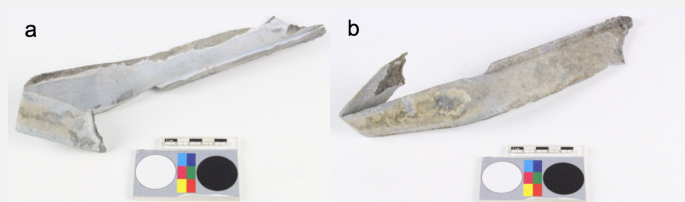
Fig. 1: Roof gutter element having different appearances on each of its surfaces: "a" on the left and "b" on the right,

Description of the artefact	A roof gutter element with remains of lead solder (Fig. 1). Its surfaces are covered by a white, strongly adherent oxide layer. Surface "b" is slightly darker in colour than surface "a" due to the presence of soil particles. Dimensions: L = 265mm; W = 47mm; T = 1mm; WT = 93g.
Type of artefact	Architectural element
Origin	Château de Germolles (14th century), Mellecey, Bourgogne, France
Recovering date	Unknown
Chronology category	Modern Times
chronology tpq	1900 A.D. ▼
chronology taq	2000 A.D. ▼
Chronology comment	19th-20th century
Burial conditions / environment	Outdoor atmosphere
Artefact location	HE-Arc CR, Neuchâtel, Neuchâtel
Owner	Château de Germolles, Mellecey, Bourgogne
Inv. number	None
Recorded conservation data	N/A

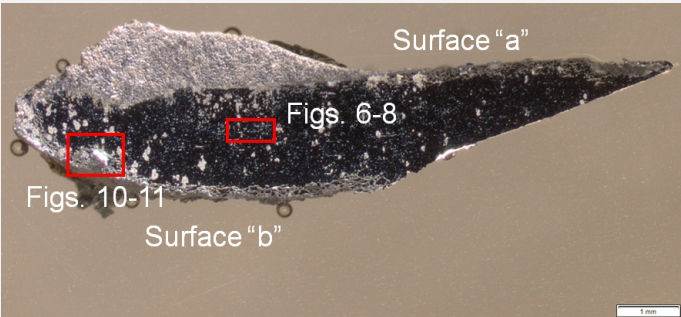
Fig. 4: Micrograph of the sample taken from the roof gutter showing the locations of Figs. 6-8 and 10-11. The uppermost area (in white) is remains of solder, while the zinc metal appears dark grey to black (the white patches are due to secondary oxidation of the sample),

A cross-section (Fig. 4) was cut out where the metal is at an angle of approximately 90° to the flat surface. Its upper edge corresponds to surface "a" and contains remains of solder, while the lower edge corresponds to surface "b".

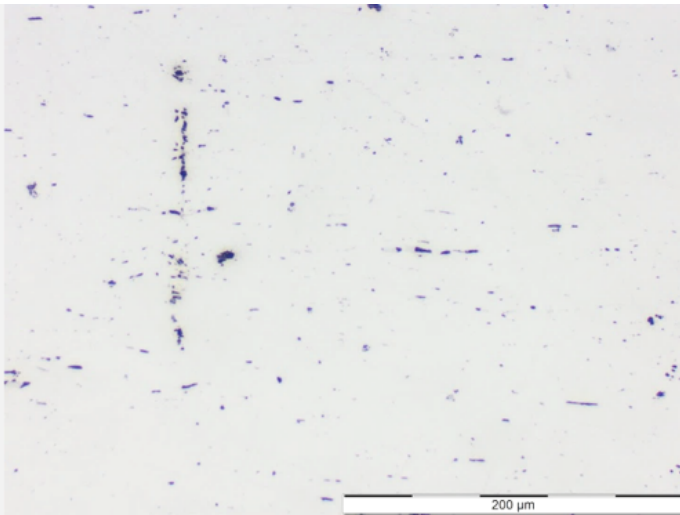
The metal appears white to light grey under bright field (Fig. 6). Under polarized light however (Fig. 78), the microstructure of the metal is visible as small polygonal grains appearing in various shades of brown, a coloured effect due to the anisotropic properties of the metal (Scott 1991: 49). In the SEM-image, white elongated inclusions are visible (Fig. 8) consisting mainly of Zn and Pb with some O (Fig. 90).

Fig. 6: Micrograph of the metal sample from Fig. 4 (detail). Unetched, bright field,

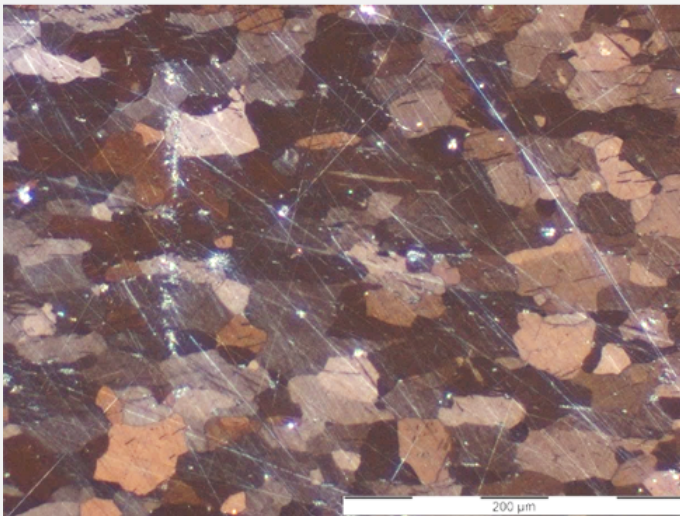
Fig. 7: Micrograph similar to Fig. 6, but under polarized light. The microstructure of the metal shows the presence of small and polygonal grains in shape,

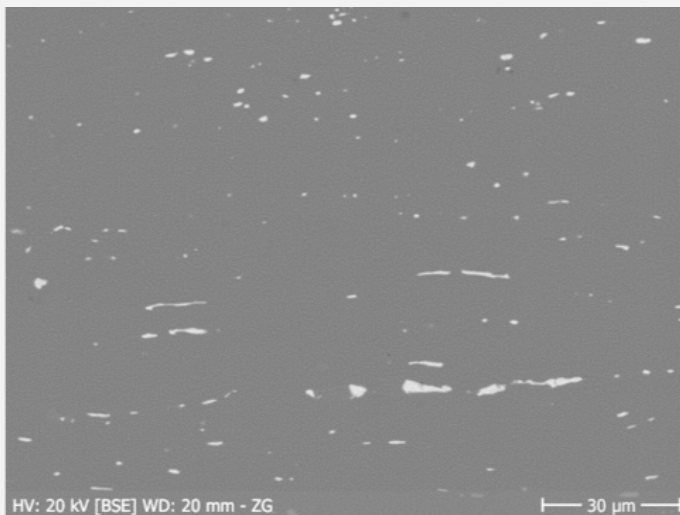
Fig. 8: SEM-image (BSE-mode) of the metal sample from Fig. 4 (detail) showing the white elongated inclusions,

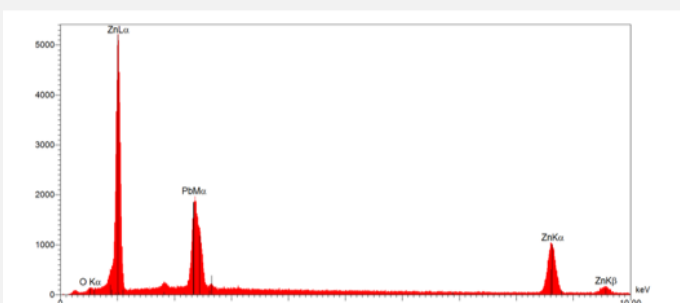
Fig. 9: SEM-EDS spectrum showing the composition of the elongated inclusions from Fig. 8. Method of analysis: SEM-EDS. Lab. of Electronic Microscopy and Microanalysis, Néode, HEI Arc,

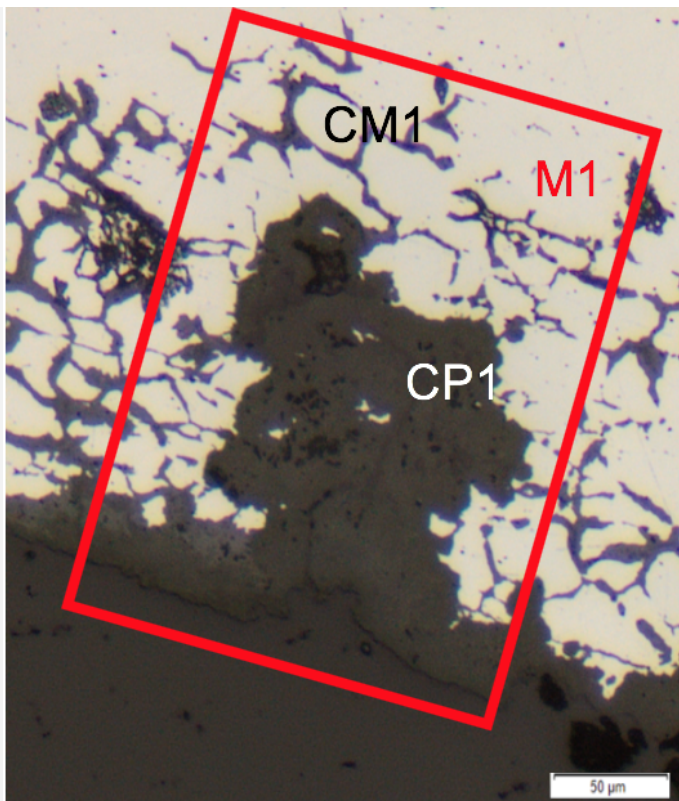
The metal is suffering from intergranular corrosion visible as a white corrosion product (CP1) located within crevices and along the grain boundaries (Figs. 10 and 11). The porous and powdery corrosion product (CP1) appears dark grey in bright field (Fig. 10) and white-grey under polarized light (Fig. 11). It consists of Zn and O (Table 1). The external corrosion product (CP1) contains some S (and not Pb as suggested by Table 1 and Fig. 13) which is probably due to atmospheric pollution. The structural composition of the corrosion product was determined by crystallographic analysis (XRD) to consist of a mixture of zincite (ZnO) and pure zinc (Zn) (Table 2, Fig 12). Mapping of the corroded area by SEM-EDS displays a similar composition but shows additionally the presence of Cl in some of the veins of the corroded metal (Fig. 13). S1 (soil material) is found on the very top of CP1.

Table 1: Chemical composition of the corrosion layers from Fig. 10. Method of analysis: SEM-EDS. Lab. of Electronic Microscopy and Microanalysis, Néode, HEI Arc, credit MiCorr_HEI Arc, C.Csefalvay. *The sum is the calculated average of three analyses of the same feature, but in different areas.

Fig. 10: Micrograph of the metal sample from Fig. 4 (detail). Unetched, bright field. The corrosion product (CP1) is located at the surface of the metal and in its crevices. Intergranular corrosion (CM1) is visible as thin grey lines in between the metal grains (M1). The corrosion structure is to compare to the stratigraphy representation of Fig. 14. The area selected for elemental chemical distribution (Fig. 13) is marked by a red rectangle,

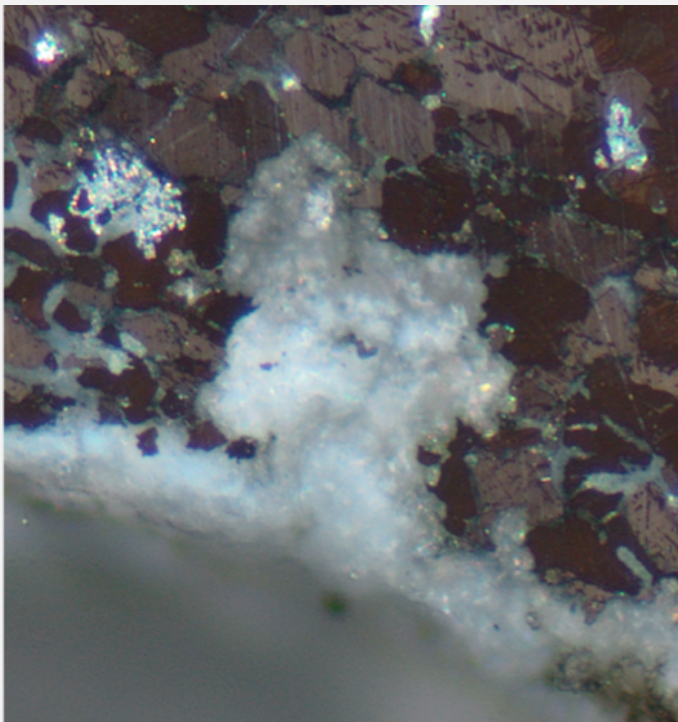
Fig. 11: Micrograph similar to Fig. 10 but under polarized light, the corrosion product (CP1) and the corroded metal (CM1) appear white,

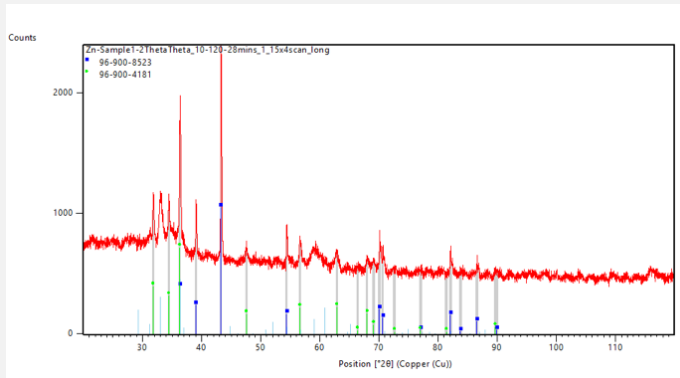
Table 2: Summary of the results from the crystallographic analysis of the white corrosion product (CP1). A representative spectrum is given in Fig. 12. Method of analysis: XRD. Center of X-ray Analytics, Empa-Swiss Federal Laboratories for Materials Science and Technology (Dübendorf), credit MiCorr_Empa, Z.Balogh-Michels. *The results are based on the analysis of two powder samples from different areas (see Fig. 2 for sample locations).

Fig. 12: XRD-spectrum for the analysis of powder sample 1. Ref. 96-900-8523 (in blue) corresponds to pure zinc and 96-900-4181 (in green) to zincite (ZnO),

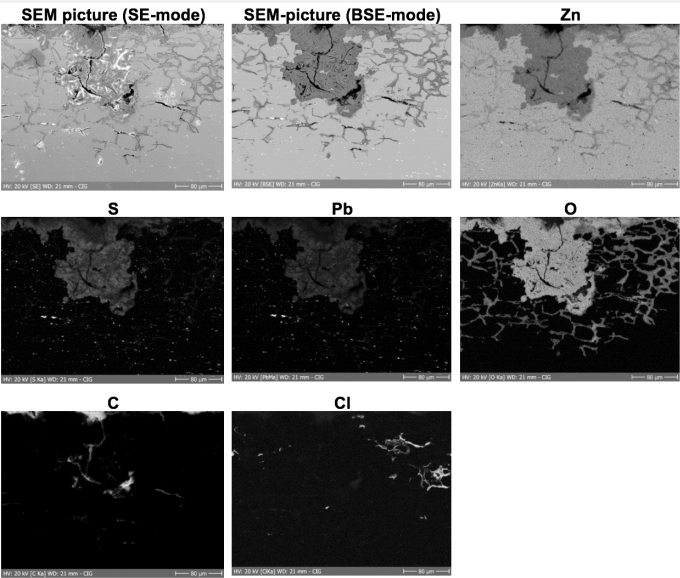
Fig. 13: SEM image and elemental chemical distribution of a selected area of Fig. 10 (rotated almost 180° and reversed). Method of analysis: SEM-EDS. Lab. of Electronic Microscopy and Microanalysis, Néode, HEI Arc,

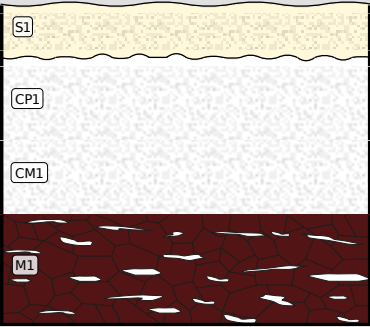
Fig. 14: Stratigraphic representation of the sample taken from the roof gutter (surface "b") in cross-section (dark field) using the MiCorr application. The characteristics of the strata are only accessible by clicking on the drawing that redirects you to the search tool by stratigraphy representation. This representation can be compared to Figs. 10 and 11, Credit UiO-IAKH, M.Hovind.
