DOMED CAP NUT – ZN AL SN CU ALLOY – MODERN TIMES – FRANCE

Artefact name Domed cap nut

Authors Christian. Degrigny (HE-Arc CR, Neuchâtel, Neuchâtel, Switzerland) & Mathea. Hovind (University of Oslo, Department of archaeology, conservation and history (IAKH-UiO), Oslo, Oslo, Norway)

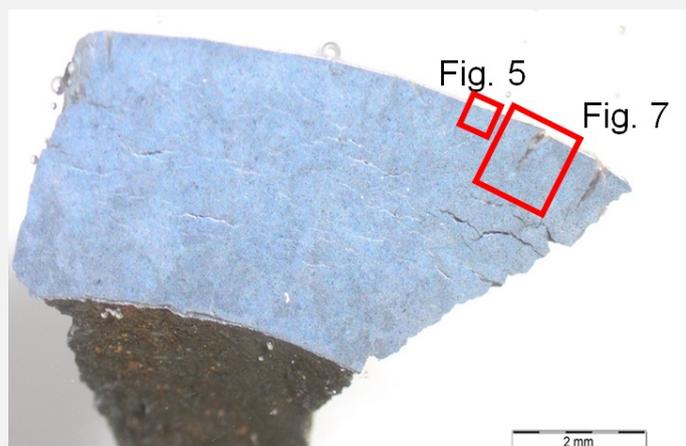
Fig. 4: Micrograph of the cross-section of the sample taken from the domed cap nut showing the locations of Figs. 5 and 7,

Description of sample	The sample is a cross section of the metal, representative of the domed cap nut. It shows external cracks extending from the metal surface and into its structure in addition to internal cracks, visible as thin lines along its longitudinal axis (Fig. 4).
Alloy	Zn Al Sn Cu Alloy
Technology	Cast and plated
Lab number of sample	NZC2018 (Ni/Zn Cap, sampled in 2018)
Sample location	HE-Arc CR, Neuchâtel, Neuchâtel
Responsible institution	HE-Arc CR, Neuchâtel, Neuchâtel
Date and aim of sampling	March 2018, study of corrosion stratigraphy and chemical analyses

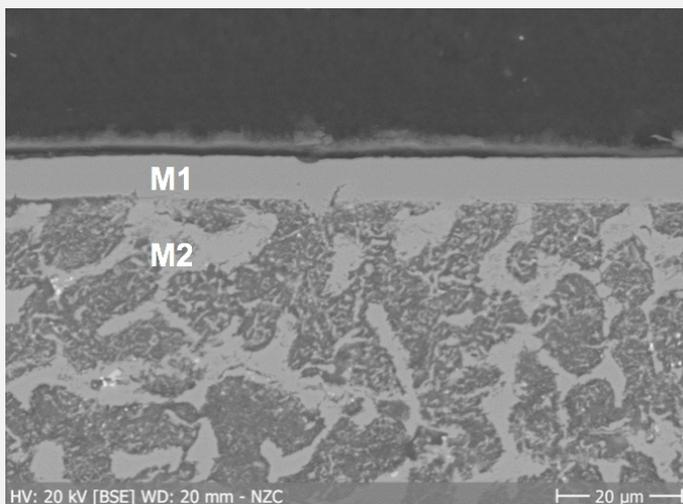
The metal of the domed cap nut (M2) consists of a Zn/Al/Pb/Cu/Sn alloy (Table 1) externally covered by a nickel-based plating (M1) (Figs. 5 and 6) containing some cobalt (Co). The bulk metal (M2) has a dendritic microstructure appearing light grey in bright field, while the interdendritic phase appears white (Fig. 7). The latter is Zn-rich, while the dendritic phase consists of approximately equal amounts of Zn and Al (Table 2, Fig. 9). Observation in SEM (BSE-mode) reveals the presence of Pb-nodules, visible as white irregular spots with a scattered distribution, in addition to opaque grey patches which are rich in Al and Fe (Fig. 8).

Fig. 5: SEM-image (BSE-mode) of a selected area from Fig. 4 (detail), showing the metal plating (M1) and the bulk metal (M2),

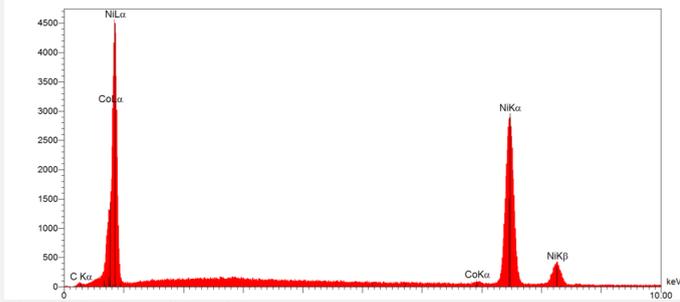
Fig. 6: EDS-spectrum showing the chemical composition of the metal plating (M1). Method of analysis: SEM-EDS. Lab. of Electronic Microscopy and and Microanalysis, Néode, HEI Arc,

The domed cap nut is nickel plated (6-7 micrometers).

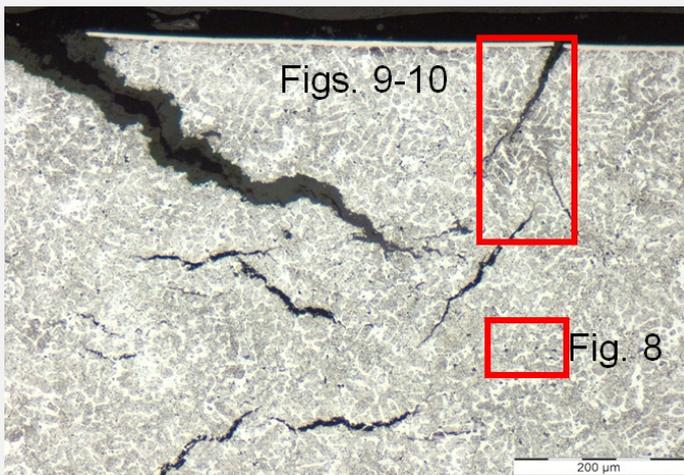
Fig. 7: Micrograph of the metal sample from Fig. 4 (detail), unetched, bright field. The dendrites appear light to dark grey while the interdendritic phase appears white. The metal is characterized by surface cracks as well as internal cracks. The lower red rectangle corresponds to Fig. 8 while the areas selected for elemental chemical distributions (Figs. 9 and 10) are marked by the upper red rectangle,

The dendritic phase is heavily oxidized compared to the interdendritic phase (Table 2 and Fig. 10). The corrosion has developed throughout the entire metal body, generating cracks (Fig. 7). The cracks are Zn and O-rich (Fig. 10) and could be composed of zinc oxide or carbonate. It could be a case of zinc pest, a corrosion phenomenon known to cause disintegration in poor quality alloys (Selwyn 2004, Zhang 2011).

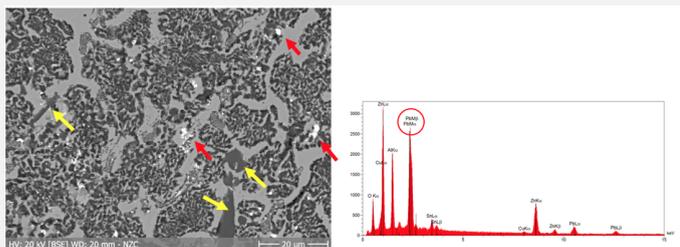
Fig. 8: SEM-image in BSE-mode (left) and EDS-spectrum (right), showing the appearance and the chemical composition of the Pb inclusions (red arrows). The inclusions appear white, the dendrites appear dark grey/black and the interdendritic phase appears grey. Grey opaque patches (yellow arrows) are Fe- and Al-rich phases,

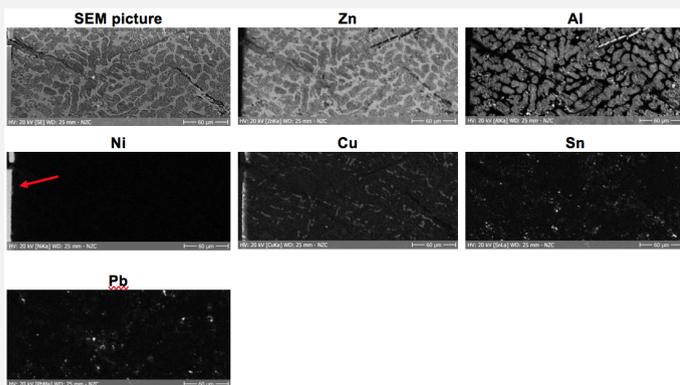
Fig. 9: SEM image and elemental chemical distribution of the selected area from Fig. 7 (rotated 270° and inverted). Method of analysis: SEM-EDS. Lab. of Electronic Microscopy and Microanalysis, Néode, HEI Arc,

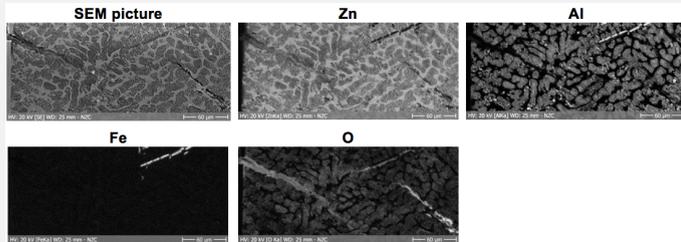
Fig. 10: SEM image and elemental chemical distribution of the selected area from Fig. 7 (rotated 270° and inverted). Method of analysis: SEM-EDS. Lab. of Electronic Microscopy and Microanalysis, Néode, HEI Arc,

Corrosion form	Internal cracking
Corrosion type	zinc pest

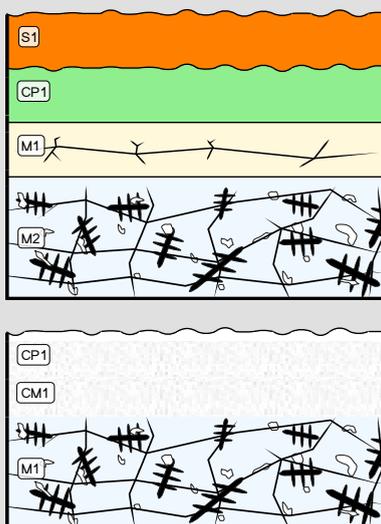
Fig. 11: Stratigraphic representation of the sample taken from the domed cap nut in cross-section (dark field) using the MiCorr application. The characteristics of the strata are only accessible by clicking on the drawing that redirects you to the search tool by stratigraphy representation. Stratigraphy representative of an area with intact metal plating (M1). S1 represents Fe-polluted soil while CP1 is a green translucent corrosion product, Credit UiO-IAKH, M.Hovind.
