DOMED CAP NUT – ZN AL SN CU ALLOY – MODERN TIMES – FRANCE

Artefact name	Domed cap nut
Authors	Christian. Degriigny (HE-Arc CR, Neuchâtel, Neuchâtel, Switzerland) & Mathea. Hovind (University of Oslo, Department of archaeology, conservation and history (IAKH-UiO), Oslo, Oslo, Norway)
Url	/artefacts/883/

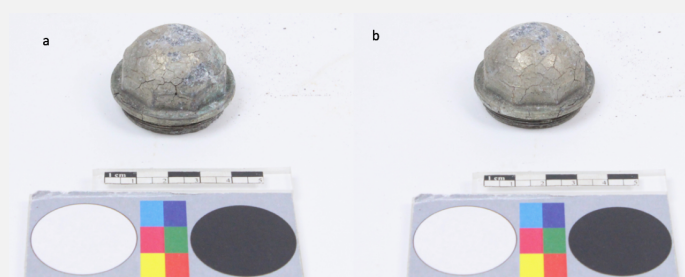
Fig. 1: Octogonal domed cap nut. Profile "a" and "b", to the left and right, respectively,

Description of the artefact	A domed cap nut made of a cast alloy with a metallic plating (Fig. 1). Its shape is octagonal and the inside is hollow. The plating is heavily cracked, leading to surface flaking. The metal underneath appears to be consumed by some kind of internal corrosion. Dimensions: L (ø) = 40mm; H = 28mm; T = 5mm; WT = 49g.
Type of artefact	Cap
Origin	Château de Germolles (14th century), Mellecey, Bourgogne, France
Recovering date	Unknown
Chronology category	Modern Times
chronology tpq	<input type="text" value="1900"/> A.D. ∨
chronology taq	<input type="text" value="2000"/> A.D. ∨
Chronology comment	19th - 20th century
Burial conditions / environment	Outdoor atmosphere
Artefact location	HE-Arc CR, Neuchâtel, Neuchâtel
Owner	Château de Germolles, Mellecey, Bourgogne

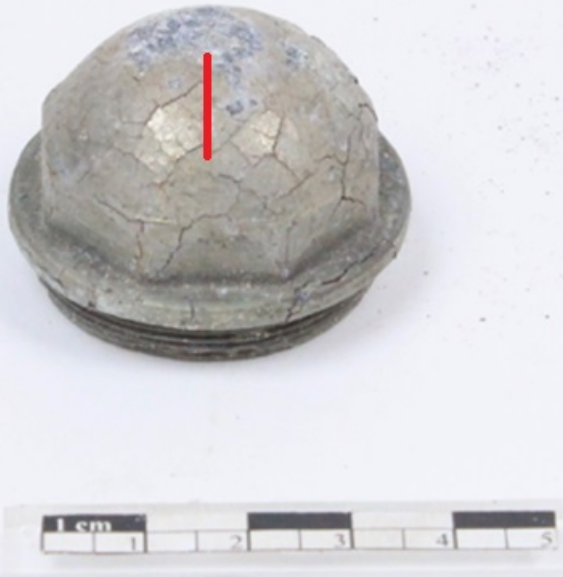
Fig. 2: Zone of the artefact submitted to visual observation and location of sampling area (a cross-section of the metal marked by the red line),

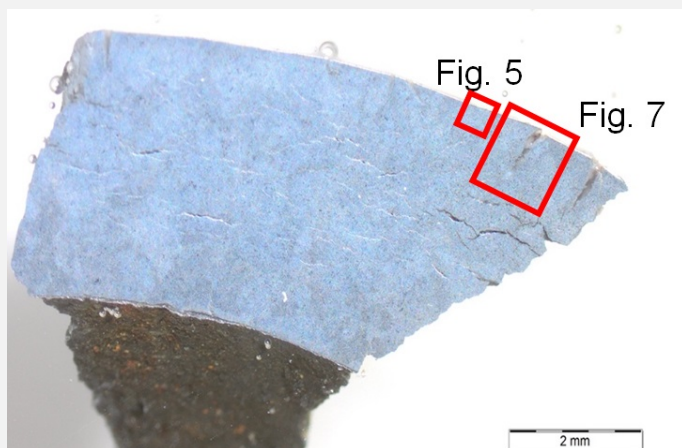
Fig. 4: Micrograph of the cross-section of the sample taken from the domed cap nut showing the locations of Figs. 5 and 7,

Description of sample	The sample is a cross section of the metal, representative of the domed cap nut. It shows external cracks extending from the metal surface and into its structure in addition to internal cracks, visible as thin lines along its longitudinal axis (Fig. 4).
Alloy	Zn Al Sn Cu Alloy
Technology	Cast and plated
Lab number of sample	NZC2018 (Ni/Zn Cap, sampled in 2018)
Sample location	HE-Arc CR, Neuchâtel, Neuchâtel
Responsible institution	HE-Arc CR, Neuchâtel, Neuchâtel
Date and aim of sampling	March 2018, study of corrosion stratigraphy and chemical analyses

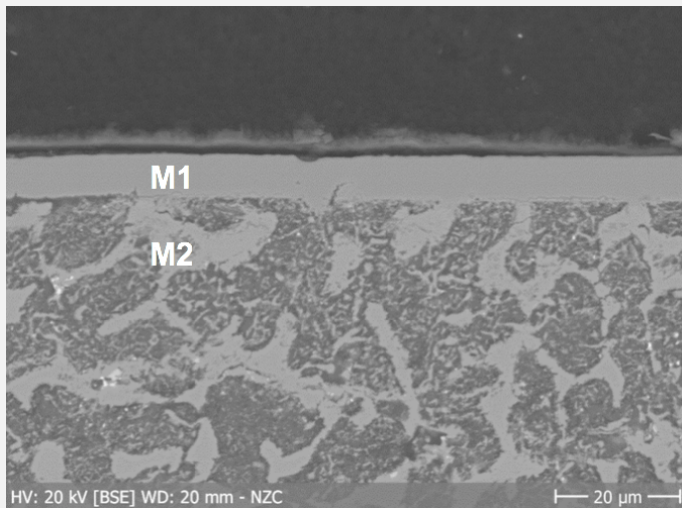
The metal of the domed cap nut (M2) consists of a Zn/Al/Pb/Cu/Sn alloy (Table 1) externally covered by a nickel-based plating (M1) (Figs. 5 and 6) containing some cobalt (Co). The bulk metal (M2) has a dendritic microstructure appearing light grey in bright field, while the interdendritic phase appears white (Fig. 7). The latter is Zn-rich, while the dendritic phase consists of approximately equal amounts of Zn and Al (Table 2, Fig. 9). Observation in SEM (BSE-mode) reveals the presence of Pb-nodules, visible as white irregular spots with a scattered distribution, in addition to opaque grey patches which are rich in Al and Fe (Fig. 8).

Fig. 5: SEM-image (BSE-mode) of a selected area from Fig. 4 (detail), showing the metal plating (M1) and the bulk metal (M2),

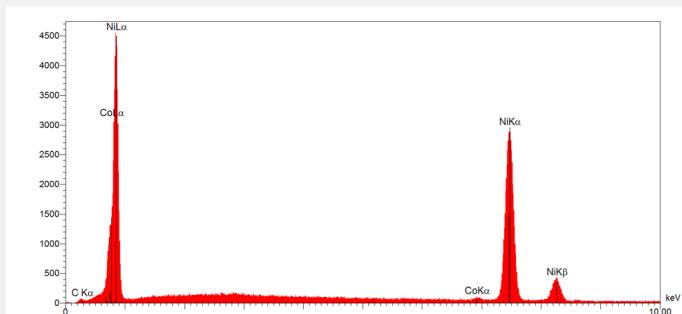
Fig. 6: EDS-spectrum showing the chemical composition of the metal plating (M1). Method of analysis: SEM-EDS. Lab. of Electronic Microscopy and and Microanalysis, Néode, HEI Arc,

The domed cap nut is nickel plated (6-7 micrometers).

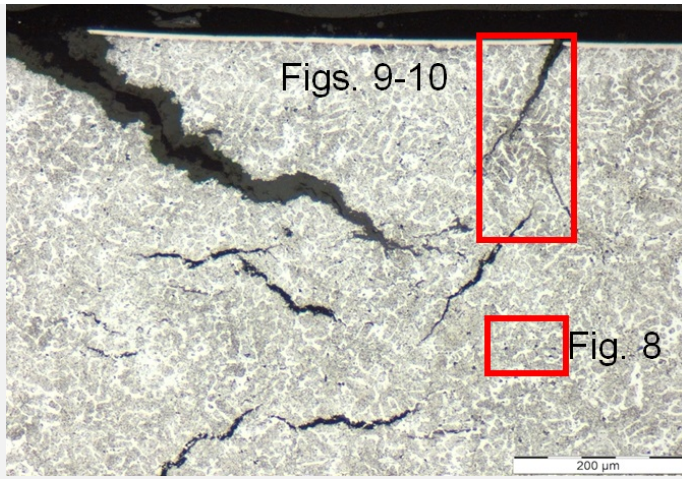
Fig. 7: Micrograph of the metal sample from Fig. 4 (detail), unetched, bright field. The dendrites appear light to dark grey while the interdendritic phase appears white. The metal is characterized by surface cracks as well as internal cracks. The lower red rectangle corresponds to Fig. 8 while the areas selected for elemental chemical distributions (Figs. 9 and 10) are marked by the upper red rectangle,

The dendritic phase is heavily oxidized compared to the interdendritic phase (Table 2 and Fig. 10). The corrosion has developed throughout the entire metal body, generating cracks (Fig. 7). The cracks are Zn and O-rich (Fig. 10) and could be composed of zinc oxide or carbonate. It could be a case of zinc pest, a corrosion phenomenon known to cause disintegration in poor quality alloys (Selwyn 2004, Zhang 2011).

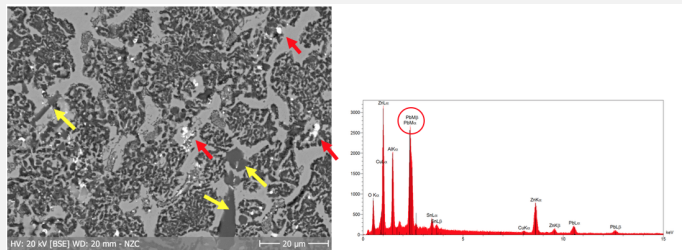
Fig. 8: SEM-image in BSE-mode (left) and EDS-spectrum (right), showing the appearance and the chemical composition of the Pb inclusions (red arrows). The inclusions appear white, the dendrites appear dark grey/black and the interdendritic phase appears grey. Grey opaque patches (yellow arrows) are Fe- and Al-rich phases,

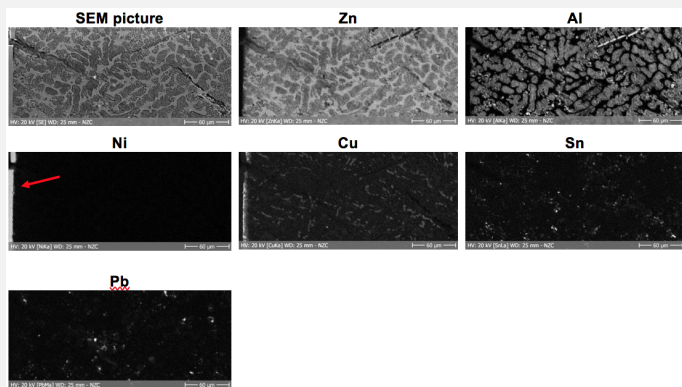
Fig. 9: SEM image and elemental chemical distribution of the selected area from Fig. 7 (rotated 270° and inverted). Method of analysis: SEM-EDS. Lab. of Electronic Microscopy and Microanalysis, Néode, HEI Arc,

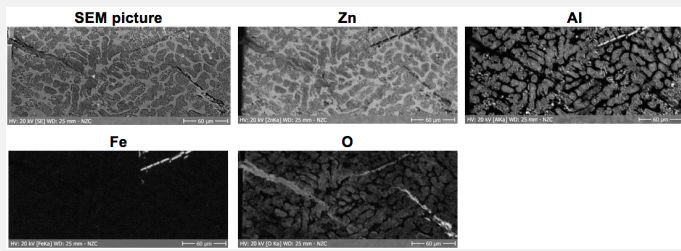
Fig. 10: SEM image and elemental chemical distribution of the selected area from Fig. 7 (rotated 270° and inversed). Method of analysis: SEM-EDS. Lab. of Electronic Microscopy and Microanalysis, Néode, HEI Arc,

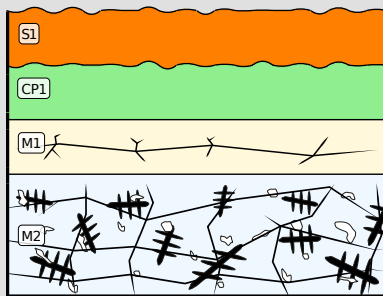
Fig. 11: Stratigraphic representation of the sample taken from the domed cap nut in cross-section (dark field) using the MiCorr application. The characteristics of the strata are only accessible by clicking on the drawing that redirects you to the search tool by stratigraphy representation. Stratigraphy representative of an area with intact metal plating (M1). S1 represents Fe-polluted soil while CP1 is a green translucent corrosion product, Credit UiO-IAKH, M.Hovind.
