LEAD CAMES OF A STAINED GLASS WINDOW 52583 – UNKNOWN – SWITZERLAND

Artefact name	Lead comes of a stained glass window 52583
Authors	Alice Gerber. (Haute École Arc Neuchâtel, Neuchâtel, Neuchâtel, Switzerland)
Url	/artefacts/884/

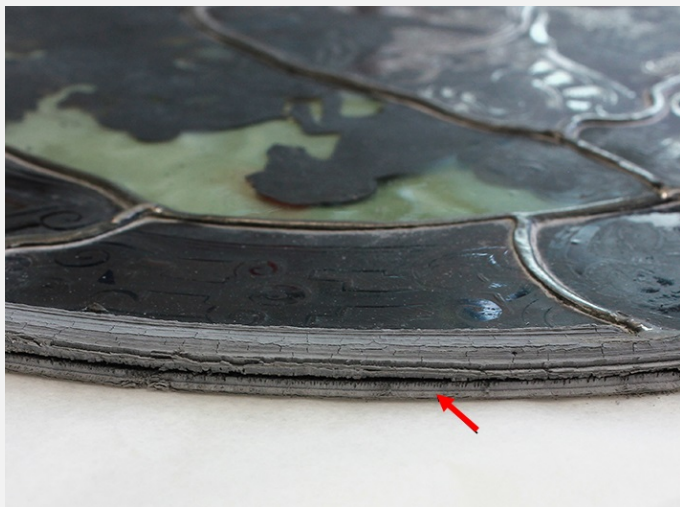
In 2009 two stained glass panels were placed in a showcase for a permanent exhibition, the lead came were then in a good conservation condition. In 2018, the lead showed voluminous efflorescence of white, powdery corrosion products.

The environment of this showcase contained a high level of acetic acid. Lead being sensitive to organic acids, it corroded strongly. This is not new, but what is interesting here is that the two objects corroded in a very heterogeneous way. One lead came may be deformed and completely covered with bulky white efflorescences, and the one next to it shows no corrosion.

The "stokar" window, which is of interest here, was restored in 2008, just before it was put on display. The restoration consisted of replacing some of the lead came. Thus, while the object is dated to the 16th century, the replaced came were new when they entered the display case. In 2018, they were completely corroded. In comparison, the other stained glass panel, with older lead came, was placed in the same display case at the same time. For this second panel, the came are slightly corroded in 2018, but not as badly as those of the 'Stokar' panel. The metal chosen by the restorer reacted more strongly with the corrosive environment (the display case) than the historical metal.

Fig. 2: Corroded "modern" lead came on the "Stokar" stained glass panel with location of the sampling area,

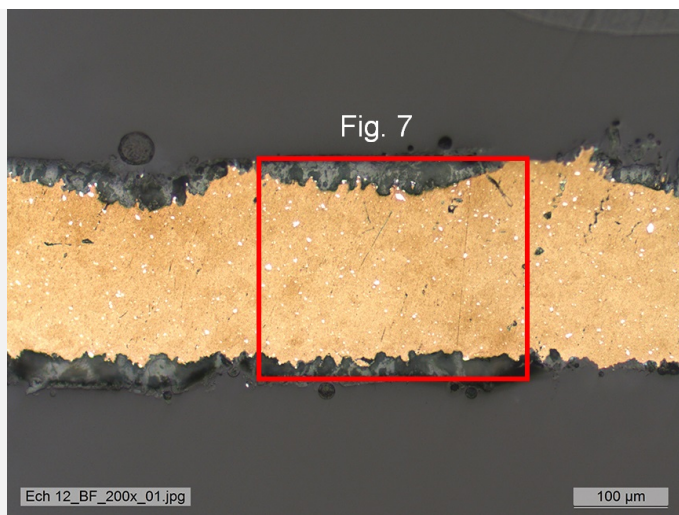
Fig. 5: Micrograph of the cross-section of the corroded lead came with location of Fig. 7, unetched, dark field. The grains of the metal are slightly visible, and the light-coloured dots in the alloy are inclusions,

The sample is a piece of metal taken from the corroded lead came of the stained glass (Fig. 2). This came was replaced during the 2009 restoration. The purpose was to understand why this new metal has been completely corroded in a few years (Fig. 2, 3 and 5), while the historical metal next to it is not affected at all.

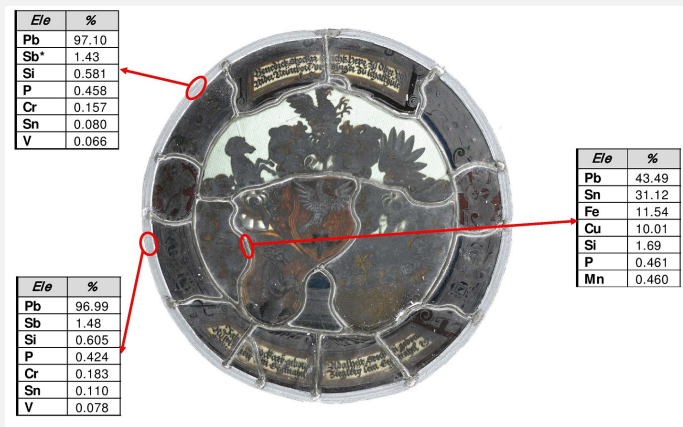
XRF analyses of the different lead comes of the "Stokar" stained glass panel showed that the tin (Sn) content is very variable from one came to another (Fig. 6). Those with a very low Sn but a high Sb (1.4%) contents are much more corroded.

Fig. 6: XRF analyses of a selection of the comes,

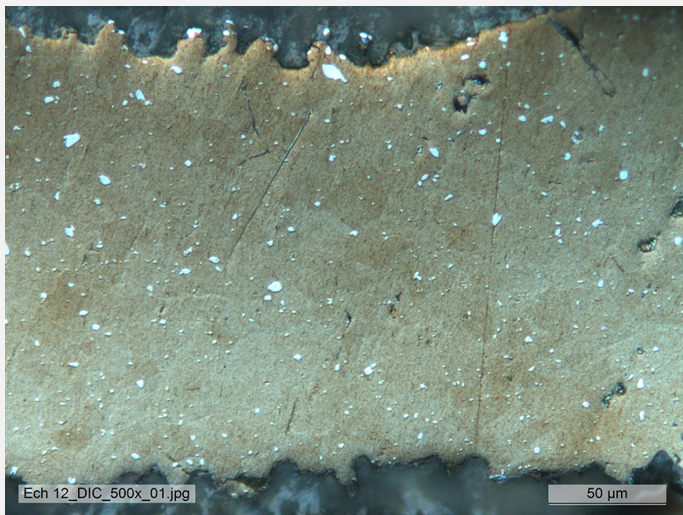
The lead alloy contains approximately 1.5% antimony. The grains of the metal are slightly visible, even without etching. The light-coloured dots in the alloy are Sb-rich inclusions (Fig. 7).

Fig. 7: Micrograph (detail of Fig. 5), unetched, dark field,

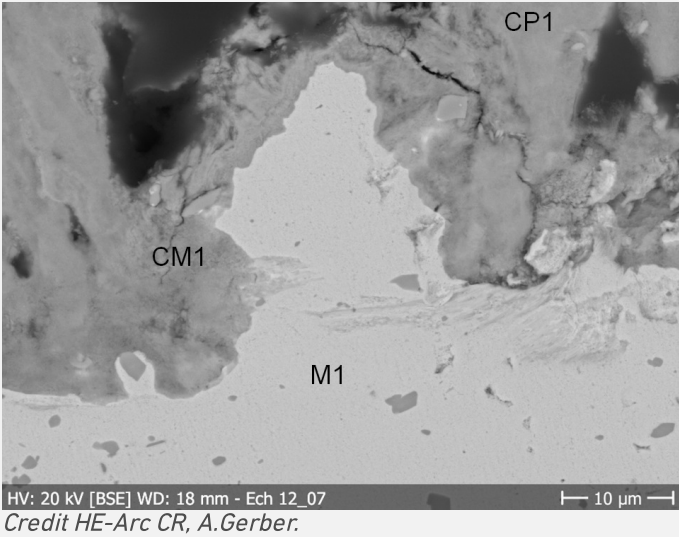
Corrosion develops specifically on comes made of a lead-antimony alloy, where antimony inclusions constitute the cathode (0.150 V/SHE) versus lead (-0.125 V/SHE) which corrodes as an anode in presence of lead acetate (the electrolyte). Fig. 8 shows that corrosion does not attack the antimony nodules in the alloy, it progresses by mineralizing the lead around these nodules.

Fig. 8: SEM image (BSE mode) of a detail of the cross-section of the corroded lead came. The area in light grey is the metal, the corrosion is in darker grey with a blurred appearance. Sb-dots are dark grey. Corrosion progresses around them, without mineralising them,

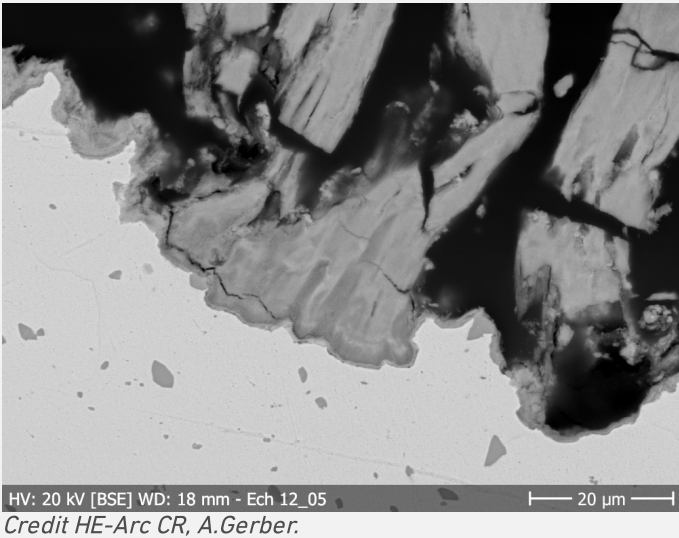
CP1 seems to be an heterogeneous compound as indicated on Figs. 8 and 9. It is heavily cracked (Fig. 9). EDX analyses do not indicate a significant difference in composition. The attack of lead by organic acids causes the formation of salts, such as lead acetate which are then transformed into basic lead carbonates by the action of CO2 from the environment as indicated by FTIR analysis of CP1.

Fig. 9: SEM image (BSE mode) of the cross-section of the corroded lead came,

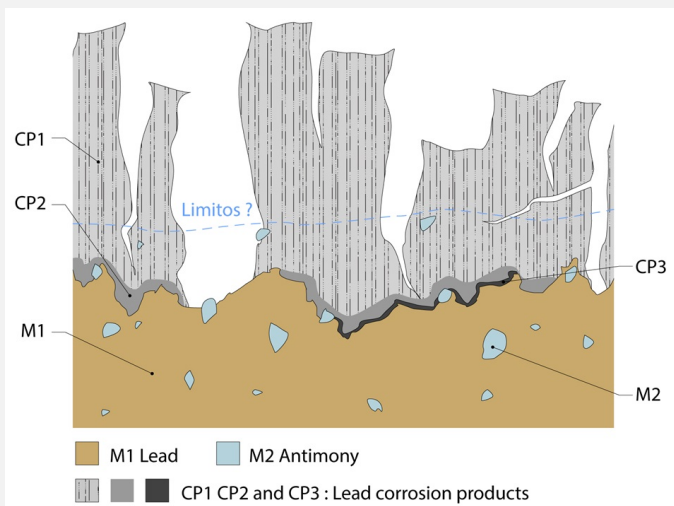
Fig. 11 shows an optimised stratigraphic representation of the corrosion structure. It is to be noted that CP1, CP2 and CP3 although visible on some cross-sections (Fig. 9) could not be differentiated by analysis.

The limit of the original surface lies somewhere in the corrosion layers. Antimony nodules are inferior markers of the limit of the original surface.

Fig. 11: Optimised stratigraphic representation of a corroded lead came integrating additional information based on the analyses carried out,
