LEAD CAMES OF A STAINED GLASS WINDOW 52583 – UNKNOWN – SWITZERLAND

Artefact name Lead comes of a stained glass window 52583

Authors Alice Gerber. (Haute École Arc Neuchâtel, Neuchâtel, Neuchâtel, Switzerland)

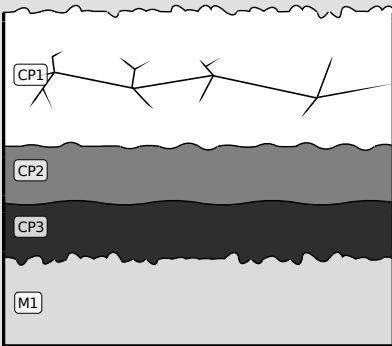
Fig. 4: Stratigraphic representation of the lead came under binocular using the MiCorr application. The characteristics of the strata are only accessible by clicking on the drawing that redirects you to the search tool by stratigraphy representation, Credit HE-Arc CR, A.Gerber.

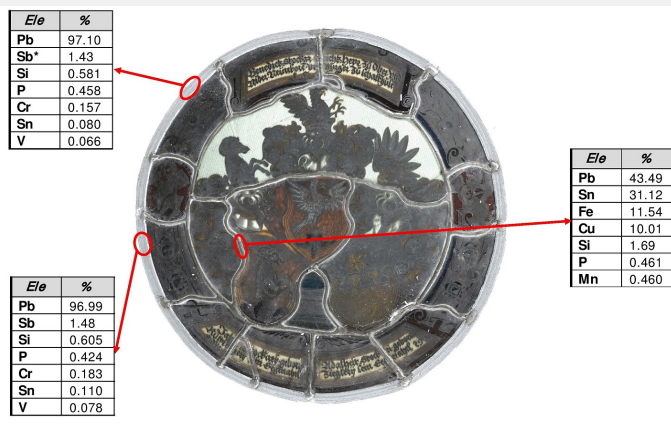
XRF analyses of the different lead comes of the "Stokar" stained glass panel showed that the tin (Sn) content is very variable from one came to another (Fig. 6). Those with a very low Sn but a high Sb (1.4%) contents are much more corroded.

Fig. 6: XRF analyses of a selection of the comes,

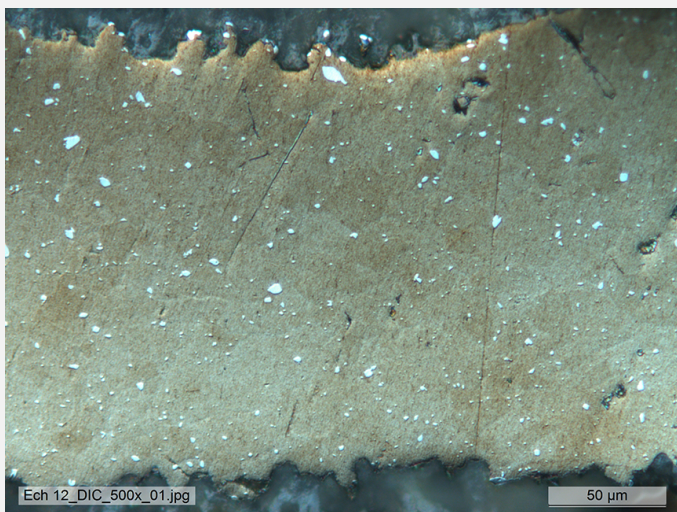
The lead alloy contains approximately 1.5% antimony. The grains of the metal are slightly visible, even without etching. The light-coloured dots in the alloy are Sb-rich inclusions (Fig. 7).

Fig. 7: Micrograph (detail of Fig. 5), unetched, dark field,

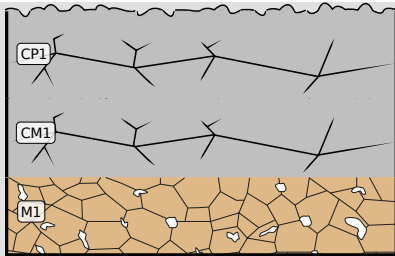
Fig. 10: Stratigraphic representation of the lead came in cross-section (dark field) using the MiCorr application with

reference to Fig. 8. The characteristics of the strata are only accessible by clicking on the drawing that redirects you to the search tool by stratigraphy representation, Credit HE-Arc CR, A.Gerber
