LEAD CAMES OF A STAINED GLASS WINDOW 52583 - UNKNOWN - SWITZERLAND

Artefact name Lead cames of a stained glass window 52583

Authors Alice Gerber. (Haute École Arc Neuchâtel, Neuchâtel, Neuchâtel, Switzerland)

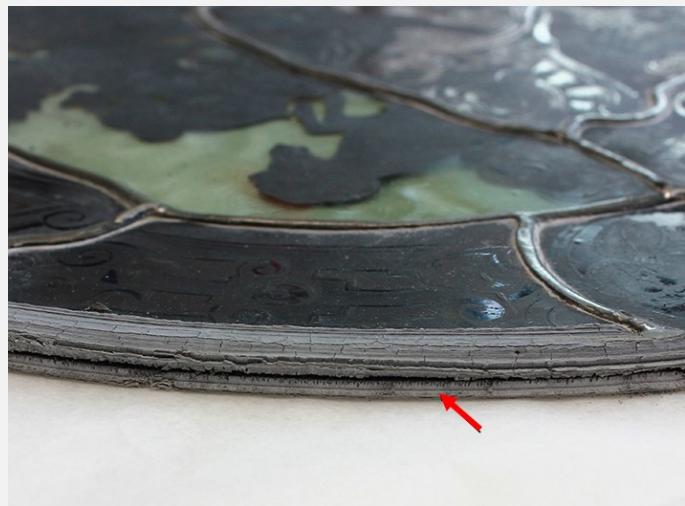
The environment of this showcase contained a high level of acetic acid. Lead being sensitive to organic acids, it corroded strongly. This is not new, but what is interesting here is that the two objects corroded in a very heterogeneous way. One lead came may be deformed and completely covered with bulky white efflorescences, and the one next to it shows no corrosion.

The "stokar" window, which is of interest here, was restored in 2008, just before it was put on display. The restoration consisted of replacing some of the lead cames. Thus, while the object is dated to the 16th century, the replaced cames were new when they entered the display case. In 2018, they were completely corroded. In comparison, the other stained glass panel, with older lead cames, was placed in the same display case at the same time. For this second panel, the cames are slightly corroded in 2018, but not as badly as those of the 'Stokar' panel. The metal chosen by the restorer reacted more strongly with the corrosive environment (the display case) than the historical metal.

Fig. 2: Corroded "modern" lead came on the "Stokar" stained glass panel with location of the sampling area,

The sample is a piece of metal taken from the corroded lead came of the stained glass (Fig. 2). This came was replaced during the 2009 restoration. The purpose was to understand why this new metal has been completely corroded in a few years (Fig. 2, 3 and 5), while the historical metal next to it is not affected at all.

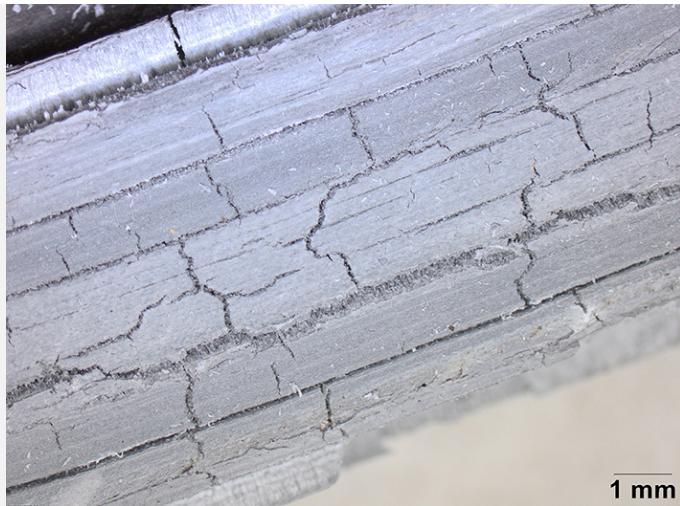
Fig. 3: Detail of the corroded lead came,

The lead came is heavily corroded and its original surface contained in the thick and very fragile corrosion layer might get lost easily in case of any physical shock.

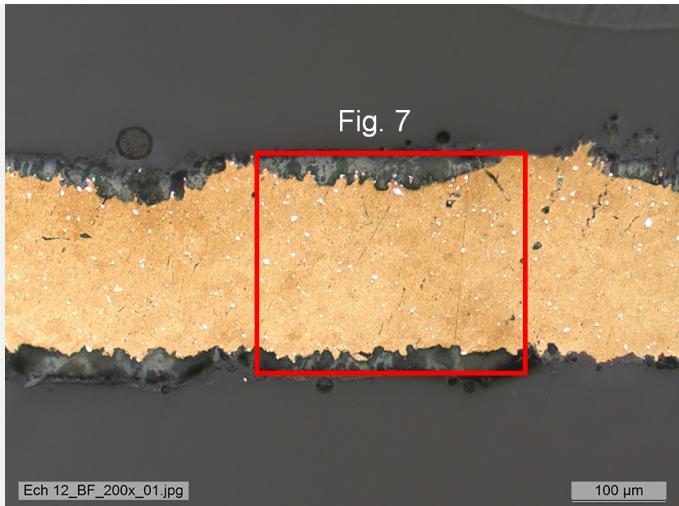
Fig. 5: Micrograph of the cross-section of the corroded lead came with location of Fig. 7, unetched, dark field. The grains of the metal are slightly visible, and the light-coloured dots in the alloy are inclusions,

The lead alloy contains approximately 1.5% antimony. The grains of the metal are slightly visible, even without etching. The light-coloured dots in the alloy are Sb-rich inclusions (Fig. 7).

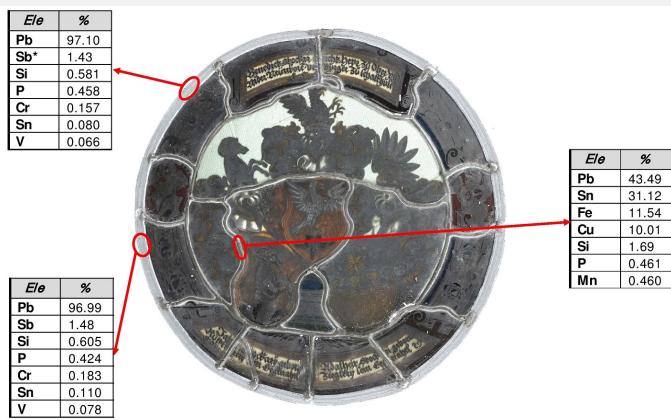
XRF analyses of the different lead cames of the "Stokar" stained glass panel showed that the tin (Sn) content is very variable from one came to another (Fig. 6). Those with a very low Sn but a high Sb (1.4%) contents are much more corroded.

Fig. 6: XRF analyses of a selection of the cames,

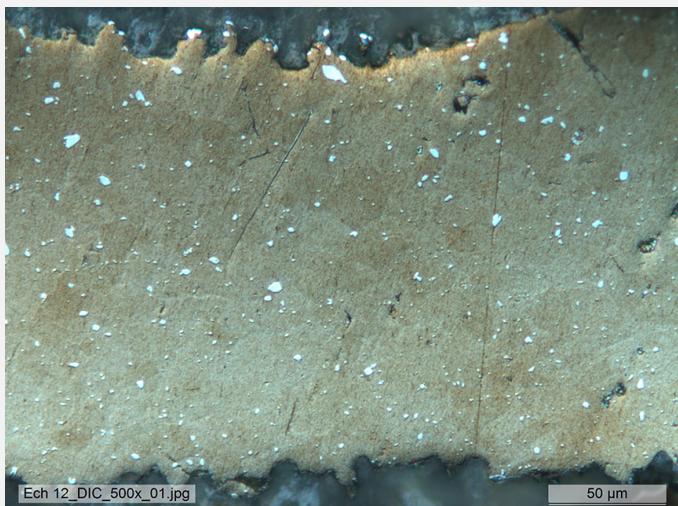
Fig. 7: Micrograph (detail of Fig. 5), unetched, dark field,

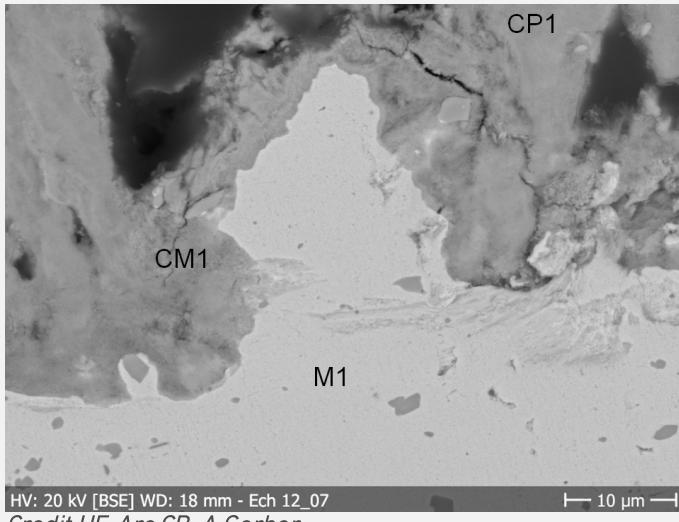
Corrosion develops specifically on cames made of a lead-antimony alloy, where antimony inclusions constitute the cathode (0.150 V/SHE) versus lead (-0.125 V/SHE) which corrodes as an anode in presence of lead acetate (the electrolyte). Fig. 8 shows that corrosion does not attack the antimony nodules in the alloy, it progresses by mineralizing the lead around these nodules.

CP1 seems to be an heterogeneous compound as indicated on Figs. 8 and 9. It is heavily cracked (Fig. 9). EDX analyses do not indicate a significant difference in composition. The attack of lead by organic acids causes the formation of salts, such as lead acetate which are then transformed into basic lead carbonates by the action of CO₂ from the environment as indicated by FTIR analysis of CP1.

Fig. 8: SEM image (BSE mode) of a detail of the cross-section of the corroded lead came. The area in light grey is the metal, the corrosion is in darker grey with a blurred appearance. Sb-dots are dark grey. Corrosion progresses around them, without mineralising them,

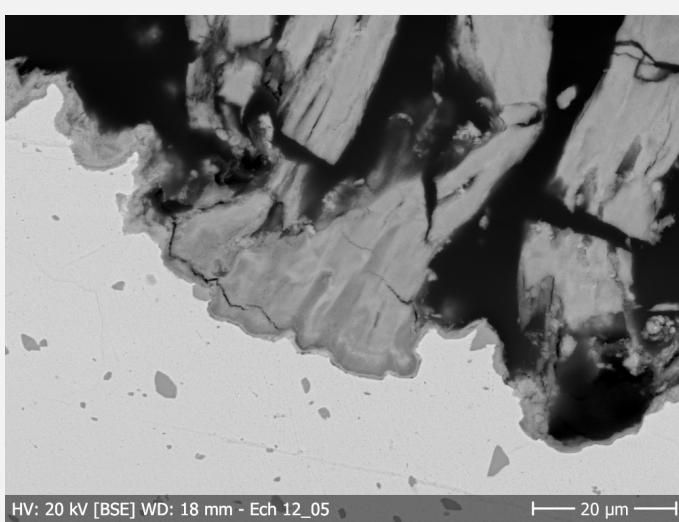
Fig. 9: SEM image (BSE mode) of the cross-section of the corroded lead came,

Fig. 11 shows an optimised stratigraphic representation of the corrosion structure. It is to be noted that CP1, CP2 and CP3 although visible on some cross-sections (Fig. 9) could not be differentiated by analysis.
