LEAD CAMES OF A STAINED GLASS WINDOW 52583 – UNKNOWN – SWITZERLAND

Artefact name	Lead comes of a stained glass window 52583
Authors	Alice Gerber. (Haute École Arc Neuchâtel, Neuchâtel, Neuchâtel, Switzerland)
Url	/artefacts/884/

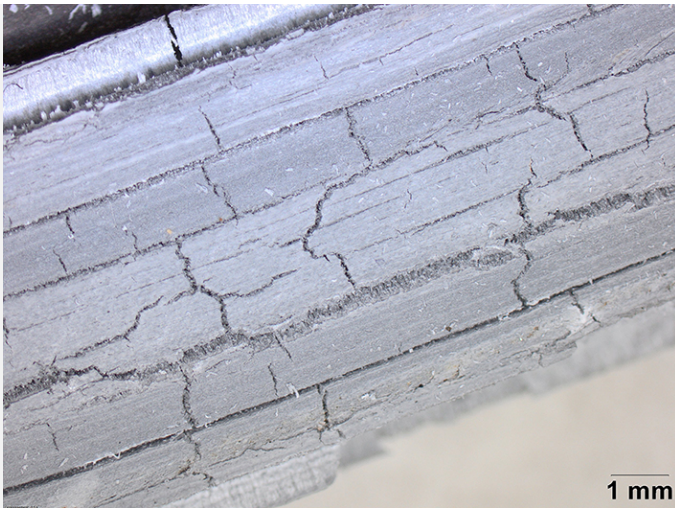
Fig. 3: Detail of the corroded lead came,

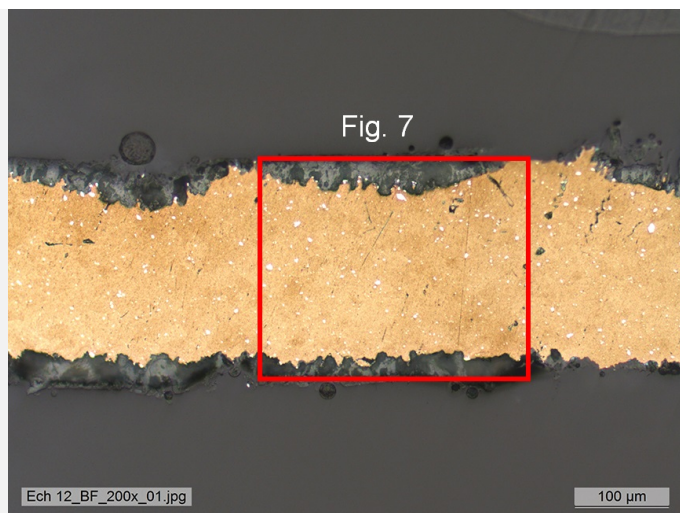
Fig. 5: Micrograph of the cross-section of the corroded lead came with location of Fig. 7, unetched, dark field. The grains of the metal are slightly visible, and the light-coloured dots in the alloy are inclusions,

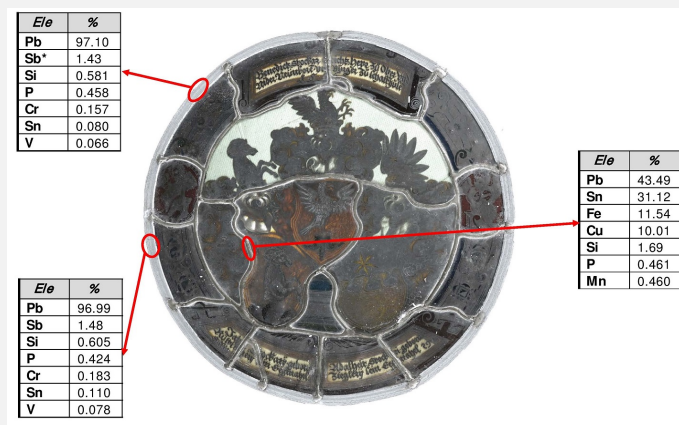
XRF analyses of the different lead comes of the "Stokar" stained glass panel showed that the tin (Sn) content is very variable from one came to another (Fig. 6). Those with a very low Sn but a high Sb (1.4%) contents are much more corroded.

Fig. 6: XRF analyses of a selection of the comes,

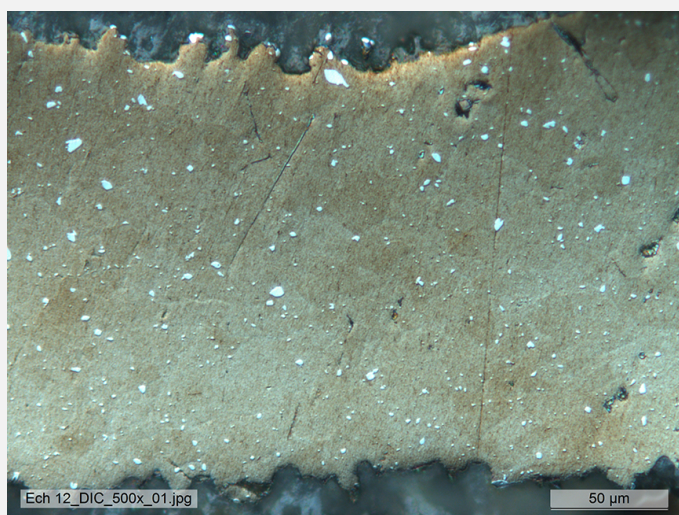
The lead alloy contains approximately 1.5% antimony. The grains of the metal are slightly visible, even without etching. The light-coloured dots in the alloy are Sb-rich inclusions (Fig. 7).

Fig. 7: Micrograph (detail of Fig. 5), unetched, dark field,
