LEAD CAMES OF A STAINED GLASS WINDOW 52583 – UNKNOWN – SWITZERLAND

Artefact name Lead comes of a stained glass window 52583

Authors Alice Gerber. (Haute École Arc Neuchâtel, Neuchâtel, Neuchâtel, Switzerland)

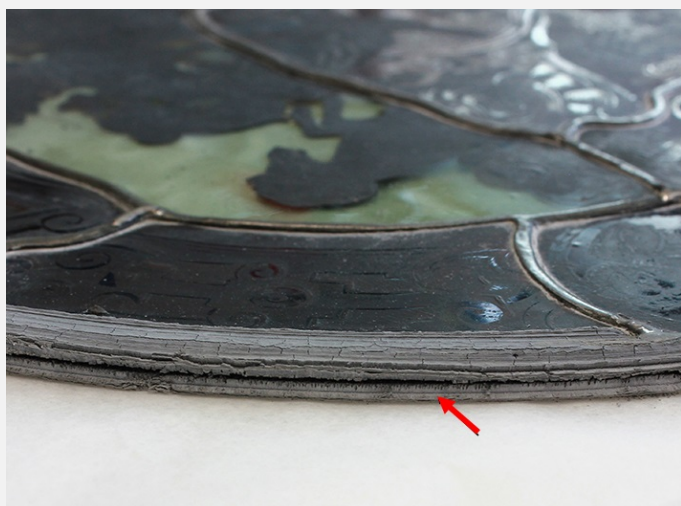
In 2009 two stained glass panels were placed in a showcase for a permanent exhibition, the lead came were then in a good conservation condition. In 2018, the lead showed voluminous efflorescence of white, powdery corrosion products.

The environment of this showcase contained a high level of acetic acid. Lead being sensitive to organic acids, it corroded strongly. This is not new, but what is interesting here is that the two objects corroded in a very heterogeneous way. One lead came may be deformed and completely covered with bulky white efflorescences, and the one next to it shows no corrosion.

The "stokar" window, which is of interest here, was restored in 2008, just before it was put on display. The restoration consisted of replacing some of the lead came. Thus, while the object is dated to the 16th century, the replaced came were new when they entered the display case. In 2018, they were completely corroded. In comparison, the other stained glass panel, with older lead came, was placed in the same display case at the same time. For this second panel, the came are slightly corroded in 2018, but not as badly as those of the 'Stokar' panel. The metal chosen by the restorer reacted more strongly with the corrosive environment (the display case) than the historical metal.

Fig. 2: Corroded "modern" lead came on the "Stokar" stained glass panel with location of the sampling area,

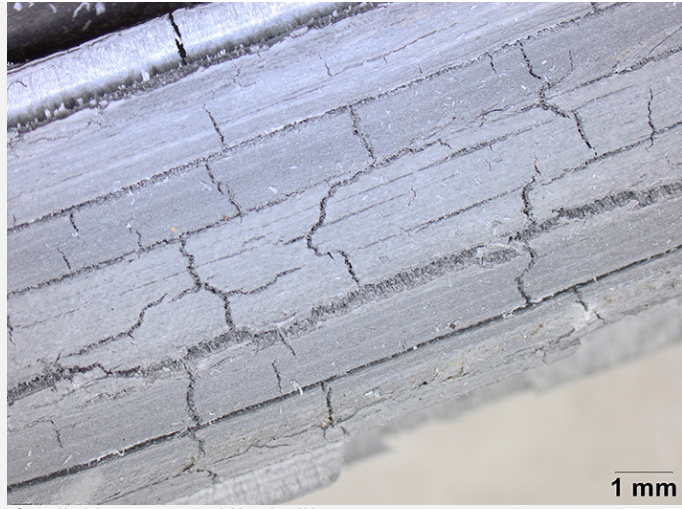
Fig. 3: Detail of the corroded lead came,

The lead came is heavily corroded and its original surface contained in the thick and very fragile corrosion layer might get lost easily in case of any physical shock.

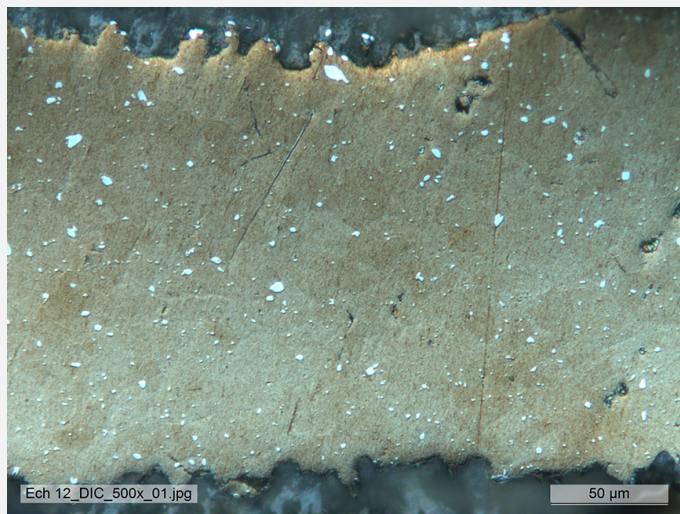
The lead alloy contains approximately 1.5% antimony. The grains of the metal are slightly visible, even without etching. The light-coloured dots in the alloy are Sb-rich inclusions (Fig. 7).

Fig. 7: Micrograph (detail of Fig. 5), unetched, dark field,

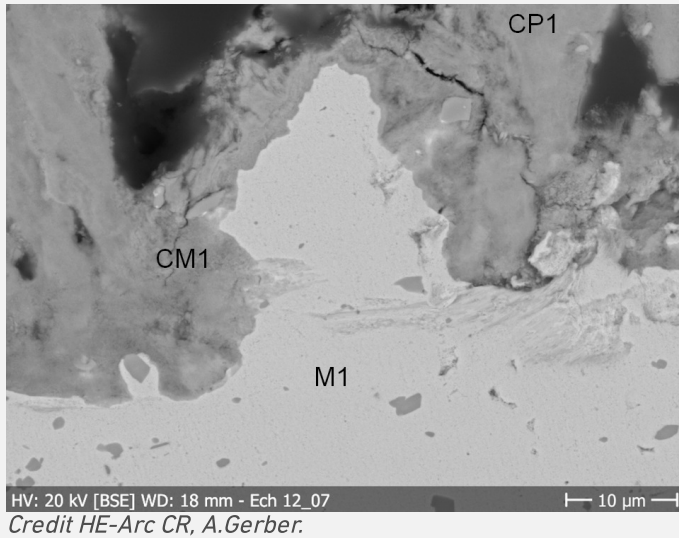
Corrosion develops specifically on comes made of a lead-antimony alloy, where antimony inclusions constitute the cathode (0.150 V/SHE) versus lead (-0.125 V/SHE) which corrodes as an anode in presence of lead acetate (the electrolyte). Fig. 8 shows that corrosion does not attack the antimony nodules in the alloy, it progresses by mineralizing the lead around these nodules.

Fig. 8: SEM image (BSE mode) of a detail of the cross-section of the corroded lead came. The area in light grey is the metal, the corrosion is in darker grey with a blurred appearance. Sb-dots are dark grey. Corrosion progresses around them, without mineralising them,

The lead came is a lead-antimony alloy. Lead is a metal that is very sensitive to organic acids. But it can be alloyed with elements that can either increase its resistance to corrosion (tin) or make it more sensitive to organic acids. Antimony (Sb) is such an element that enhances active corrosion due to the galvanic effect between this element and lead.

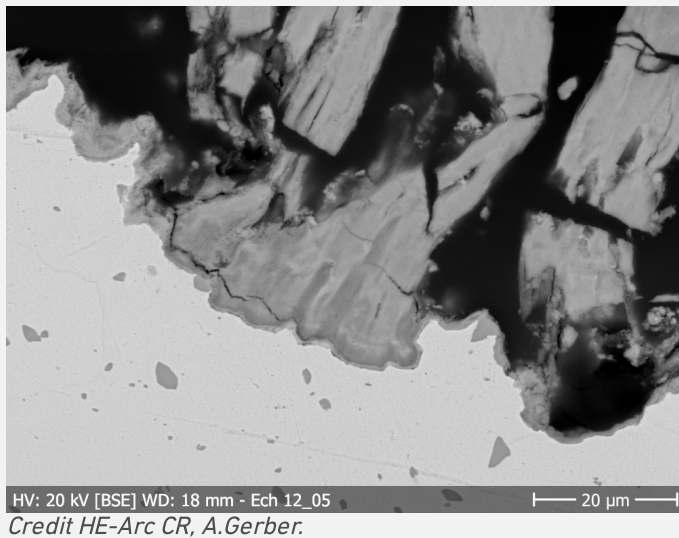
CP1 seems to be a heterogeneous compound as indicated on Figs. 8 and 9. It is heavily cracked (Fig. 9). EDX analyses do not indicate a significant difference in composition. The attack of lead by organic acids causes the formation of salts, such as lead acetate which are then transformed into basic lead carbonates by the action of CO₂ from the environment as indicated by FTIR analysis of CP1.

Fig. 9: SEM image (BSE mode) of the cross-section of the corroded lead came,
