# LEAD CAMES OF A STAINED GLASS WINDOW 52583 – UNKNOWN – SWITZERLAND

**Artefact name** Lead comes of a stained glass window 52583

**Authors** Alice Gerber. (Haute École Arc Neuchâtel, Neuchâtel, Neuchâtel, Switzerland)

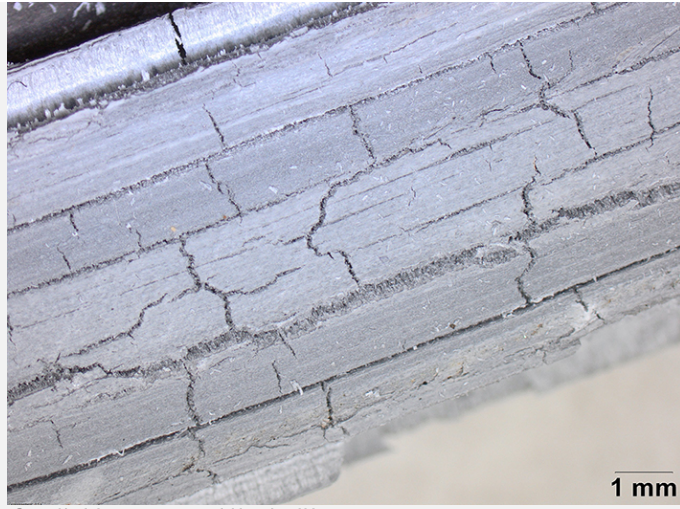
The environment of this showcase contained a high level of acetic acid. Lead being sensitive to organic acids, it corroded strongly. This is not new, but what is interesting here is that the two objects corroded in a very heterogeneous way. One lead came may be deformed and completely covered with bulky white efflorescences, and the one next to it shows no corrosion.

Fig. 3: Detail of the corroded lead came,
