# LEAD CAMES OF A STAINED GLASS WINDOW 52583 – UNKNOWN – SWITZERLAND

**Artefact name** Lead comes of a stained glass window 52583

**Authors** Alice Gerber. (Haute École Arc Neuchâtel, Neuchâtel, Neuchâtel, Switzerland)

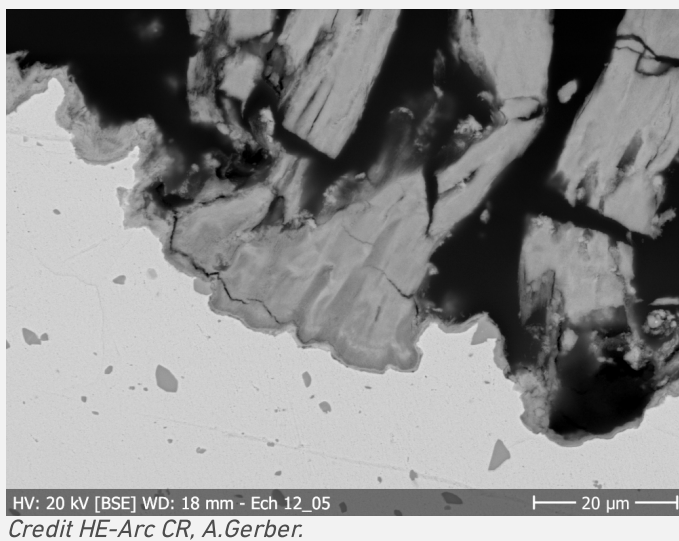
CP1 seems to be a heterogeneous compound as indicated on Figs. 8 and 9. It is heavily cracked (Fig. 9). EDX analyses do not indicate a significant difference in composition. The attack of lead by organic acids causes the formation of salts, such as lead acetate which are then transformed into basic lead carbonates by the action of CO<sub>2</sub> from the environment as indicated by FTIR analysis of CP1.

Fig. 9: SEM image (BSE mode) of the cross-section of the corroded lead came,
