HISPANO-SUIZA WATER PUMP - AL ALLOY - FRANCE

Artefact name Hispano-Suiza water pump

Authors Christian. Degrigny (HE-Arc CR, Neuchâtel, Neuchâtel, Switzerland) & Elodie. Granget (HE-Arc CR, Neuchâtel, Neuchâtel, Switzerland) & Brice. Chalançon (MNAM (Musée National de l'Automobile de Mulhouse), Mulhouse, Alsace, France)

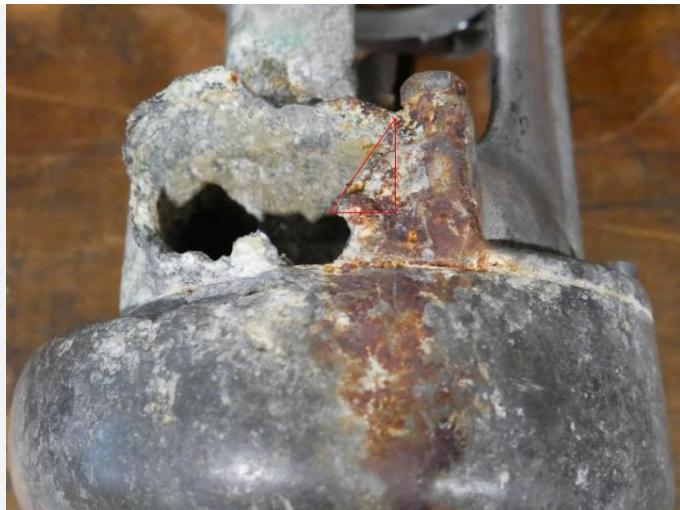
Fig. 3: Location of sampling area on the Hispano water pump,

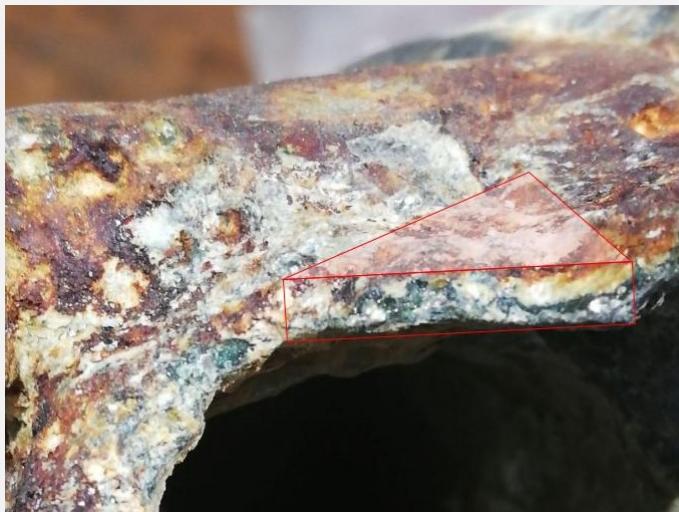
The exit pipe of the fastening part considered within this study is heavily corroded.

Fig. 4: Close-up view of the Hispano water pump, with the exit pipe sampling area,

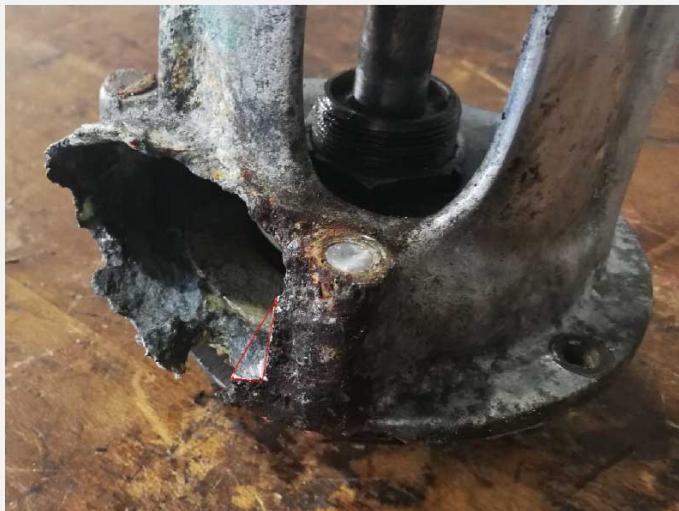
Fig. 5: Close-up view of the corroded exit pipe of the disassembled Hispano water pump, showing the sampled area,

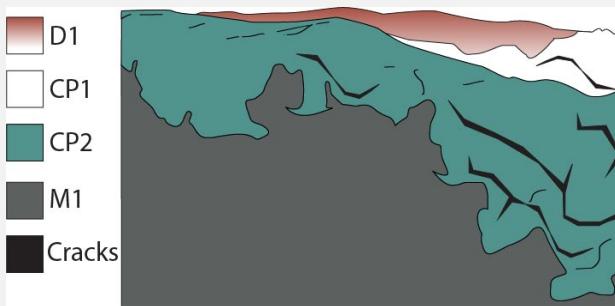
The CP strata show big cracks and can be removed with a bit of scratching (severable). CP2 has a green-blueish color. Over most of the corroded part there is a thick red-orange deposit. This is probably coming from the corroded

steel screws, used to fasten the parts of the water-pump.

Fig. 6: Stratigraphic representation of the corroded exit pipe of the water pump by macroscopic observation, M = metal, CP = corrosion product, D = deposit,

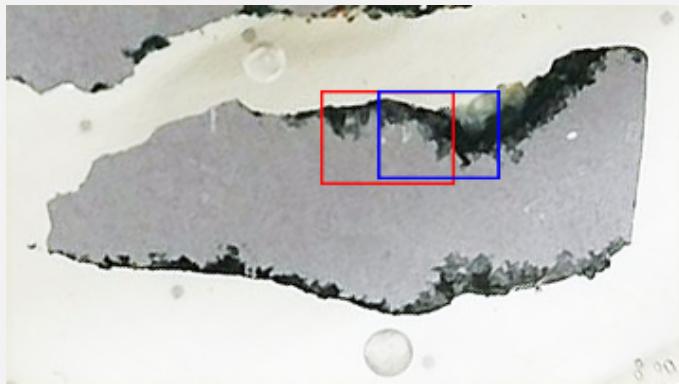
Fig. 7: Micrograph of the sample taken from the corroded exit pipe of the fastening part of the water pump (Figs. 3 to 5), showing the location of Figs. 8-9 in red and Figs. 11-15 in blue. This is a transversal cut of what is left of the exit pipe, severely consumed by corrosion,

A fragment of the exit pipe of the fastening part of the pump has been sampled and embedded as shown on Fig. 7. This is a transversal cut of what is left of the exit pipe, severely consumed by corrosion.

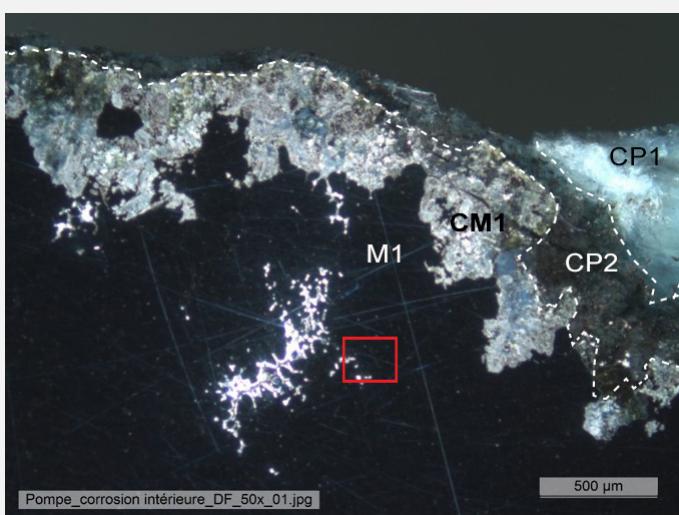
The porosity of this aluminium-copper alloy (Table 1) has been confirmed by optical (Figs. 8 and 9) and SEM observations on the cross-section of the fastening part's fragment (Fig. 10). The metal has a dendritic microstructure (Fig. 10).

Fig. 8: Micrograph of the selected area (in red) of the sample shown on Fig. 7, unetched, dark field with location of Fig. 10,

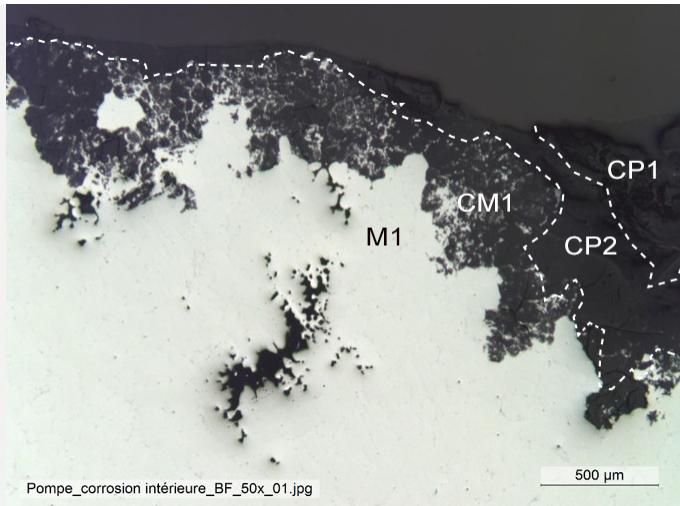
Fig. 9: Micrograph similar to Fig. 8, unetched, bright field,

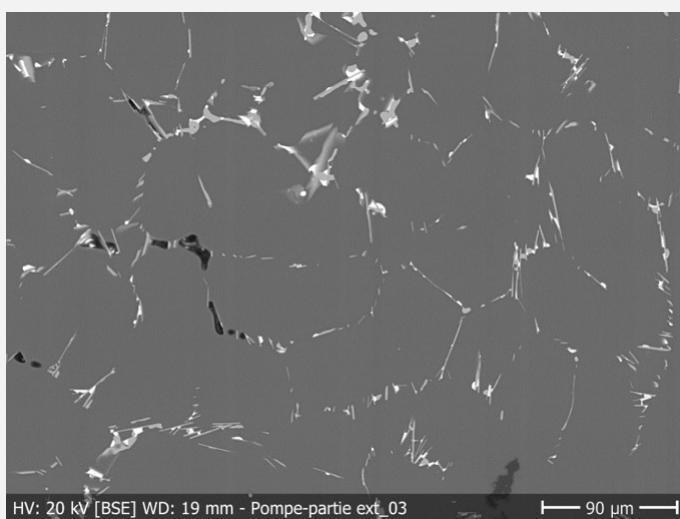
Local analyses on each phase appearing on Fig. 10 showed that the main phase is composed of Al and the interdendritic phases are composed of Al, Cu and Fe as well as Sn precipitates. This distribution is given through EDS elemental chemical distributions (Figs. 12 to 14).

Fig. 10: SEM image (BSE mode) of the metal sample from Fig. 8 showing the microstructure of the fastening part. Black = pore, dark grey = main phase, light grey = interdendritic phase and white = Sn precipitate,

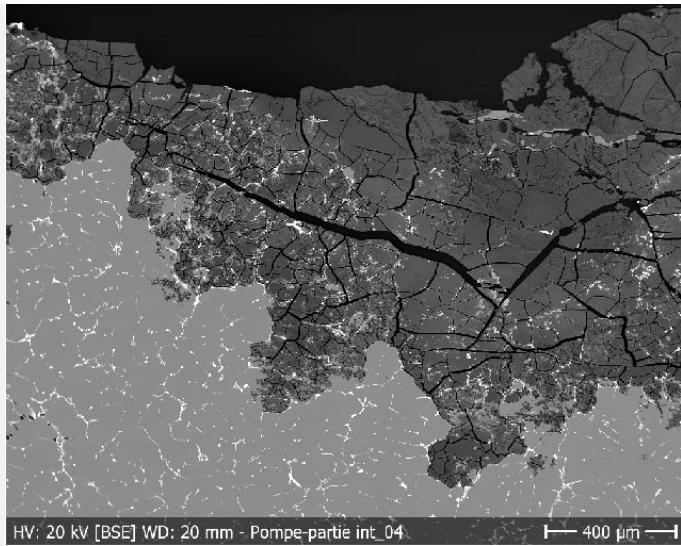
The SEM image of Fig. 11 clearly shows a network of cracks throughout CM1 and CPs. These cracks are not marking any clear separation between strata, but seem to affect all corrosion layers. The main Al phase is preferentially oxidized, while the interdendritic phase seems to be preserved in the corrosion products (Figs. 11 to 13). Na and K but no Fe are detected in the corrosion layers CM1 and CPs (Fig. 14). This surface is in contact with the coolant (glycol + additives, usually mixed 1/1 in water), which sometimes contain Na or K-based corrosion inhibitors. A cluster of CaCO₃ was identified on the very surface of the sample (Fig. 15). CaCO₃ can sometimes precipitate if the water used to mix the coolant is hard.

Fig. 11: SEM image (BSE mode) of the selected area (in blue) of the sample shown on Fig. 7, showing the remaining metal on the bottom and CM1 /CPs on top.

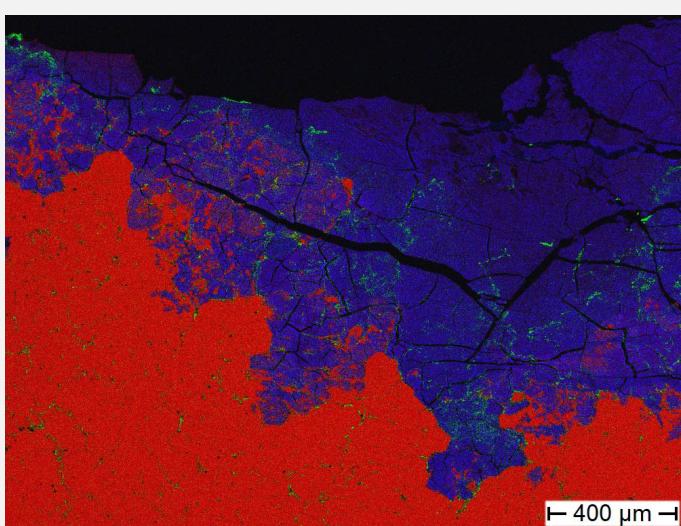
Fig. 12: Al (red), O (blue) and Cu (green) distribution of the area of Fig. 11. Method of analysis: SEM-EDS. Lab. of Electronic Microscopy and Microanalysis, Néode, HEI Arc,

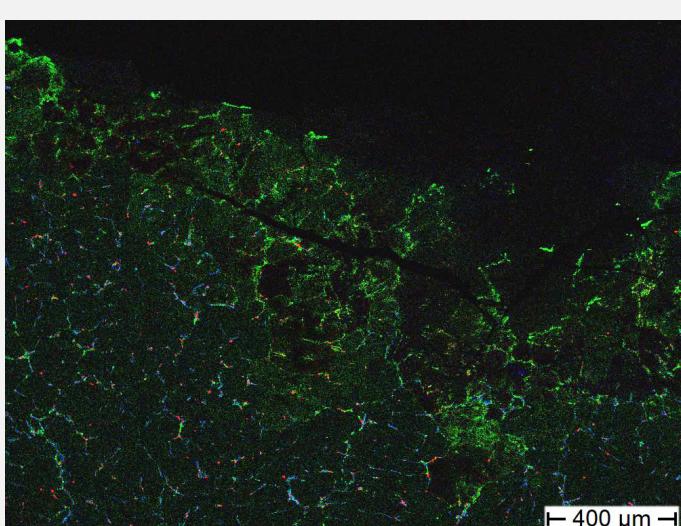
Fig. 13: Sn (red), Fe (blue) and Cu (green) distribution of the area of Fig. 11. Method of analysis: SEM-EDS. Lab. of Electronic Microscopy and Microanalysis, Néode, HEI Arc,

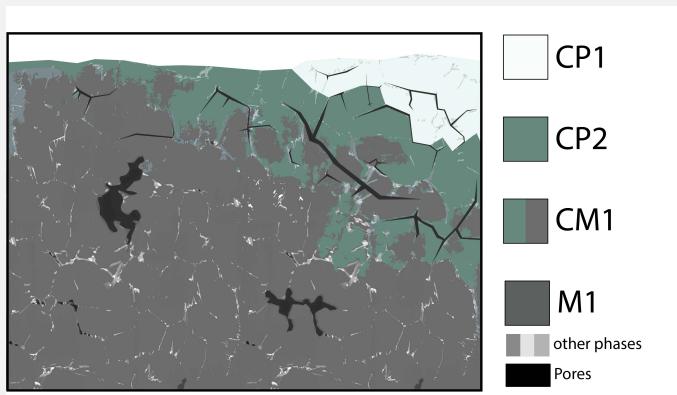
Fig. 17: Improved stratigraphic representation of the corrosion structure of the exit pipe of the disassembled Hispano water pump,

The heavily corroded exit pipe of the fastening part of this Hispano-suiza water pump is made out of an Al-Cu cast alloy with traces of Sn, Fe and Si(?). The corrosion is through the dendritic microstructure: the main phase (Al) is preferentially oxidized, while the interdendritic phase (Fe, Sn, Cu) and Sn precipitates are preserved in the corrosion products. This component of the engine being in contact with the coolant might explain the presence of Na, K and Ca in the corrosion layers.
