HISPANO-SUIZA WATER PUMP – AL ALLOY – FRANCE

Artefact name Hispano-Suiza water pump

Authors Christian. Degriigny (HE-Arc CR, Neuchâtel, Neuchâtel, Switzerland) & Elodie. Granget (HE-Arc CR, Neuchâtel, Neuchâtel, Switzerland) & Brice. Chalançon (MNAM (Musée National de l'Automobile de Mulhouse), Mulhouse, Alsace, France)

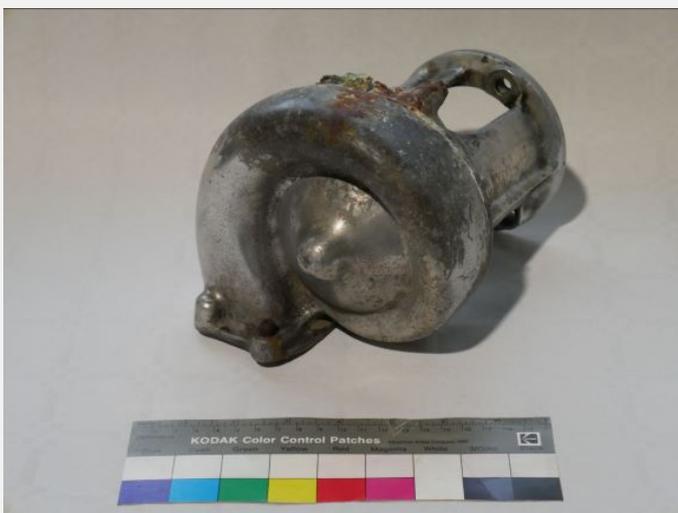
Fig. 1: Hispano-suiza water pump, unknown model,

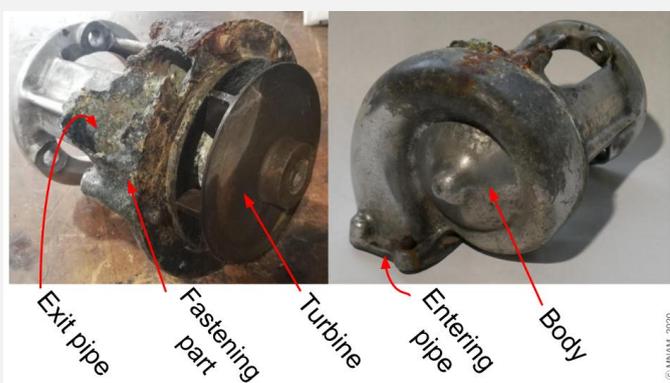
Fig. 2: Body, turbine, fastening part and pipes located on the Hispano water pump,

The exit pipe of the fastening part considered within this study is heavily corroded.

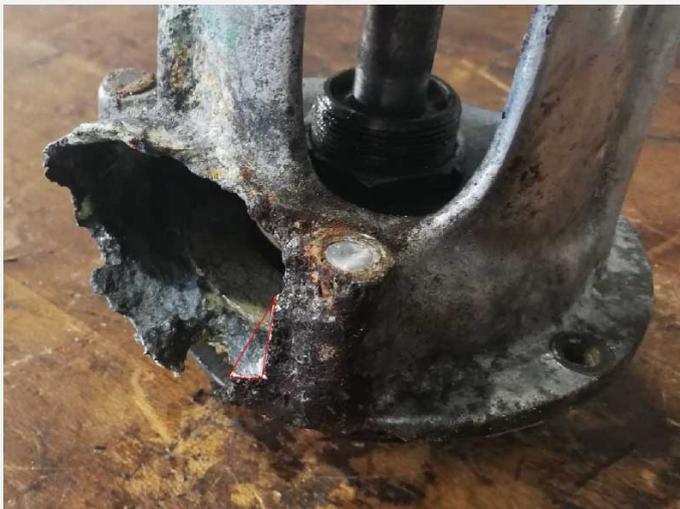
Fig. 5: Close-up view of the corroded exit pipe of the disassembled Hispano water pump, showing the sampled area,

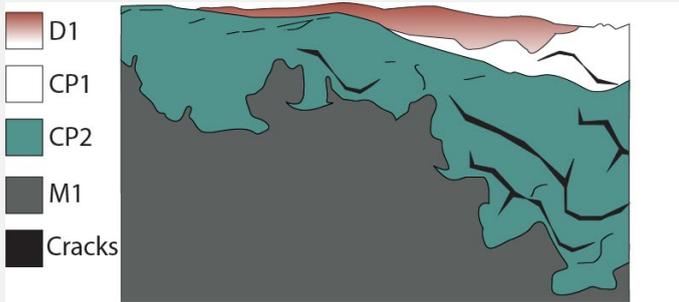
The CP strata show big cracks and can be removed with a bit of scratching (severable). CP2 has a green-blueish color. Over most of the corroded part there is a thick red-orange deposit. This is probably coming from the corroded

steel screws, used to fasten the parts of the water-pump.

Fig. 6: Stratigraphic representation of the corroded exit pipe of the water pump by macroscopic observation, M = metal, CP = corrosion product, D = deposit,

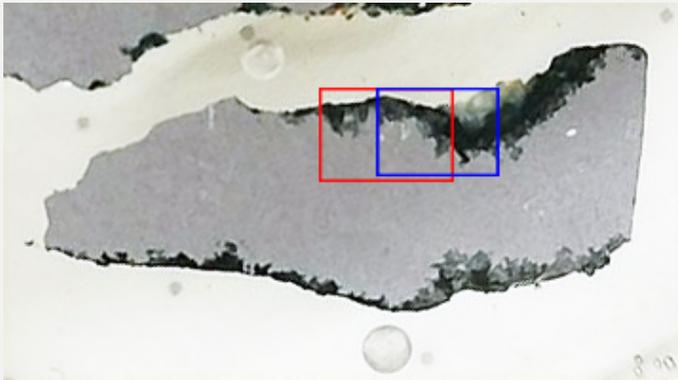
Fig. 7: Micrograph of the sample taken from the corroded exit pipe of the fastening part of the water pump (Figs. 3 to 5), showing the location of Figs. 8-9 in red and Figs. 11-15 in blue. This is a transversal cut of what is left of the exit pipe, severely consumed by corrosion,

A fragment of the exit pipe of the fastening part of the pump has been sampled and embedded as shown on Fig. 7. This is a transversal cut of what is left of the exit pipe, severely consumed by corrosion.

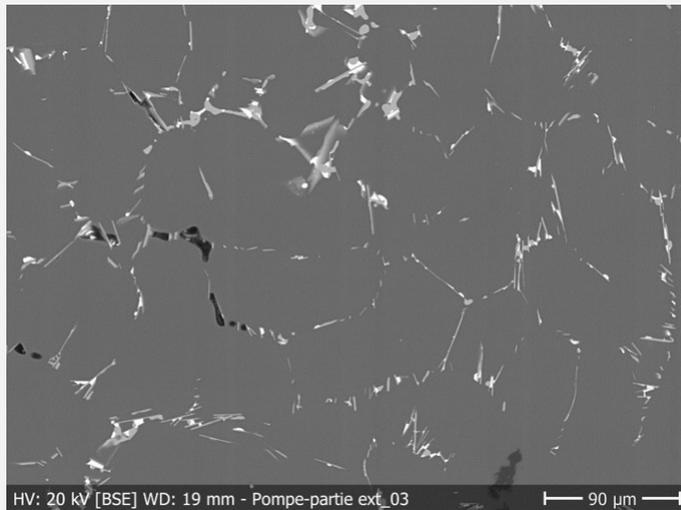
The porosity of this aluminium-copper alloy (Table 1) has been confirmed by optical (Figs. 8 and 9) and SEM observations on the cross-section of the fastening part's fragment (Fig. 10). The metal has a dendritic microstructure (Fig. 10).

Local analyses on each phase appearing on Fig. 10 showed that the main phase is composed of Al and the interdendritic phases are composed of Al, Cu and Fe as well as Sn precipitates. This distribution is given through EDS elemental chemical distributions (Figs. 12 to 14).

Fig. 10: SEM image (BSE mode) of the metal sample from Fig. 8 showing the microstructure of the fastening part. Black = pore, dark grey = main phase, light grey = interdendritic phase and white = Sn precipitate,

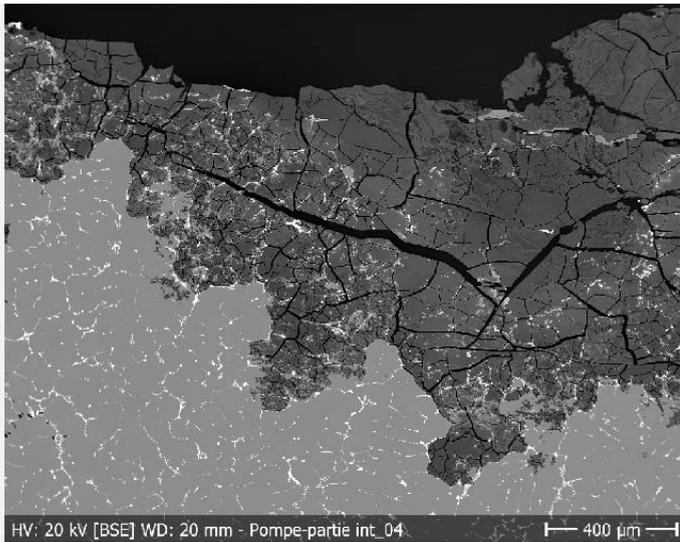
The SEM image of Fig. 11 clearly shows a network of cracks throughout CM1 and CPs. These cracks are not marking any clear separation between strata, but seem to affect all corrosion layers. The main Al phase is preferentially oxidized, while the interdendritic phase seems to be preserved in the corrosion products (Figs. 11 to 13). Na and K but no Fe are detected in the corrosion layers CM1 and CPs (Fig. 14). This surface is in contact with the coolant (glycol + additives, usually mixed 1/1 in water), which sometimes contain Na or K-based corrosion inhibitors. A cluster of CaCO₃ was identified on the very surface of the sample (Fig. 15). CaCO₃ can sometimes precipitate if the water used to mix the coolant is hard.

Fig. 11: SEM image (BSE mode) of the selected area (in blue) of the sample shown on Fig. 7, showing the remaining metal on the bottom and CM1 /CPs on top,

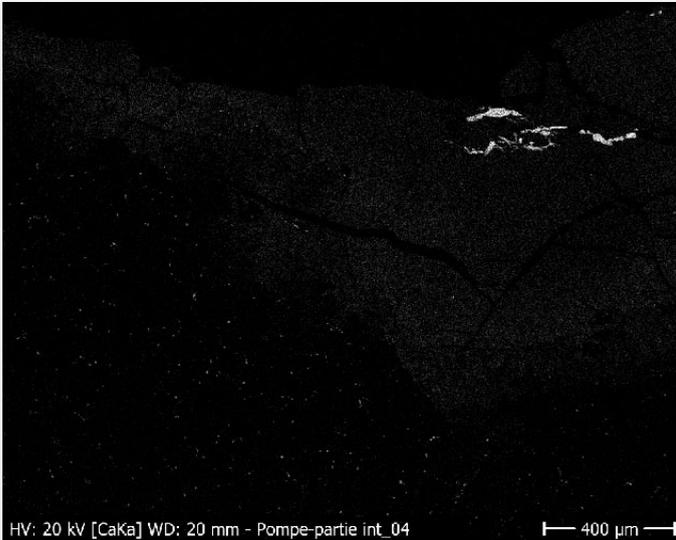
Fig. 15: Ca distribution of the area of Fig. 11. Method of analysis: SEM-EDS. Lab. of Electronic Microscopy and Microanalysis, Néode, HEI Arc,

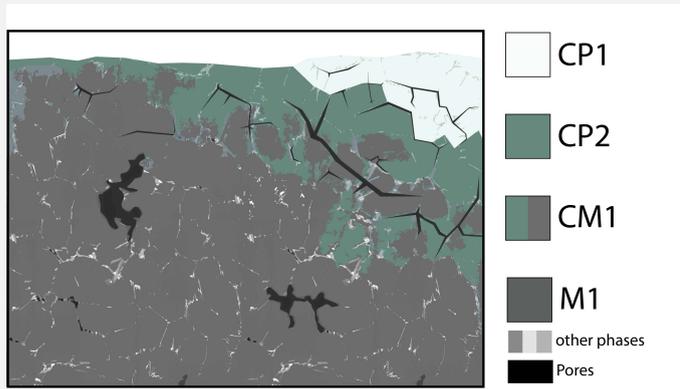
Fig. 17: Improved stratigraphic representation of the corrosion structure of the exit pipe of the disassembled Hispano water pump,

The heavily corroded exit pipe of the fastening part of this Hispano-suiza water pump is made out of an Al-Cu cast alloy with traces of Sn, Fe and Si(?). The corrosion is through the dendritic microstructure: the main phase (Al) is preferentially oxidized, while the interdendritic phase (Fe, Sn, Cu) and Sn precipitates are preserved in the corrosion products. This component of the engine being in contact with the coolant might explain the presence of Na, K and Ca in the corrosion layers.
