HISPANO-SUIZA WATER PUMP - AL ALLOY - FRANCE

Artefact name	Hispano-Suiza water pump
Authors	Christian. Degriigny (HE-Arc CR, Neuchâtel, Neuchâtel, Switzerland) & Elodie. Granget (HE-Arc CR, Neuchâtel, Neuchâtel, Switzerland) & Brice. Chalançon (MNAM (Musée National de l'Automobile de Mulhouse), Mulhouse, Alsace, France)
Url	/artefacts/886/

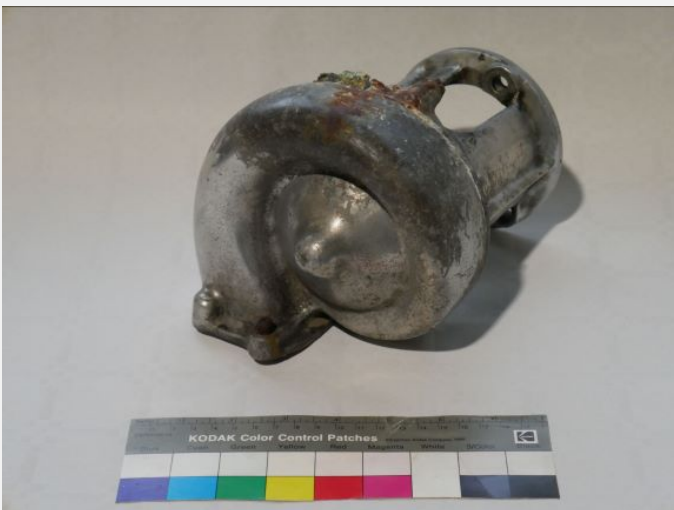
Fig. 1: Hispano-suiza water pump, unknown model,

Description of the artefact This Hispano-suiza water pump (Fig. 1), measuring around 15x15x20 cm, is made of 3 parts (Fig. 2):

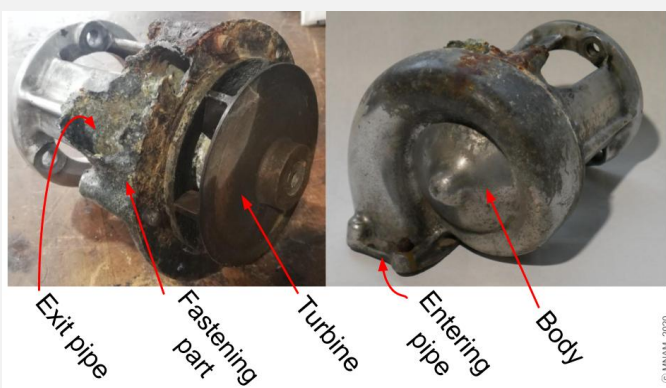
Fig. 2: Body, turbine, fastening part and pipes located on the Hispano water pump,

The exit pipe of the fastening part considered within this study is heavily corroded.

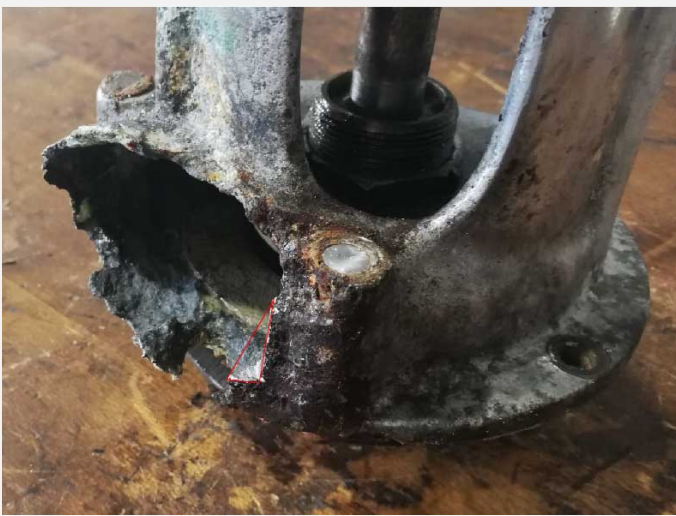
Fig. 5: Close-up view of the corroded exit pipe of the disassembled Hispano water pump, showing the sampled area,

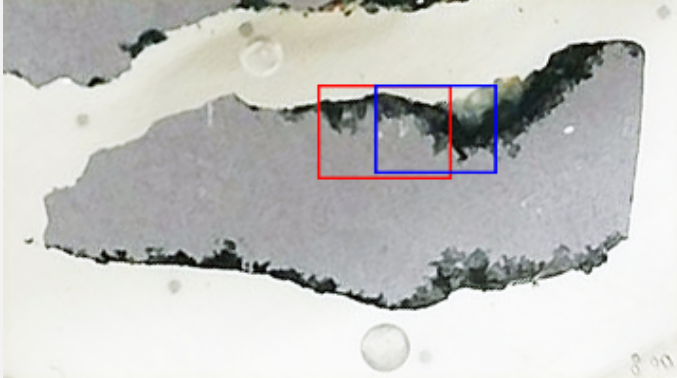
Fig. 7: Micrograph of the sample taken from the corroded exit pipe of the fastening part of the water pump (Figs. 3 to 5), showing the location of Figs. 8-9 in red and Figs. 11-15 in blue. This is a transversal cut of what is left of the exit pipe, severely consumed by corrosion,

Description of sample	A fragment of the exit pipe of the fastening part of the pump has been sampled and embedded as shown on Fig. 7. This is a transversal cut of what is left of the exit pipe, severely consumed by corrosion.
Alloy	Al Alloy
Technology	Cast
Lab number of sample	None
Sample location	HE-Arc CR, Neuchâtel, Neuchâtel
Responsible institution	MNAM (Musée National de l'Automobile de Mulhouse), Mulhouse, Alsace
Date and aim of sampling	31.12.2019 - Sampled for Metallography

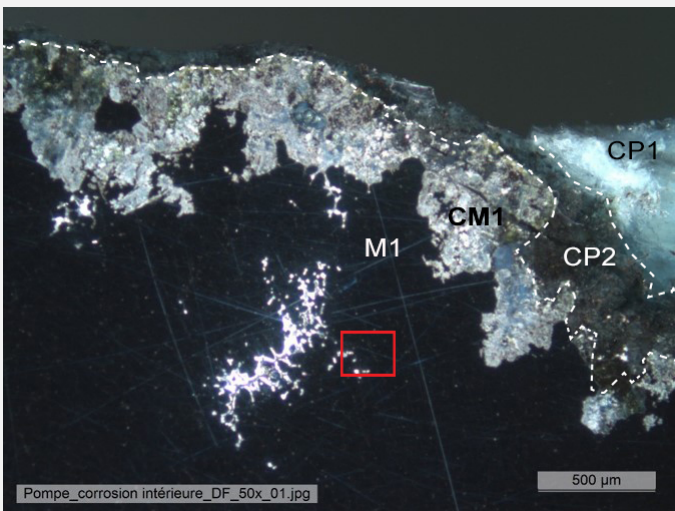
The porosity of this aluminium-copper alloy (Table 1) has been confirmed by optical (Figs. 8 and 9) and SEM observations on the cross-section of the fastening part's fragment (Fig. 10). The metal has a dendritic microstructure (Fig. 10).

Fig. 8: Micrograph of the selected area (in red) of the sample shown on Fig. 7, unetched, dark field with location of Fig. 10,

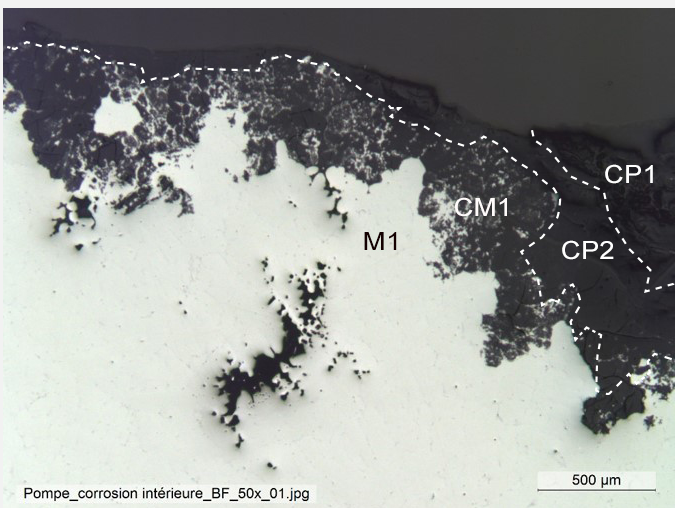
Fig. 9: Micrograph similar to Fig. 8, unetched, bright field,

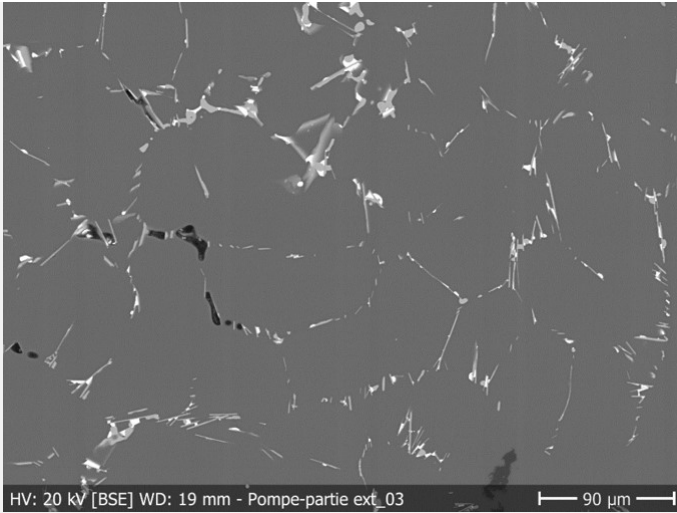
Local analyses on each phase appearing on Fig. 10 showed that the main phase is composed of Al and the interdendritic phases are composed of Al, Cu and Fe as well as Sn precipitates. This distribution is given through EDS elemental chemical distributions (Figs. 12 to 14).

Fig. 10: SEM image (BSE mode) of the metal sample from Fig. 8 showing the microstructure of the fastening part. Black = pore, dark grey = main phase, light grey = interdendritic phase and white = Sn precipitate,

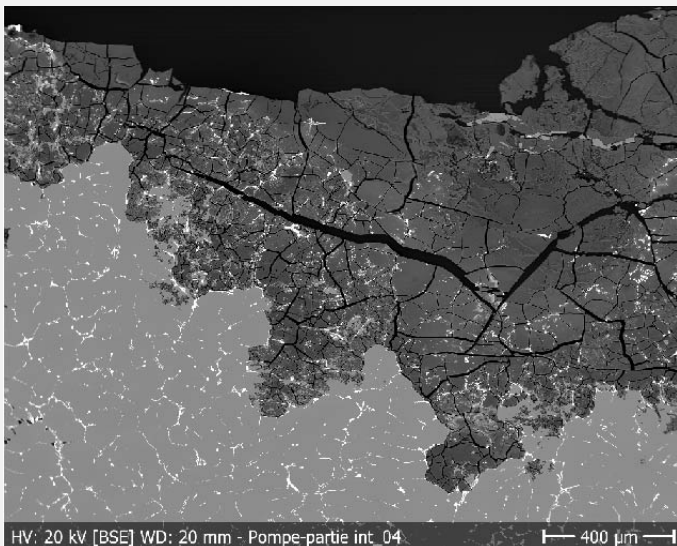
The SEM image of Fig. 11 clearly shows a network of cracks throughout CM1 and CPs. These cracks are not marking any clear separation between strata, but seem to affect all corrosion layers. The main Al phase is preferentially oxidized, while the interdendritic phase seems to be preserved in the corrosion products (Figs. 11 to 13). Na and K but no Fe are detected in the corrosion layers CM1 and CPs (Fig. 14). This surface is in contact with the coolant (glycol + additives, usually mixed 1/1 in water), which sometimes contain Na or K-based corrosion inhibitors. A cluster of CaCO₃ was identified on the very surface of the sample (Fig. 15). CaCO₃ can sometimes precipitate if the water used to mix the coolant is hard.

Fig. 11: SEM image (BSE mode) of the selected area (in blue) of the sample shown on Fig. 7, showing the remaining metal on the bottom and CM1 /CPs on top,

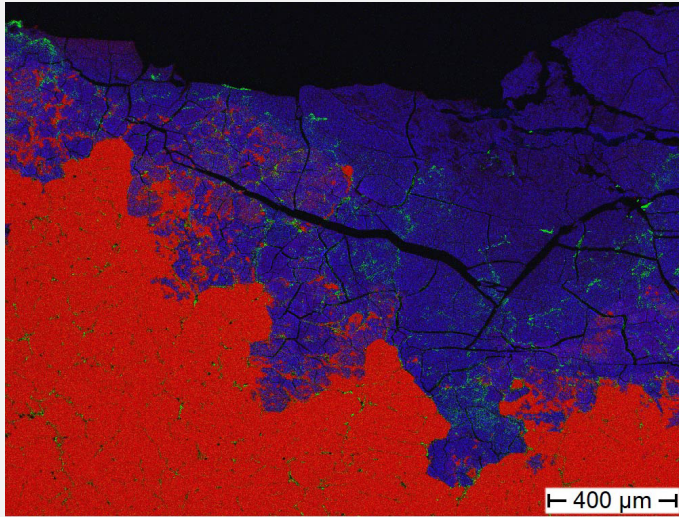
Fig. 12: Al (red), O (blue) and Cu (green) distribution of the area of Fig. 11. Method of analysis: SEM-EDS. Lab. of Electronic Microscopy and Microanalysis, Néode, HEI Arc,

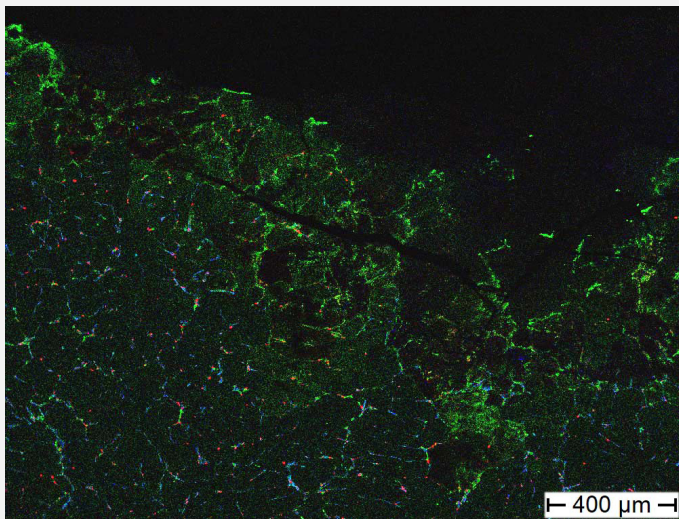
Fig. 13: Sn (red), Fe (blue) and Cu (green) distribution of the area of Fig. 11. Method of analysis: SEM-EDS. Lab. of Electronic Microscopy and Microanalysis, Néode, HEI Arc,

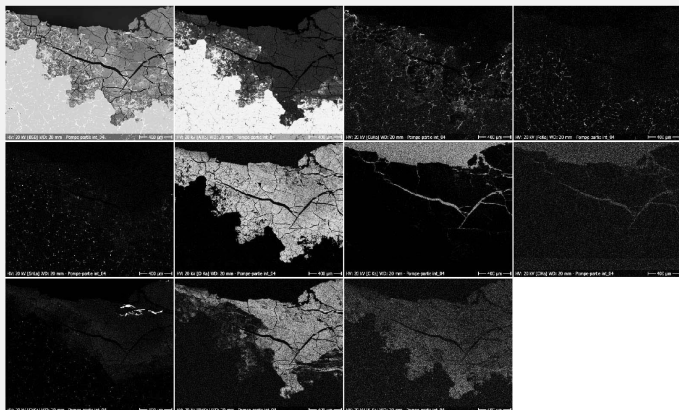
Fig. 14: SEM image and elemental chemical distribution of the area of Fig. 11. Method of analysis: SEM-EDS. Lab. of Electronic Microscopy and Microanalysis, Néode, HEI Arc,

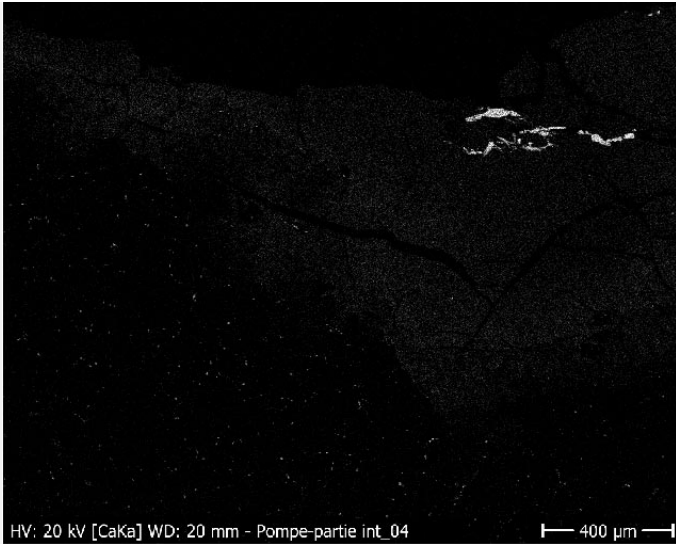
Fig. 15: Ca distribution of the area of Fig. 11. Method of analysis: SEM-EDS. Lab. of Electronic Microscopy and Microanalysis, Néode, HEI Arc,

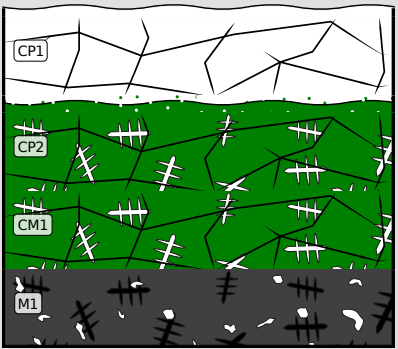
Fig. 16: Stratigraphic representation of the sample taken from the fastening part of the Hispano water pump in cross-section (dark field) using the MiCorr application. The characteristics of the strata are only accessible by clicking on the drawing that redirects you to the search tool by stratigraphy representation. This representation can be compared to Fig. 9, Credit HE-Arc CR, E.Granget.

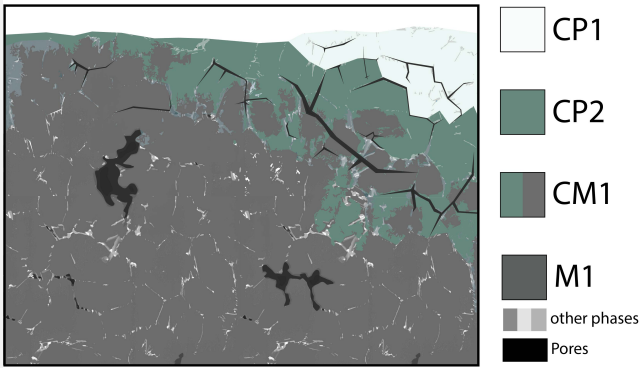
Fig. 17: Improved stratigraphic representation of the corrosion structure of the exit pipe of the disassembled Hispano water pump,

The heavily corroded exit pipe of the fastening part of this Hispano-suiza water pump is made out of an Al-Cu cast alloy with traces of Sn, Fe and Si(?). The corrosion is through the dendritic microstructure: the main phase (Al) is preferentially oxidized, while the interdendritic phase (Fe, Sn, Cu) and Sn precipitates are preserved in the corrosion products. This component of the engine being in contact with the coolant might explain the presence of Na, K and Ca in the corrosion layers.
