HISPANO-SUIZA WATER PUMP - AL ALLOY - FRANCE

Artefact name	Hispano-Suiza water pump
Authors	Christian. Degriigny (HE-Arc CR, Neuchâtel, Neuchâtel, Switzerland) & Elodie. Granget (HE-Arc CR, Neuchâtel, Neuchâtel, Switzerland) & Brice. Chalançon (MNAM (Musée National de l'Automobile de Mulhouse), Mulhouse, Alsace, France)
Url	/artefacts/886/

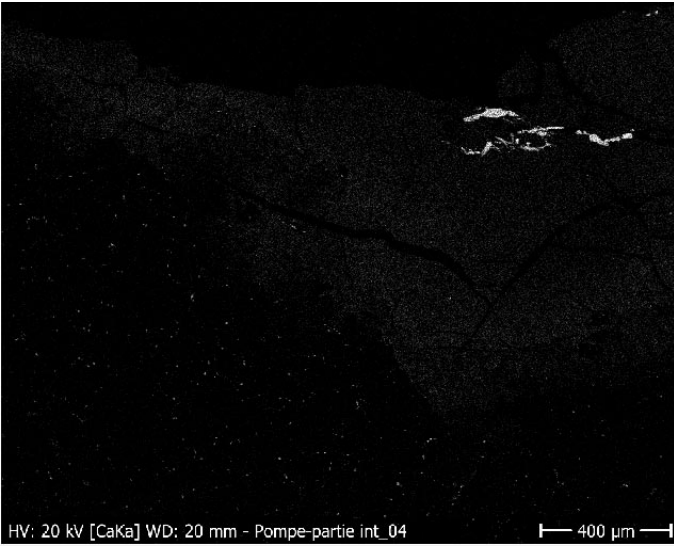
Fig. 15: Ca distribution of the area of Fig. 11. Method of analysis: SEM-EDS. Lab. of Electronic Microscopy and Microanalysis, Néode, HEI Arc,

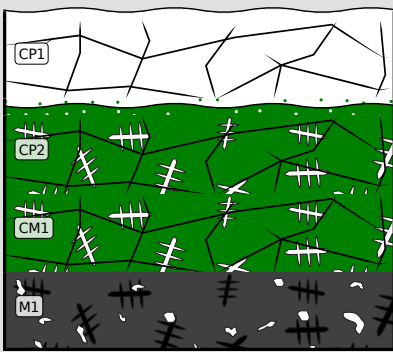
Fig. 16: Stratigraphic representation of the sample taken from the fastening part of the Hispano water pump in cross-section (dark field) using the MiCorr application. The characteristics of the strata are only accessible by clicking on the drawing that redirects you to the search tool by stratigraphy representation. This representation can be compared to Fig. 9, Credit HE-Arc CR, E.Granget.
