# HISPANO-SUIZA WATER PUMP – AL ALLOY – FRANCE

<b>Artefact name</b>	Hispano-Suiza water pump
<b>Authors</b>	Christian. Degriigny (HE-Arc CR, Neuchâtel, Neuchâtel, Switzerland) & Elodie. Granget (HE-Arc CR, Neuchâtel, Neuchâtel, Switzerland) & Brice. Chalançon (MNAM (Musée National de l'Automobile de Mulhouse), Mulhouse, Alsace, France)
<b>Url</b>	/artefacts/886/

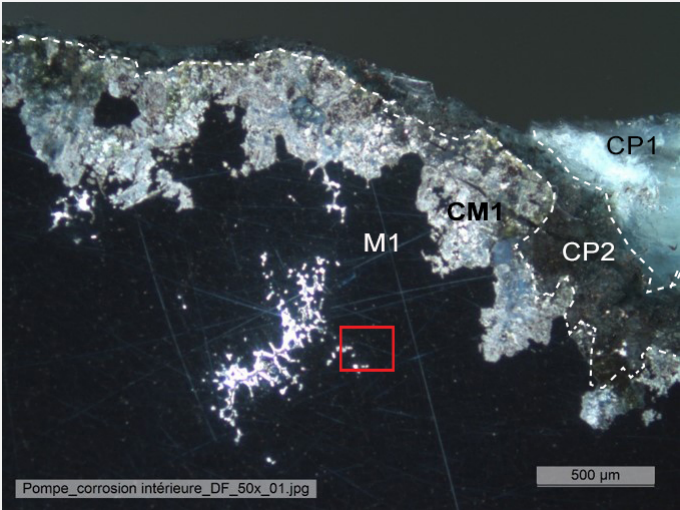
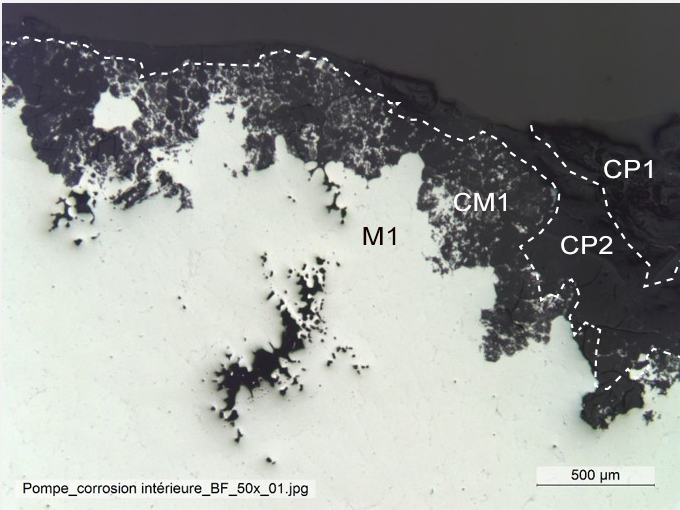
The porosity of this aluminium-copper alloy (Table 1) has been confirmed by optical (Figs. 8 and 9) and SEM observations on the cross-section of the fastening part's fragment (Fig. 10). The metal has a dendritic microstructure (Fig. 10).

Fig. 8: Micrograph of the selected area (in red) of the sample shown on Fig. 7, unetched, dark field with location of Fig. 10,

Fig. 9: Micrograph similar to Fig. 8, unetched, bright field,

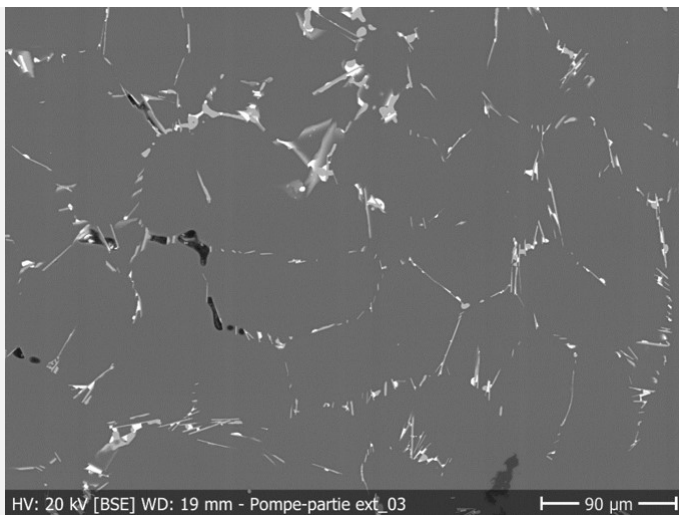
Local analyses on each phase appearing on Fig. 10 showed that the main phase is composed of Al and the interdendritic phases are composed of Al, Cu and Fe as well as Sn precipitates. This distribution is given through EDS elemental chemical distributions (Figs. 12 to 14).

Fig. 10: SEM image (BSE mode) of the metal sample from Fig. 8 showing the microstructure of the fastening part. Black = pore, dark grey = main phase, light grey = interdendritic phase and white = Sn precipitate,

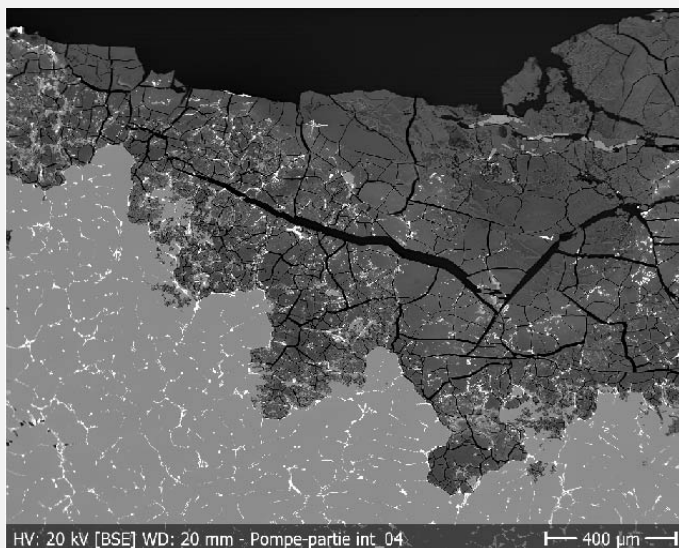
The SEM image of Fig. 11 clearly shows a network of cracks throughout CM1 and CPs. These cracks are not marking any clear separation between strata, but seem to affect all corrosion layers. The main Al phase is preferentially oxidized, while the interdendritic phase seems to be preserved in the corrosion products (Figs. 11 to 13). Na and K but no Fe are detected in the corrosion layers CM1 and CPs (Fig. 14). This surface is in contact with the coolant (glycol + additives, usually mixed 1/1 in water), which sometimes contain Na or K-based corrosion inhibitors. A cluster of CaCO<sub>3</sub> was identified on the very surface of the sample (Fig. 15). CaCO<sub>3</sub> can sometimes precipitate if the water used to mix the coolant is hard.

Fig. 11: SEM image (BSE mode) of the selected area (in blue) of the sample shown on Fig. 7, showing the remaining metal on the bottom and CM1 /CPs on top,

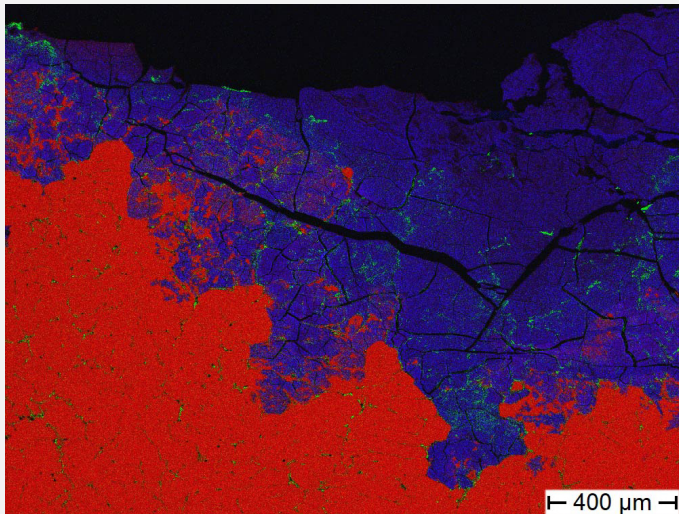
Fig. 12: Al (red), O (blue) and Cu (green) distribution of the area of Fig. 11. Method of analysis: SEM-EDS. Lab. of Electronic Microscopy and Microanalysis, Néode, HEI Arc,

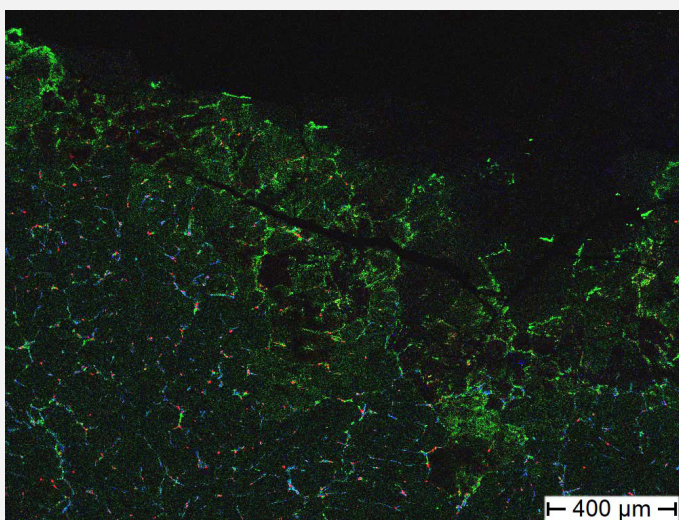
Fig. 13: Sn (red), Fe (blue) and Cu (green) distribution of the area of Fig. 11. Method of analysis: SEM-EDS. Lab. of Electronic Microscopy and Microanalysis, Néode, HEI Arc,

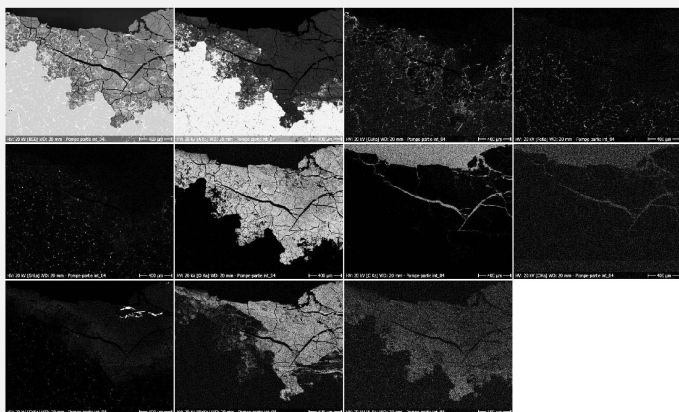
Fig. 14: SEM image and elemental chemical distribution of the area of Fig. 11. Method of analysis: SEM-EDS. Lab. of Electronic Microscopy and Microanalysis, Néode, HEI Arc,

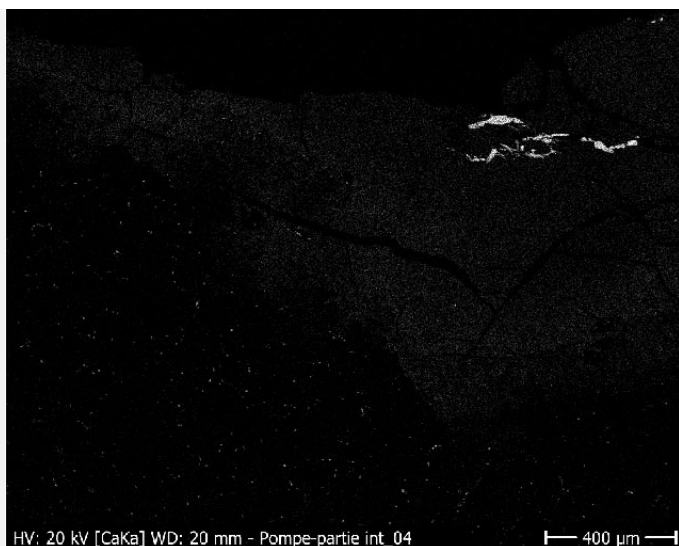
Fig. 15: Ca distribution of the area of Fig. 11. Method of analysis: SEM-EDS. Lab. of Electronic Microscopy and Microanalysis, Néode, HEI Arc,

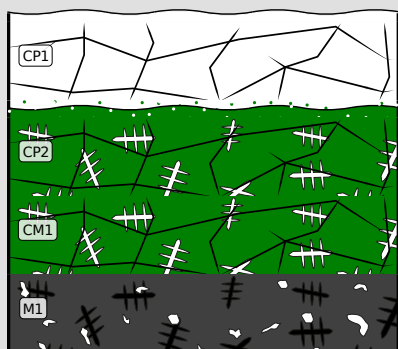
Fig. 16: Stratigraphic representation of the sample taken from the fastening part of the Hispano water pump in cross-section (dark field) using the MiCorr application. The characteristics of the strata are only accessible by clicking on the drawing that redirects you to the search tool by stratigraphy representation. This representation can be compared to Fig. 9, Credit HE-Arc CR, E.Granget.

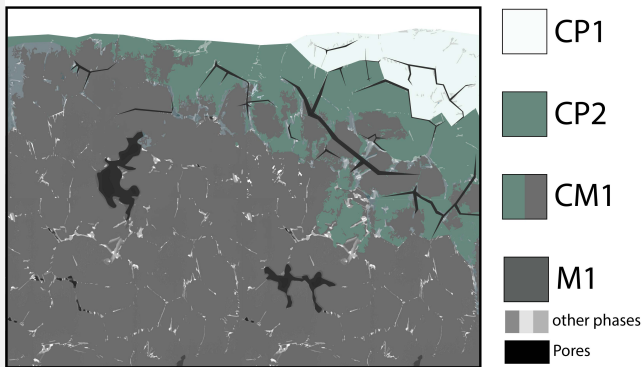
The schematic representation of corrosion layers of Fig. 6 integrating additional information based on the analyses carried out is given in Fig. 17.

Fig. 17: Improved stratigraphic representation of the corrosion structure of the exit pipe of the disassembled Hispano water pump,

The heavily corroded exit pipe of the fastening part of this Hispano-suiza water pump is made out of an Al-Cu cast alloy with traces of Sn, Fe and Si(?). The corrosion is through the dendritic microstructure: the main phase (Al) is preferentially oxidized, while the interdendritic phase (Fe, Sn, Cu) and Sn precipitates are preserved in the corrosion products. This component of the engine being in contact with the coolant might explain the presence of Na, K and Ca in the corrosion layers.
