BUGATTI COOLING SYSTEM PIPE – AL ALLOY – UNKNOWN – FRANCE

Artefact name	Bugatti cooling system pipe
Authors	Christian. Degriigny (HE-Arc CR, Neuchâtel, Neuchâtel, Switzerland) & Elodie. Granget (HE-Arc CR, Neuchâtel, Neuchâtel, Switzerland) & Brice. Chalançon (MNAM (Musée National de l'Automobile de Mulhouse), Mulhouse, Alsace, France)
Url	/artefacts/888/

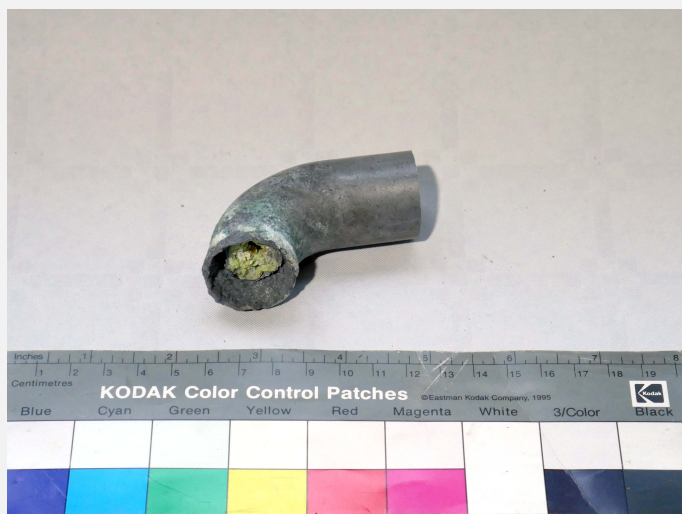
Fig. 1: Bugatti water pipe, unknown model,

Description of the artefact	<p>This section of a pipe was given to the MNAM as study material, without indication of provenance. The pipe is angled, sharply cut on one end and heavily corroded on the other, the inside being clogged by a brittle yellowish deposit.</p> <p>Looking at its shape, it is safe to assume that this is an exit pipe from the upper part of the engine (Fig. 2 and complementary information below).</p>
Type of artefact	Technical object
Origin	MNAM (Musée National de l'Automobile de Mulhouse), Mulhouse, Alsace, France
Recovering date	Unknown
Chronology category	Unknown
chronology tpq	<div>1920</div> <div>A.D. ▾</div>
chronology taq	<div>1930</div> <div>A.D. ▾</div>
Chronology comment	
Burial conditions / environment	Outdoor to indoor atmosphere
Artefact location	MNAM (Musée National de l'Automobile de Mulhouse), Mulhouse, Alsace
Owner	MNAM (Musée National de l'Automobile de Mulhouse), Mulhouse, Alsace

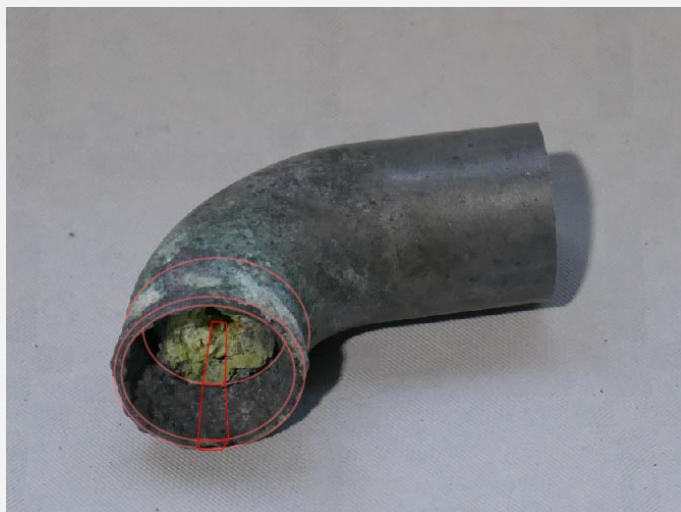
Fig. 3: Heavily corroded side of the Bugatti water pipe showing the sampling area indicated in red,

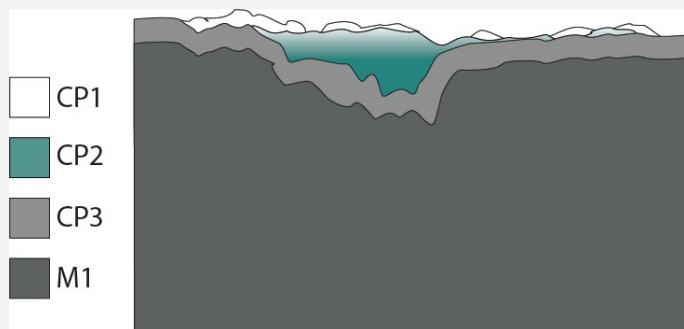
The stratum M is an aluminium alloy. Three CP strata have been identified. CP3 has a greyish mate color and is covering all of the corroded side of the pipe. Scattered over this uniform layer, blue-green (CP2) and white (CP1) spots of corrosion products can be found.

Fig. 4: Stratigraphic representation of the corrosion structure of the external surface of the water pipe from visual macroscopic observation,

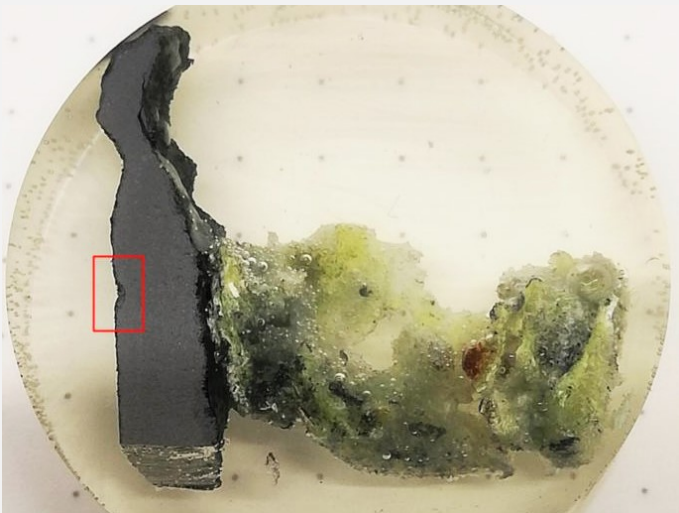
Fig. 6: Micrograph of the sample taken from the corroded exit pipe of the Bugatti water pump (Fig. 3), showing the location of Figs. 7-8 and 11 to 14 in red,

A radial section of the pipe has been sampled and embedded as shown on Fig.6. The cross-section shows not only the metal sampled but the accompanying thick yellow deposit that was clogging the pipe. Pitting corrosion develops all along the profile of the sample. A selected area (in red) is further investigated in Figs. 7-8 and 11-14.

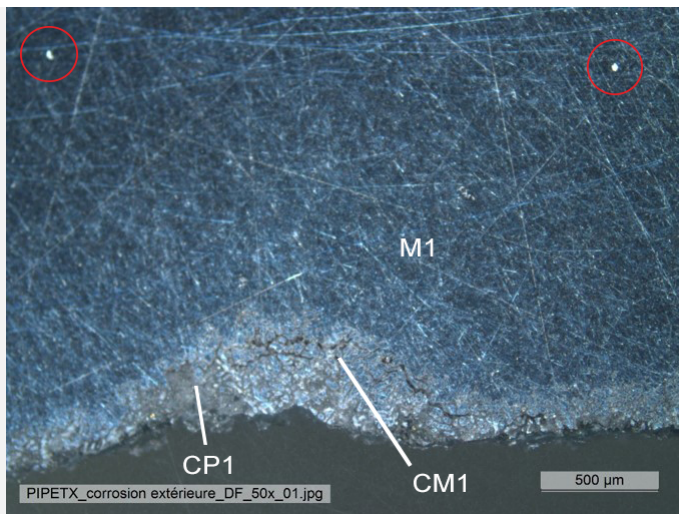
The metal is an aluminium alloy containing both Cu and Zn. It is slightly porous (Fig. 7, red circles). Its dendritic microstructure is revealed by observation in bright field (Fig. 8) and with SEM (Fig. 9).

Fig. 7: Micrograph of the selected area shown on Fig.6 (rotated by 90°), unetched, dark field with indication of pores (red circles),

The BF and DF images (Figs. 7 and 8) show a few big cracks at the interface between CM1 and M1. The SEM image shows that they expand in a network of additional microcracks (Fig. 13). The pipe suffers from a uniform interdendritic corrosion. The Al, Cu and Zn phase is oxidising preferentially, developing then aluminium oxides, versus the interdendritic phases. In some places, pits of corrosion formed. SEM cartography showed a concentration of Cl at the base of the pit (Fig. 14: Green).

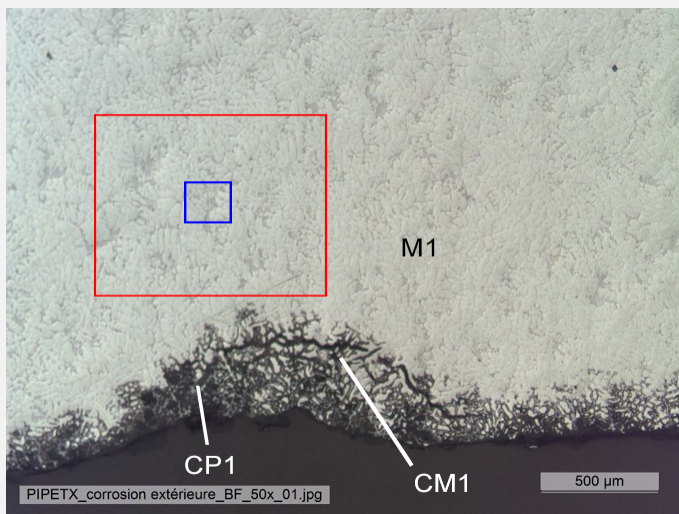
Fig. 8: Micrograph similar to Fig. 7, unetched, bright field showing the locations of Fig. 9 (in red) and Fig. 10 (in blue),

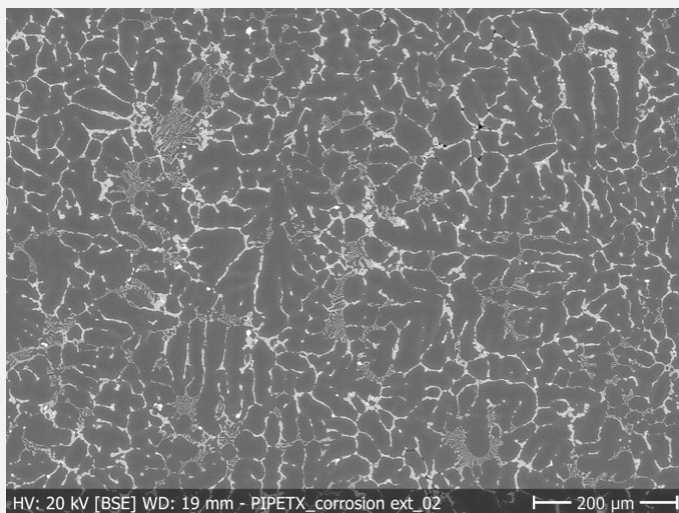
Fig. 9: SEM image (BSE mode) of the metal sample from Fig. 8 showing the microstructure of the pipe. Dark grey = main phase (Al), medium grey = interdendritic phase 1 (eutectic Al, Fe, Cu), light grey = interdendritic phase 2 (Al, Cu) and white = precipitates (Si, Sn),

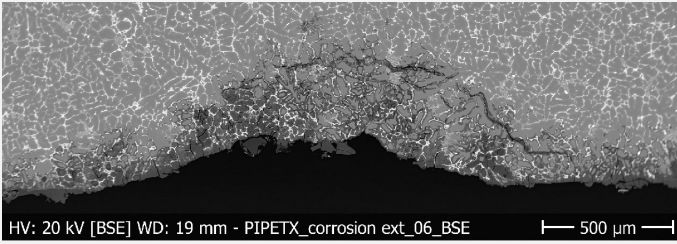
Fig. 13: SEM image of the pitting corrosion of the pipe. BSE, 20kV. Black = Cracks, Dark grey = oxydation, Medium grey = main phase, Light grey = interdendritic phase,

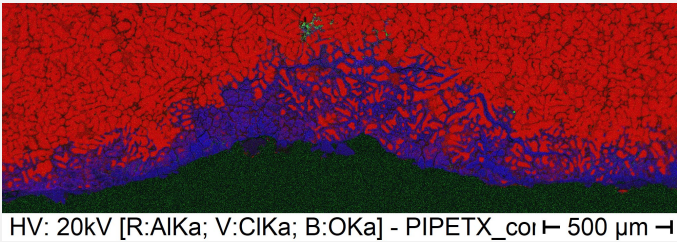
Fig. 14: SEM cartography of a pit of corrosion developing on the pipe. 20kV. Red = Al, Green = Cl, Blue = O,

The external surface shows a uniform interdendritic corrosion preferentially consuming the dendritic phase (Al, Cu, Zn). Pitting corrosion has been identified, with Cl pockets at the base of the pit.

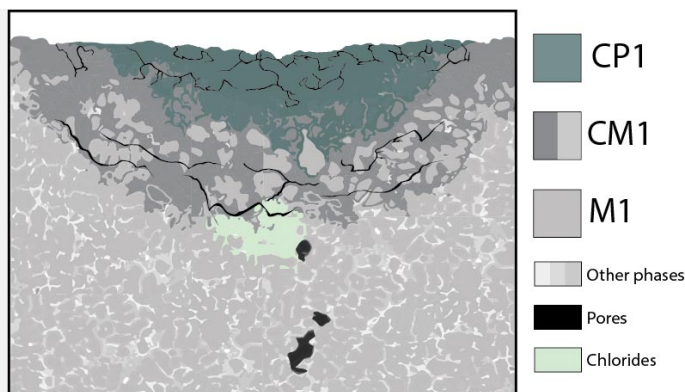
The schematic representation of corrosion layers of Fig. 4 integrating additional information based on the analyses carried out is given in Fig. 15.

Fig. 15: Improved stratigraphic representation of the exit pipe,
