## BUGATTI COOLING SYSTEM PIPE – AL ALLOY – UNKNOWN – FRANCE

**Artefact name** Bugatti cooling system pipe

**Authors** Christian. Degriigny (HE-Arc CR, Neuchâtel, Neuchâtel, Switzerland) & Elodie. Granget (HE-Arc CR, Neuchâtel, Neuchâtel, Switzerland) & Brice. Chalanson (MNAM (Musée National de l'Automobile de Mulhouse), Mulhouse, Alsace, France)

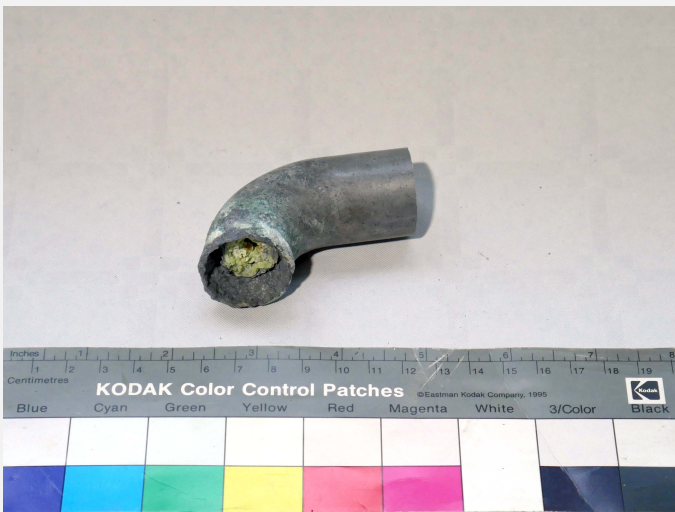
Fig. 1: Bugatti water pipe, unknown model,

| <b>Description of the artefact</b> | <p>This section of a pipe was given to the MNAM as study material, without indication of provenance. The pipe is angled, sharply cut on one end and heavily corroded on the other, the inside being clogged by a brittle yellowish deposit.</p> <p>Looking at its shape, it is safe to assume that this is an exit pipe from the upper part of the engine (Fig. 2 and complementary information below).</p> |

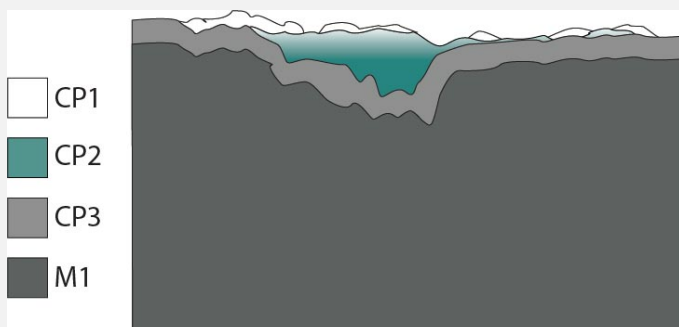
The stratum M is an aluminium alloy. Three CP strata have been identified. CP3 has a greyish mate color and is covering all of the corroded side of the pipe. Scattered over this uniform layer, blue-green (CP2) and white (CP1) spots of corrosion products can be found.

Fig. 4: Stratigraphic representation of the corrosion structure of the external surface of the water pipe from visual macroscopic observation,

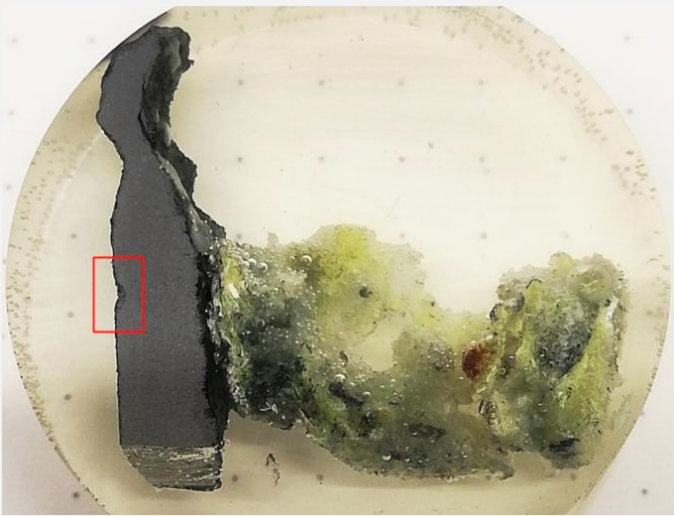
Fig. 6: Micrograph of the sample taken from the corroded exit pipe of the Bugatti water pump (Fig. 3), showing the location of Figs. 7-8 and 11 to 14 in red,

The cross-section shows not only the metal sampled but the accompanying thick yellow deposit that was clugging the pipe. Pitting corrosion develops all along the profile of the sample. A selected area (in red) is further investigated in Figs. 7-8 and 11-14.

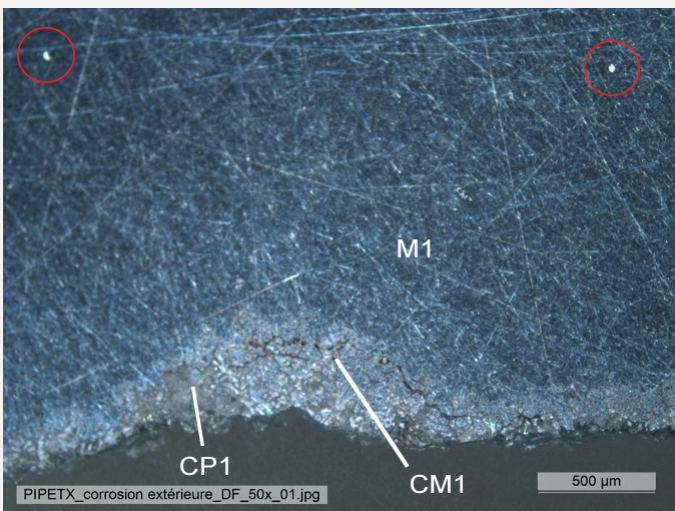
The metal is an aluminium alloy containing both Cu and Zn. It is slightly porous (Fig. 7, red circles). Its dendritic microstructure is revealed by observation in bright field (Fig. 8) and with SEM (Fig. 9).

Fig. 7: Micrograph of the selected area shown on Fig.6 (rotated by 90°), unetched, dark field with indication of pores (red circles),

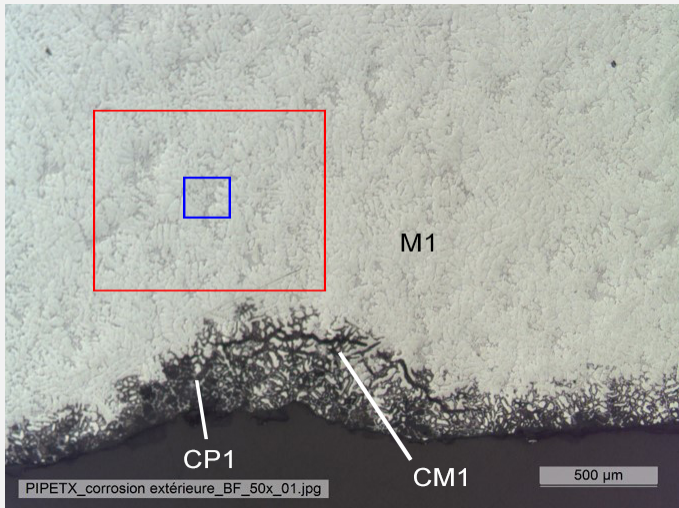
Fig. 8: Micrograph similar to Fig. 7, unetched, bright field showing the locations of Fig. 9 (in red) and Fig. 10 (in blue),

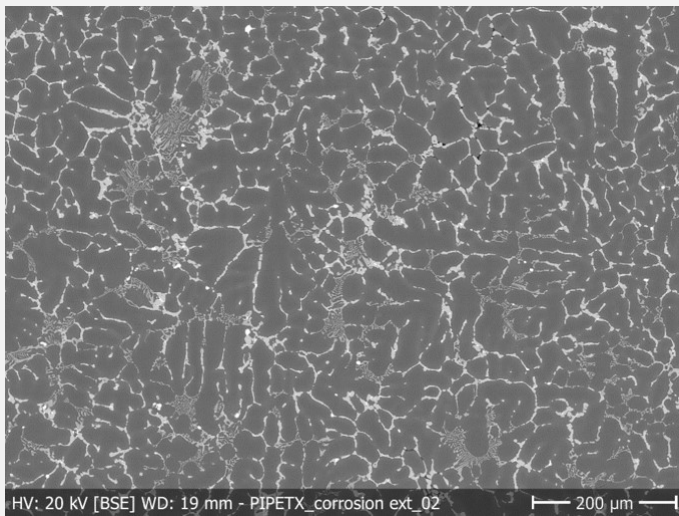
Fig. 9: SEM image (BSE mode) of the metal sample from Fig. 8 showing the microstructure of the pipe. Dark grey = main phase (Al), medium grey = interdendritic phase 1 (eutectic Al, Fe, Cu), light grey = interdendritic phase 2 (Al, Cu) and white = precipitates (Si, Sn),

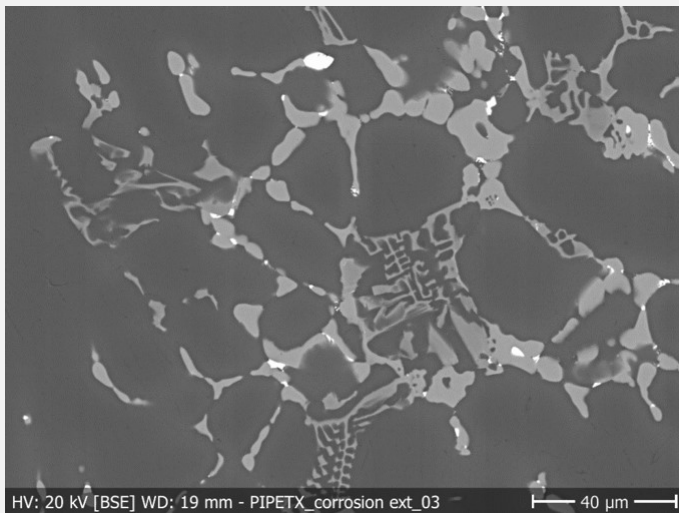
Fig. 10: Close-up image of Fig. 9,

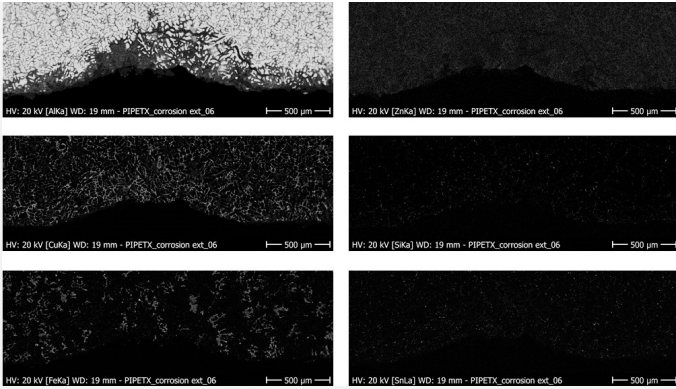
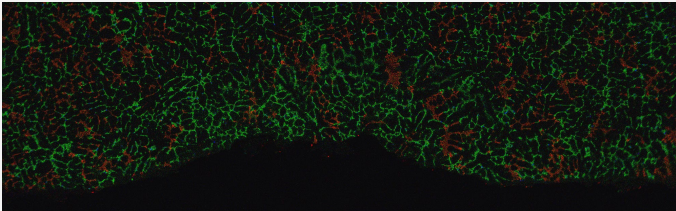
Zn is uniformly present in the alloy. There are two interdendritic phases (Fig. 12): a eutectic phase containing Al, Fe and Cu, and a second phase containing mostly Al, Cu. Additionally Sn and Si precipitates could be identified.

Fig. 11: SEM image and EDS elemental chemical distribution of main and interdendritic phases of the pipe. 20kV,

Fig. 12: Fe (red), Cu (green) and Sn (blue) chemical distribution of the area of Fig. 8. Method of analysis: SEM-EDS. Lab. of Electronic Microscopy and Microanalysis, Néode, HEI Arc,

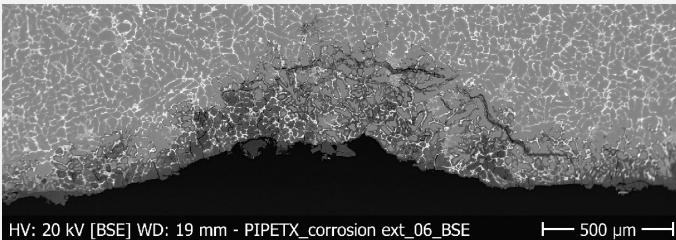
The BF and DF images (Figs. 7 and 8) show a few big cracks at the interface between CM1 and M1. The SEM image shows that they expand in a network of additional microcracks (Fig. 13). The pipe suffers from a uniform interdendritic corrosion. The Al, Cu and Zn phase is oxidising preferentially, developing then aluminium oxides, versus the interdendritic phases. In some places, pits of corrosion formed. SEM cartography showed a concentration of Cl at the base of the pit (Fig. 14: Green).

Fig. 13: SEM image of the pitting corrosion of the pipe. BSE, 20kV. Black = Cracks, Dark grey = oxydation, Medium grey = main phase, Light grey = interdendritic phase,

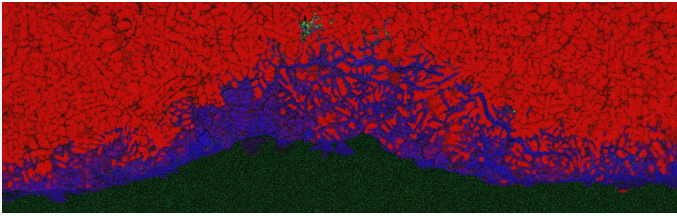
Fig. 14: SEM cartography of a pit of corrosion developing on the pipe. 20kV. Red = Al, Green = Cl, Blue = O,

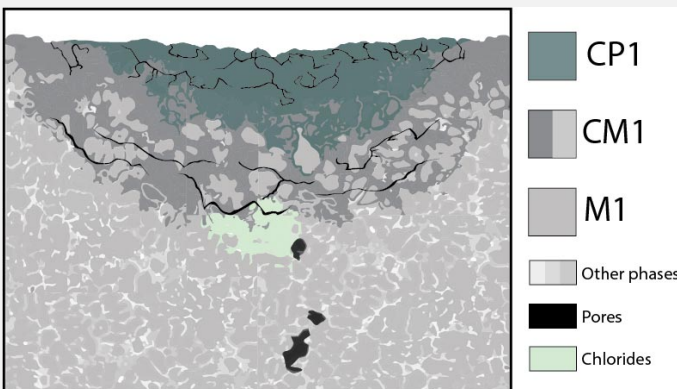
Fig. 15: Improved stratigraphic representation of the exit pipe,

The external surface shows a uniform interdendritic corrosion preferentially consuming the dendritic phase (Al, Cu, Zn). Pitting corrosion has been identified, with Cl pockets at the base of the pit.
