BUGATTI COOLING SYSTEM PIPE - AL ALLOY - UNKNOWN - FRANCE

Artefact name Bugatti cooling system pipe

Authors Christian. Degrigny (HE-Arc CR, Neuchâtel, Neuchâtel, Switzerland) & Elodie. Granget (HE-Arc CR, Neuchâtel, Neuchâtel, Switzerland) & Brice. Chalauçon (MNAM (Musée National de l'Automobile de Mulhouse), Mulhouse, Alsace, France)

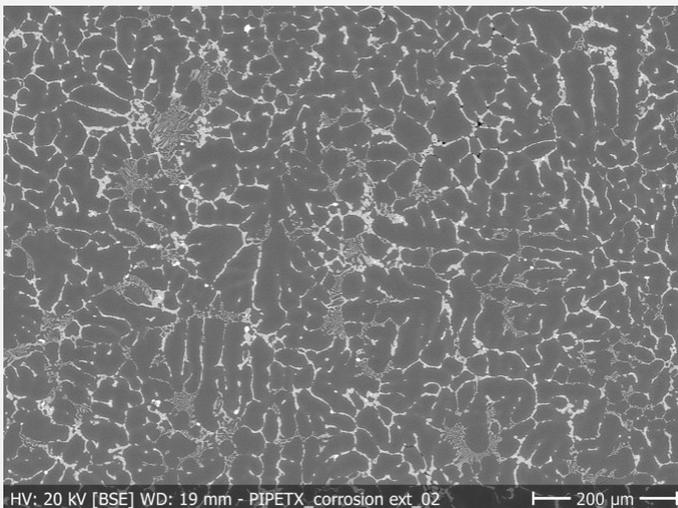
Fig. 9: SEM image (BSE mode) of the metal sample from Fig. 8 showing the microstructure of the pipe. Dark grey = main phase (Al), medium grey = interdendritic phase 1 (eutectic Al, Fe, Cu), light grey = interdendritic phase 2 (Al, Cu) and white = precipitates (Si, Sn),

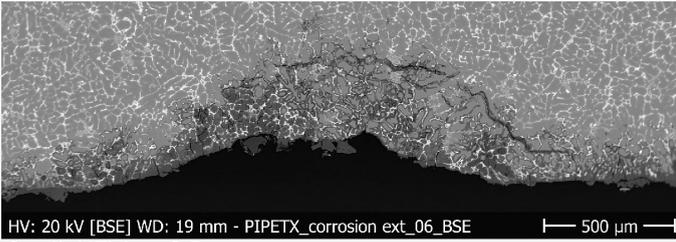
The BF and DF images (Figs. 7 and 8) show a few big cracks at the interface between CM1 and M1. The SEM image shows that they expand in a network of additional microcracks (Fig. 13). The pipe suffers from a uniform interdendritic corrosion. The Al, Cu and Zn phase is oxidising preferentially, developing then aluminium oxides, versus the interdendritic phases. In some places, pits of corrosion formed. SEM cartography showed a concentration of Cl at the base of the pit (Fig. 14: Green).

Fig. 13: SEM image of the pitting corrosion of the pipe. BSE, 20kV. Black = Cracks, Dark grey = oxydation, Medium grey = main phase, Light grey = interdendritic phase,

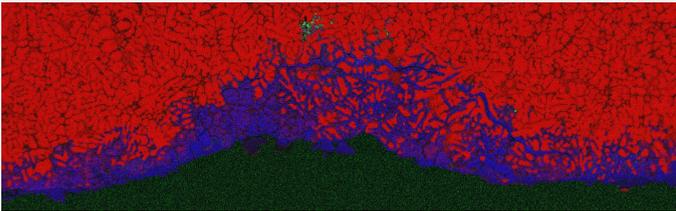
Fig. 14: SEM cartography of a pit of corrosion developing on the pipe. 20kV. Red = Al, Green = Cl, Blue = O,

The external surface shows a uniform interdendritic corrosion preferentially consuming the dendritic phase (Al, Cu, Zn). Pitting corrosion has been identified, with Cl pockets at the base of the pit.

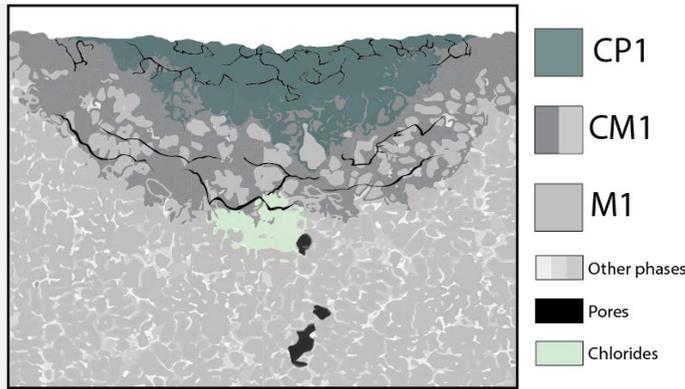
The schematic representation of corrosion layers of Fig. 4 integrating additional information based on the analyses carried out is given in Fig. 15.

Fig. 15: Improved stratigraphic representation of the exit pipe,
