## BUGATTI COOLING SYSTEM PIPE – AL ALLOY – UNKNOWN – FRANCE

**Artefact name** Bugatti cooling system pipe

**Authors** Christian. Degriigny (HE-Arc CR, Neuchâtel, Neuchâtel, Switzerland) & Elodie. Granget (HE-Arc CR, Neuchâtel, Neuchâtel, Switzerland) & Brice. Chalanson (MNAM (Musée National de l'Automobile de Mulhouse), Mulhouse, Alsace, France)

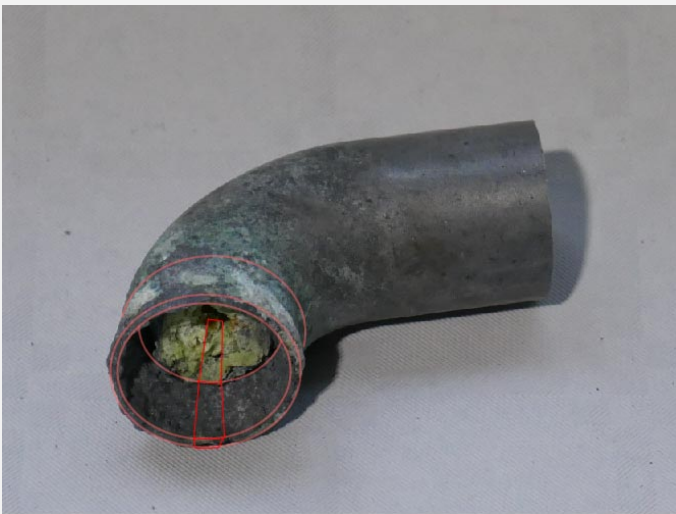
Fig. 3: Heavily corroded side of the Bugatti water pipe showing the sampling area indicated in red,

One end of the pipe is heavily corroded and entirely clogged by corrosion products and other deposits on the inside. This deposit could not be analyzed.
