BUGATTI COOLING SYSTEM PIPE – AL ALLOY – UNKNOWN – FRANCE

Artefact name Bugatti cooling system pipe

Authors Christian. Degriigny (HE-Arc CR, Neuchâtel, Neuchâtel, Switzerland) & Elodie. Granget (HE-Arc CR, Neuchâtel, Neuchâtel, Switzerland) & Brice. Chalançon (MNAM (Musée National de l'Automobile de Mulhouse), Mulhouse, Alsace, France)

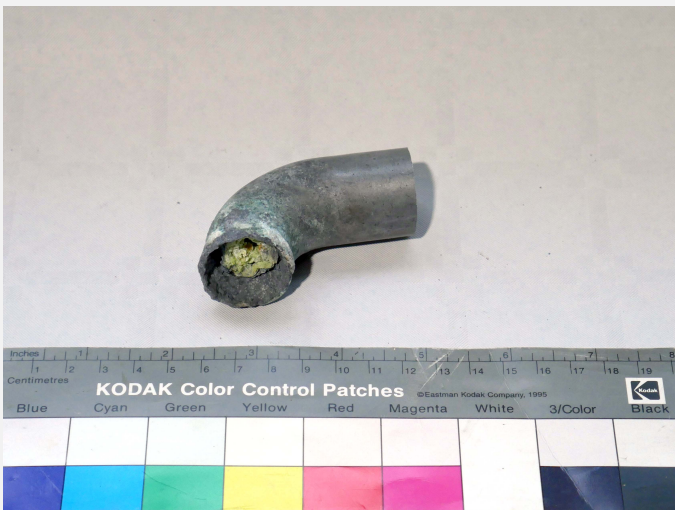
Fig. 1: Bugatti water pipe, unknown model,

Description of the artefact	<p>This section of a pipe was given to the MNAM as study material, without indication of provenance. The pipe is angled, sharply cut on one end and heavily corroded on the other, the inside being clogged by a brittle yellowish deposit.</p> <p>Looking at its shape, it is safe to assume that this is an exit pipe from the upper part of the engine (Fig. 2 and complementary information below).</p>
Type of artefact	Technical object
Origin	MNAM (Musée National de l'Automobile de Mulhouse), Mulhouse, Alsace, France
Recovering date	Unknown
Chronology category	Unknown
chronology tpq	<div>1920</div> <div>A.D. ▼</div>
chronology taq	<div>1930</div> <div>A.D. ▼</div>
Chronology comment	
Burial conditions / environment	Outdoor to indoor atmosphere
Artefact location	MNAM (Musée National de l'Automobile de Mulhouse), Mulhouse, Alsace
Owner	MNAM (Musée National de l'Automobile de Mulhouse), Mulhouse, Alsace

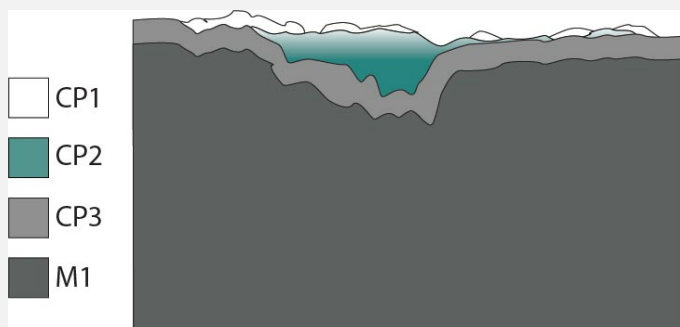
The stratum M is an aluminium alloy. Three CP strata have been identified. CP3 has a greyish mate color and is covering all of the corroded side of the pipe. Scattered over this uniform layer, blue-green (CP2) and white (CP1) spots of corrosion products can be found.

Fig. 4: Stratigraphic representation of the corrosion structure of the external surface of the water pipe from visual macroscopic observation,

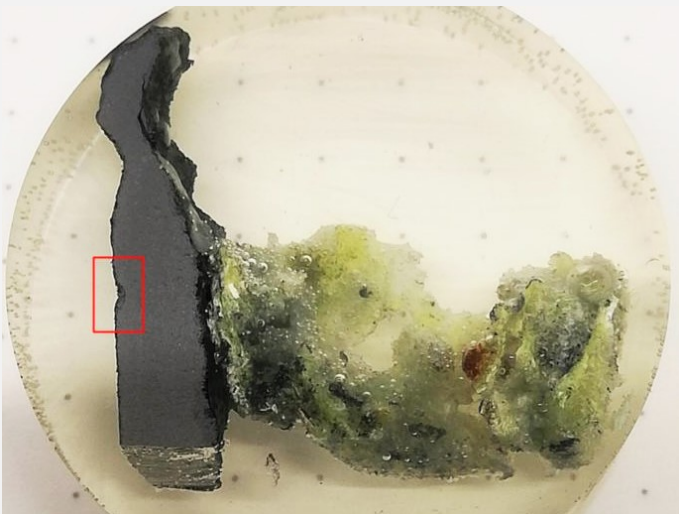
Fig. 6: Micrograph of the sample taken from the corroded exit pipe of the Bugatti water pump (Fig. 3), showing the location of Figs. 7-8 and 11 to 14 in red,

Description of sample	<p>A radial section of the pipe has been sampled and embedded as shown on Fig.6.</p> <p>The cross-section shows not only the metal sampled but the accompanying thick yellow deposit that was clogging the pipe. Pitting corrosion develops all along the profile of the sample. A selected area (in red) is further investigated in Figs. 7-8 and 11-14.</p>
Alloy	Al Alloy
Technology	Cast
Lab number of sample	None
Sample location	HE-Arc CR, Neuchâtel, Neuchâtel
Responsible institution	MNAM (Musée National de l'Automobile de Mulhouse), Mulhouse, Alsace
Date and aim of sampling	31.12.2019 - Sampled for Metallography

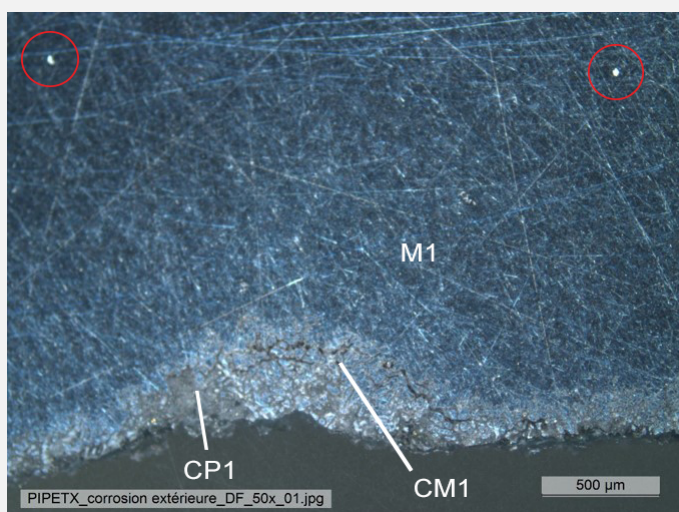
The metal is an aluminium alloy containing both Cu and Zn. It is slightly porous (Fig. 7, red circles). Its dendritic microstructure is revealed by observation in bright field (Fig. 8) and with SEM (Fig. 9).

Fig. 7: Micrograph of the selected area shown on Fig.6 (rotated by 90°), unetched, dark field with indication of pores (red circles),

The BF and DF images (Figs. 7 and 8) show a few big cracks at the interface between CM1 and M1. The SEM image shows that they expand in a network of additional microcracks (Fig. 13). The pipe suffers from a uniform interdendritic corrosion. The Al, Cu and Zn phase is oxidising preferentially, developing then aluminium oxides, versus the interdendritic phases. In some places, pits of corrosion formed. SEM cartography showed a concentration of Cl at the base of the pit (Fig. 14: Green).

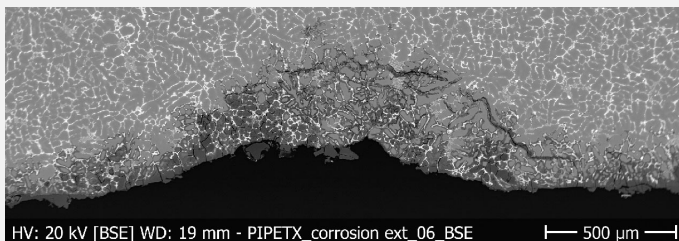
Fig. 13: SEM image of the pitting corrosion of the pipe. BSE, 20kV. Black = Cracks, Dark grey = oxydation, Medium grey = main phase, Light grey = interdendritic phase,

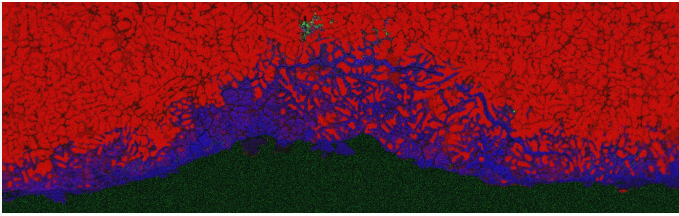
Fig. 14: SEM cartography of a pit of corrosion developing on the pipe. 20kV. Red = Al, Green = Cl, Blue = O,

The external surface shows a uniform interdendritic corrosion preferentially consuming the dendritic phase (Al, Cu, Zn). Pitting corrosion has been identified, with Cl pockets at the base of the pit.

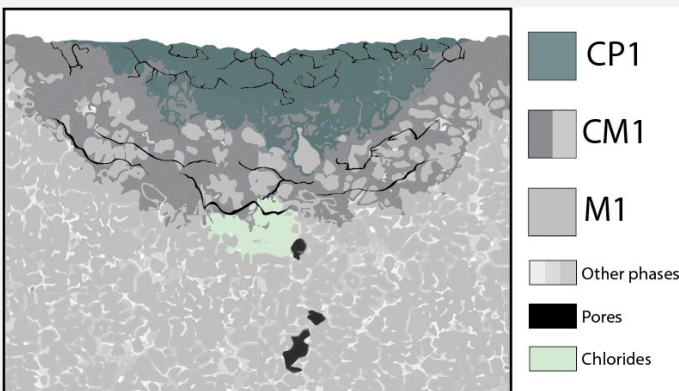
The schematic representation of corrosion layers of Fig. 4 integrating additional information based on the analyses carried out is given in Fig. 15.

Fig. 15: Improved stratigraphic representation of the exit pipe,
