## BUGATTI COOLING SYSTEM PIPE – AL ALLOY – UNKNOWN – FRANCE

**Artefact name** Bugatti cooling system pipe

**Authors** Christian. Degriigny (HE-Arc CR, Neuchâtel, Neuchâtel, Switzerland) & Elodie. Granget (HE-Arc CR, Neuchâtel, Neuchâtel, Switzerland) & Brice. Chalançon (MNAM (Musée National de l'Automobile de Mulhouse), Mulhouse, Alsace, France)

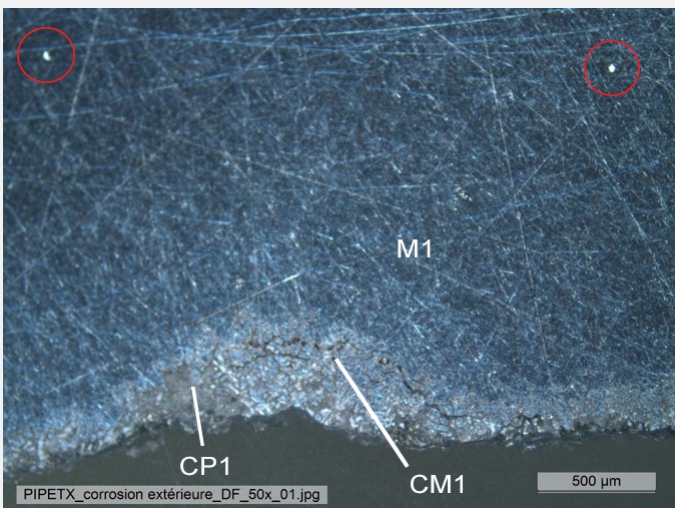
The metal is an aluminium alloy containing both Cu and Zn. It is slightly porous (Fig. 7, red circles). Its dendritic microstructure is revealed by observation in bright field (Fig. 8) and with SEM (Fig. 9).

Fig. 7: Micrograph of the selected area shown on Fig.6 (rotated by 90°), unetched, dark field with indication of pores (red circles),

The BF and DF images (Figs. 7 and 8) show a few big cracks at the interface between CM1 and M1. The SEM image shows that they expand in a network of additional microcracks (Fig. 13). The pipe suffers from a uniform interdendritic corrosion. The Al, Cu and Zn phase is oxidising preferentially, developing then aluminium oxides, versus the interdendritic phases. In some places, pits of corrosion formed. SEM cartography showed a concentration of Cl at the base of the pit (Fig. 14: Green).
