# SHINGLE OF A ROOF - CU ALLOY - MODERN TIMES - SWITZERLAND

Artefact name Shingle of a roof

**Authors** Marianne. Senn (EMPA, Dübendorf, Zurich, Switzerland) & Christian. Degrigny (HE-Arc CR, Neuchâtel,

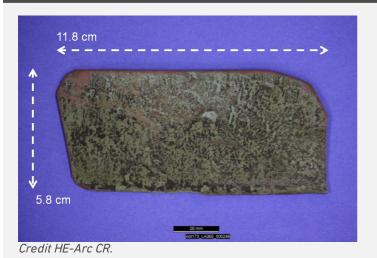
Fig. 1: Shingle of a roof, internal side,

**Description of the artefact** Shingle, slightly curved, the internal side is covered with heterogeneously distributed green

and black corrosion products (Fig. 1). The external side shows a regular dark green corrosion

crust. Dimensions: L = 11.8cm; W = 5.8cm.

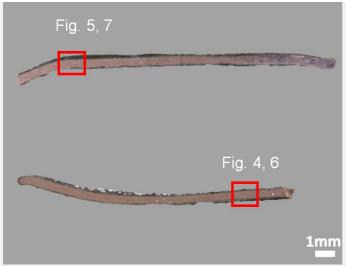
Fig. 3: Micrograph of the cross-sections of the sample taken from the shingle showing the location of Figs. 4 to 7,

Description of sample Two samples were taken (Fig. 3). The polished samples show a well-preserved metal surface

with a thin corrosion crust, T = 0.5mm.

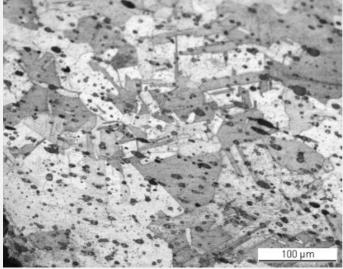
The remaining metal is a copper alloy (Table 1). The evenly distributed inclusions observed under SEM, SE-mode, are either light-grey or white (Fig. 4). The oval shape of the light-grey inclusions is due to deformation, probably by hot rolling (a common technique in the 18th century). Under polarised light they look red (Fig. 6) and their analysis reveals a composition similar to cuprite/Cu20 (Table 2). The white inclusions are rich in Pb and are remnants of the refining process (Table 2). The etched copper shows a structure of polygonal and twinned grains (Fig. 5). The grain size is variable. The average hardness of the metal is about HV1 70.

Fig. 5: Micrograph of the metal sample from Fig. 3 (detail), etched, bright field. The metal shows a structure of polygonal and twinned grains. Cuprite inclusions appear as dark spots,

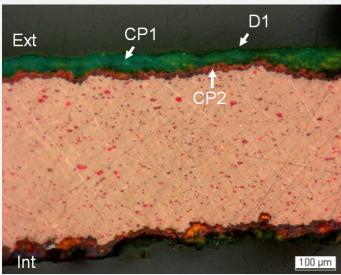
The corrosion crusts of the external and internal sides are distinctively different (Fig. 6). On the internal side an irregular reddish-orange corrosion layer has developed, and pitting corrosion has occurred. The more uniform corrosion layers on the external side consist of a reddish-orange layer, with a thicker green layer above. In some areas, dark-red corrosion products can be observed between the green and reddish-orange sub-layers. The same dark-red sub-layer can be seen in areas on the internal side covering the reddish-orange corrosion products. The reddish-orange corrosion layer on both sides (CP2) has a chemical composition similar to cuprite/Cu2O, while the green layer on the external side (CP1) contains Cu, S and O and is enriched on its upper surface with Si (Table 3 and Fig. 7). XRD analysis of the corrosion products on the external side of another shingle fragment from the same roof identified brochantite/ $Cu_4SO_4(OH)_6$  and cuprite as corrosion products (Rapport d'analyse no. MAH 98-257). These results are confirmed by Raman spectroscopy of the external side of this sample where the same compounds were clearly identified (Figs. 8 and 9).

Fig. 6: Micrograph of the metal sample from Fig. 3 and corresponding to the stratigraphy of Fig. 10, polarised light. External side: the regular corrosion crust with outer green, inner red-orange corrosion products and intermediate darkred corrosion products. Internal side: the irregular corrosion crust with inner red-orange and outer dark-red corrosion products.

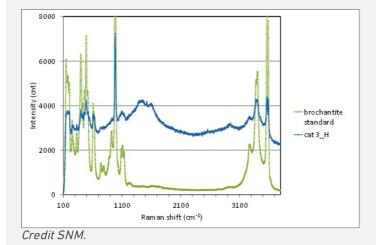
Fig. 9: Raman spectrum of the green outer corrosion layer (CP1) of the external side (cat3\_H) compared to a brochantite standard spectrum. Settings: laser wavelength 532nm, acquisition time 100s, one accumulation, filter D2 (0.75-0.8 mW), hole 500, slit 80, grating 600. The peak indicated with an arrow on the cat3\_H spectrum is due to fluorescence. Method of analysis: Raman spectroscopy, Lab Swiss National Museum, Affoltern a. Albis ZH,
