SHINGLE OF A ROOF – CU ALLOY – MODERN TIMES – SWITZERLAND

Artefact name	Shingle of a roof
Authors	Marianne. Senn (EMPA, Dübendorf, Zurich, Switzerland) & Christian. Degryny (HE-Arc CR, Neuchâtel, Neuchâtel, Switzerland)
Url	/artefacts/892/

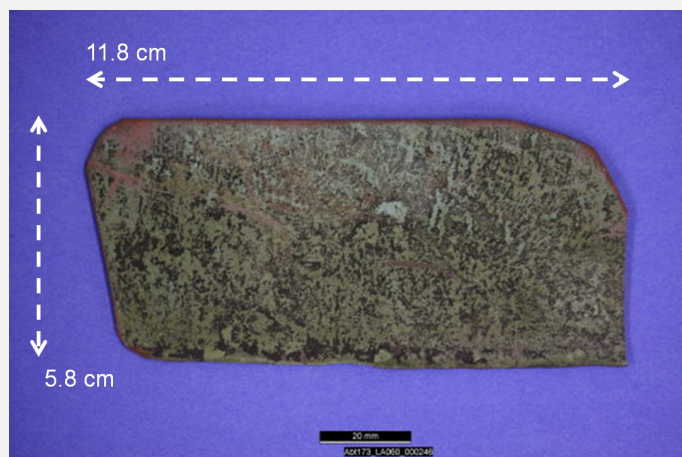
Fig. 1: Shingle of a roof, internal side,

Description of the artefact	Shingle, slightly curved, the internal side is covered with heterogeneously distributed green and black corrosion products (Fig. 1). The external side shows a regular dark green corrosion crust. Dimensions: L = 11.8cm; W = 5.8cm.
Type of artefact	Architectural element
Origin	Roof of the Abbey of St Gallen, Sankt Gallen, Saint Gallen, Switzerland
Recovering date	None
Chronology category	Modern Times
chronology tpq	1780 A.D. ▼
chronology taq	---- ▼
Chronology comment

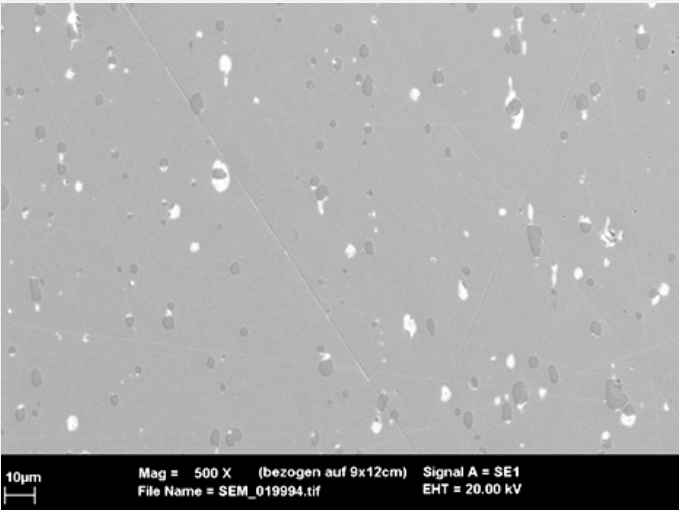
The remaining metal is a copper alloy (Table 1). The evenly distributed inclusions observed under SEM, SE-mode, are either light-grey or white (Fig. 4). The oval shape of the light-grey inclusions is due to deformation, probably by hot rolling (a common technique in the 18th century). Under polarised light they look red (Fig. 6) and their analysis reveals a composition similar to cuprite/Cu₂O (Table 2). The white inclusions are rich in Pb and are remnants of the refining process (Table 2). The etched copper shows a structure of polygonal and twinned grains (Fig. 5). The grain size is variable. The average hardness of the metal is about HV1 70.

Table 2: Chemical composition (mass %) of the inclusions in the metal (from Fig. 4). Method of analysis: SEM/EDS, Laboratory of Analytical Chemistry, Empa.

Fig. 4: SEM image, SE-mode, of the metal sample from Fig. 3 (detail). Light-grey and white inclusions are distributed evenly,

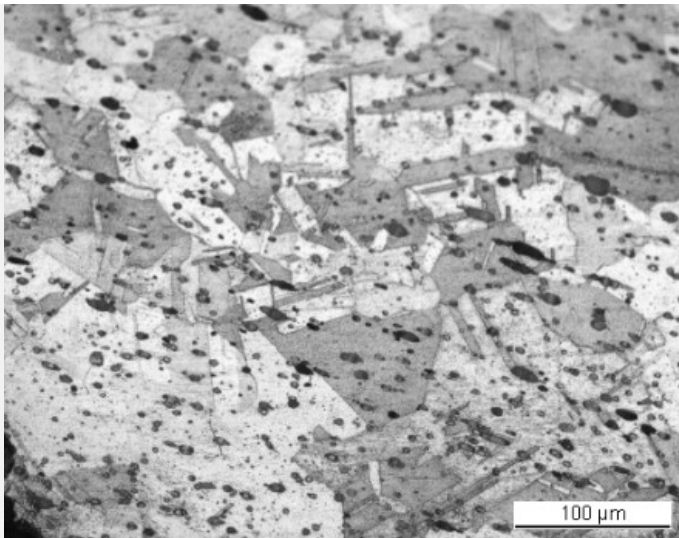
Fig. 5: Micrograph of the metal sample from Fig. 3 (detail), etched, bright field. The metal shows a structure of polygonal and twinned grains. Cuprite inclusions appear as dark spots, and elongated inclusions are visible.

Microstructure	Polygonal and twinned grains, elongated inclusions
First metal element	Cu
Other metal elements	Pb

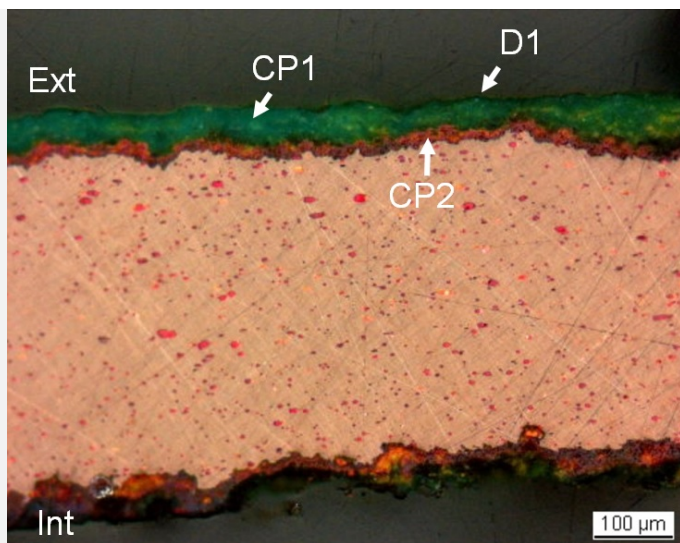
The corrosion crusts of the external and internal sides are distinctively different (Fig. 6). On the internal side an irregular reddish-orange corrosion layer has developed, and pitting corrosion has occurred. The more uniform corrosion layers on the external side consist of a reddish-orange layer, with a thicker green layer above. In some areas, dark-red corrosion products can be observed between the green and reddish-orange sub-layers. The same dark-red sub-layer can be seen in areas on the internal side covering the reddish-orange corrosion products. The reddish-orange corrosion layer on both sides (CP2) has a chemical composition similar to cuprite/ Cu_2O , while the green layer on the external side (CP1) contains Cu, S and O and is enriched on its upper surface with Si (Table 3 and Fig. 7). XRD analysis of the corrosion products on the external side of another shingle fragment from the same roof identified brochantite/ $\text{Cu}_4\text{SO}_4(\text{OH})_6$ and cuprite as corrosion products (Rapport d'analyse no. MAH 98-257). These results are confirmed by Raman spectroscopy of the external side of this sample where the same compounds were clearly identified (Figs. 8 and 9).

Fig. 6: Micrograph of the metal sample from Fig. 3 and corresponding to the stratigraphy of Fig. 10, polarised light. External side: the regular corrosion crust with outer green, inner red-orange corrosion products and intermediate dark-red corrosion products. Internal side: the irregular corrosion crust with inner red-orange and outer dark-red corrosion products,

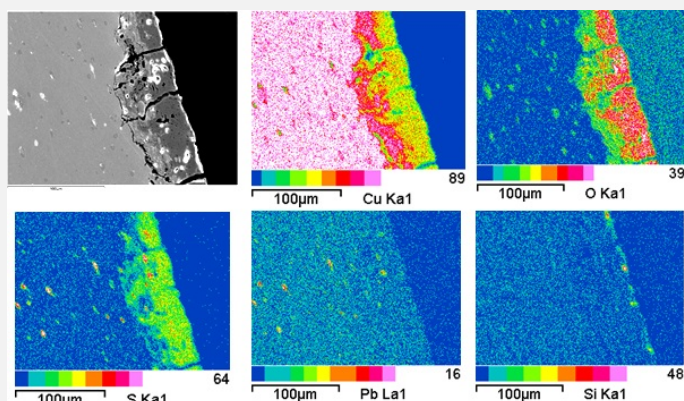
Table 3: Chemical composition (mass %) of the corrosion layers of the external side. Method of analysis: SEM/EDS, Laboratory of Analytical Chemistry, Empa.

Fig. 7: SEM image, SE-mode, and elemental chemical distribution of a selected area on the external side (rotated image, detail of Fig. 3). Method of examination: SEM/EDS, Laboratory of Analytical Chemistry, Empa,

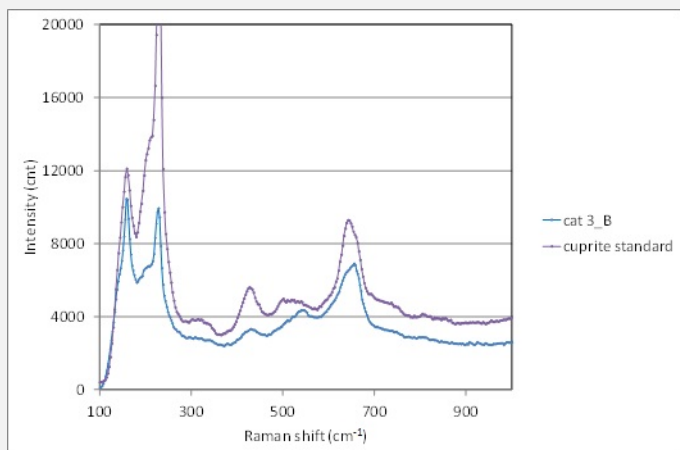
Fig. 8: Raman spectrum of the red-orange inner corrosion layer (CP2) of the external side (cat3_B) compared to a cuprite standard spectrum. Settings: laser wavelength 532nm, acquisition time 100s, one accumulation, filter D2 (0.75-0.8 mW), hole 500, slit 80, grating 600. Method of analysis: Raman spectroscopy, Lab Swiss National Museum, Affoltern a. Albis ZH,

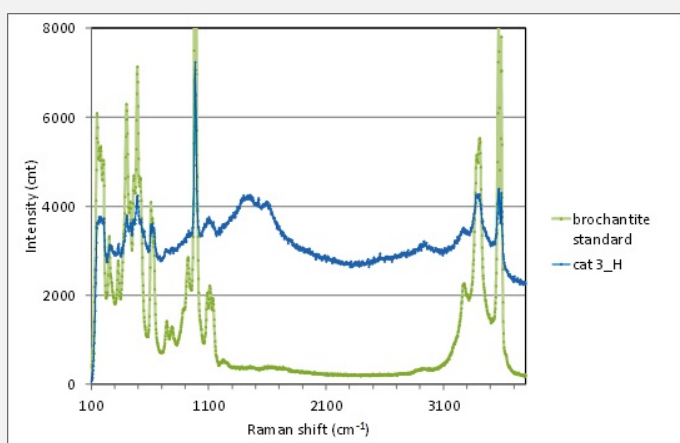
Fig. 9: Raman spectrum of the green outer corrosion layer (CP1) of the external side (cat3_H) compared to a brochantite standard spectrum. Settings: laser wavelength 532nm, acquisition time 100s, one accumulation, filter D2 (0.75-0.8 mW), hole 500, slit 80, grating 600. The peak indicated with an arrow on the cat3_H spectrum is due to fluorescence. Method of analysis: Raman spectroscopy, Lab Swiss National Museum, Affoltern a. Albis ZH,

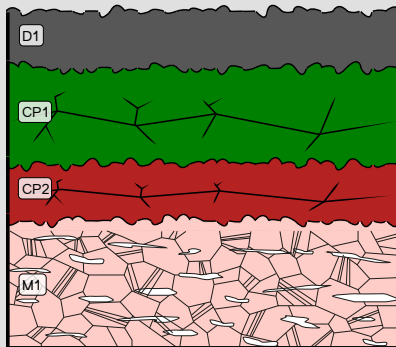
Fig. 10: Stratigraphic representation of the sample taken from the shingle in cross-section (dark field) using the MiCorr application. The characteristics of the strata are only accessible by clicking on the drawing that redirects you to the search tool by stratigraphy representation. This representation can be compared to Fig. 6, Credit HE-Arc CR.
