SHINGLE OF A ROOF – CU ALLOY – MODERN TIMES – SWITZERLAND

Artefact name	Shingle of a roof
Authors	Marianne. Senn (EMPA, Dübendorf, Zurich, Switzerland) & Christian. Degriigny (HE-Arc CR, Neuchâtel, Neuchâtel, Switzerland)
Url	/artefacts/892/

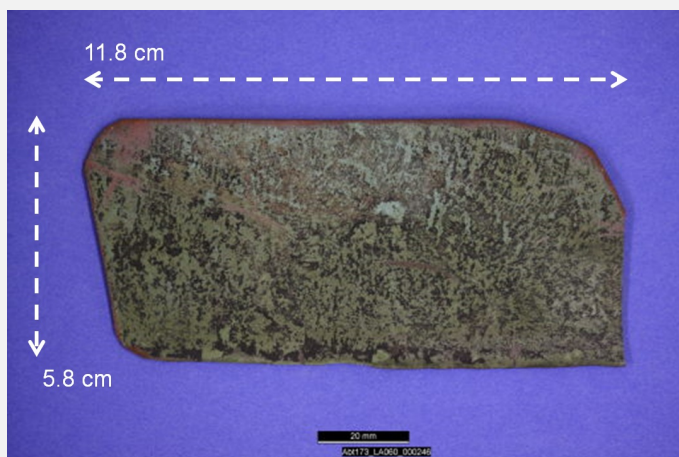
Fig. 1: Shingle of a roof, internal side,

Description of the artefact	Shingle, slightly curved, the internal side is covered with heterogeneously distributed green and black corrosion products (Fig. 1). The external side shows a regular dark green corrosion crust. Dimensions: L = 11.8cm; W = 5.8cm.
Type of artefact	Architectural element
Origin	Roof of the Abbey of St Gallen, Sankt Gallen, Saint Gallen, Switzerland
Recovering date	None
Chronology category	Modern Times
chronology tpq	1780 A.D. ▼
chronology taq	----- ▼
Chronology comment

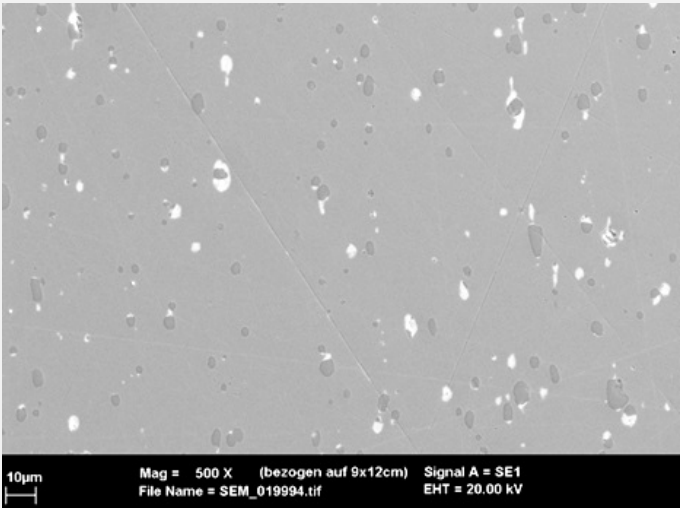
The remaining metal is a copper alloy (Table 1). The evenly distributed inclusions observed under SEM, SE-mode, are either light-grey or white (Fig. 4). The oval shape of the light-grey inclusions is due to deformation, probably by hot rolling (a common technique in the 18th century). Under polarised light they look red (Fig. 6) and their analysis reveals a composition similar to cuprite/Cu₂O (Table 2). The white inclusions are rich in Pb and are remnants of the refining process (Table 2). The etched copper shows a structure of polygonal and twinned grains (Fig. 5). The grain size is variable. The average hardness of the metal is about HV1 70.

Fig. 4: SEM image, SE-mode, of the metal sample from Fig. 3 (detail). Light-grey and white inclusions are distributed evenly,

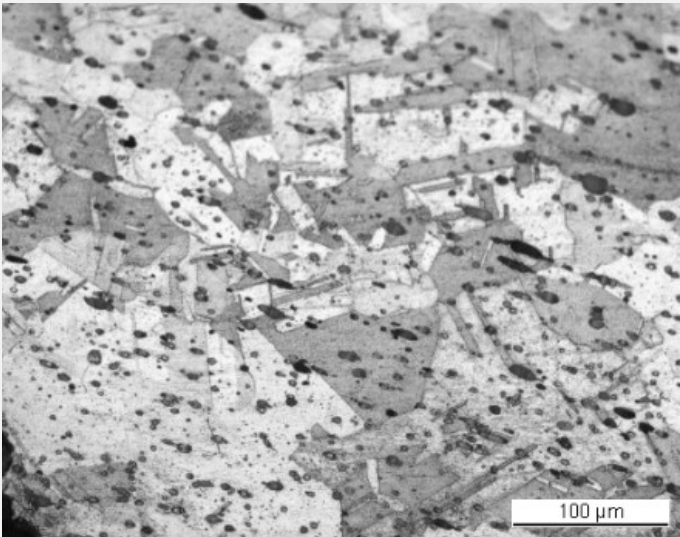
Fig. 5: Micrograph of the metal sample from Fig. 3 (detail), etched, bright field. The metal shows a structure of polygonal and twinned grains. Cuprite inclusions appear as dark spots,

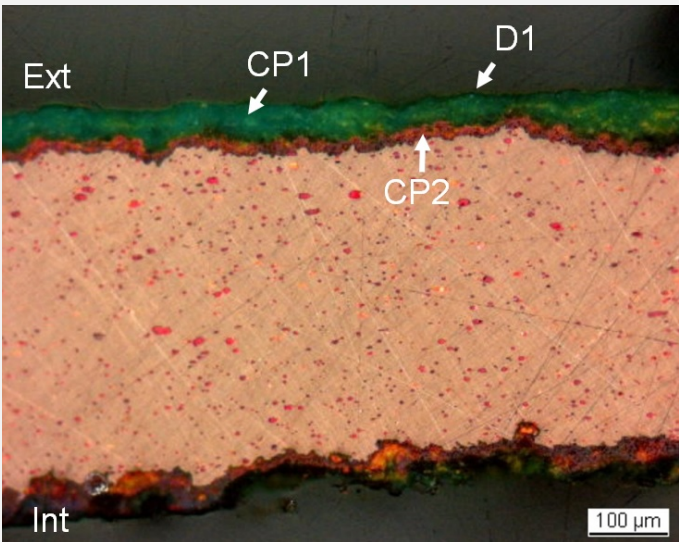
The corrosion crusts of the external and internal sides are distinctively different (Fig. 6). On the internal side an irregular reddish-orange corrosion layer has developed, and pitting corrosion has occurred. The more uniform corrosion layers on the external side consist of a reddish-orange layer, with a thicker green layer above. In some areas, dark-red corrosion products can be observed between the green and reddish-orange sub-layers. The same dark-red sub-layer can be seen in areas on the internal side covering the reddish-orange corrosion products. The reddish-orange corrosion layer on both sides (CP2) has a chemical composition similar to cuprite/Cu₂O, while the green layer on the external side (CP1) contains Cu, S and O and is enriched on its upper surface with Si (Table 3 and Fig. 7). XRD analysis of the corrosion products on the external side of another shingle fragment from the same roof identified brochantite/Cu₄SO₄(OH)₆ and cuprite as corrosion products (Rapport d'analyse no. MAH 98-257). These results are confirmed by Raman spectroscopy of the external side of this sample where the same compounds were clearly identified (Figs. 8 and 9).

Fig. 6: Micrograph of the metal sample from Fig. 3 and corresponding to the stratigraphy of Fig. 10, polarised light. External side: the regular corrosion crust with outer green, inner red-orange corrosion products and intermediate dark-red corrosion products. Internal side: the irregular corrosion crust with inner red-orange and outer dark-red corrosion products,

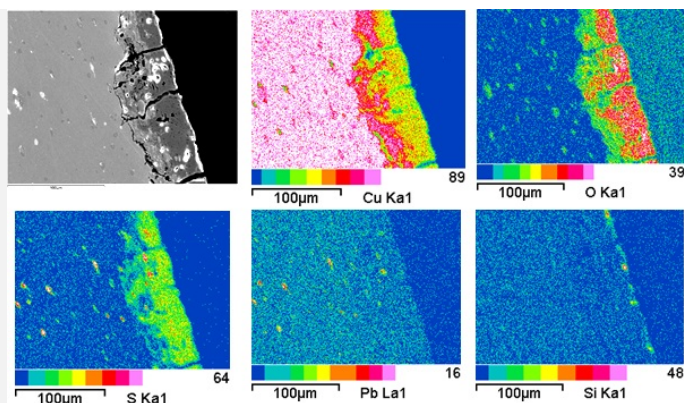
Fig. 7: SEM image, SE-mode, and elemental chemical distribution of a selected area on the external side (rotated image, detail of Fig. 3). Method of examination: SEM/EDS, Laboratory of Analytical Chemistry, Empa,

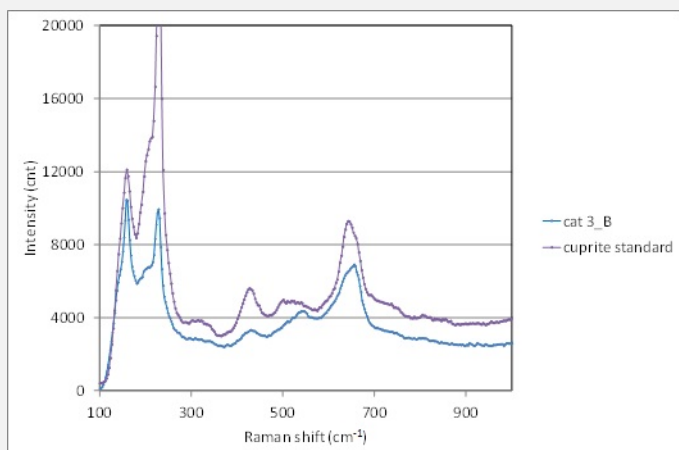
Fig. 8: Raman spectrum of the red-orange inner corrosion layer (CP2) of the external side (cat3_B) compared to a cuprite standard spectrum. Settings: laser wavelength 532nm, acquisition time 100s, one accumulation, filter D2 (0.75-0.8 mW), hole 500, slit 80, grating 600. Method of analysis: Raman spectroscopy, Lab Swiss National Museum, Affoltern a. Albis ZH,

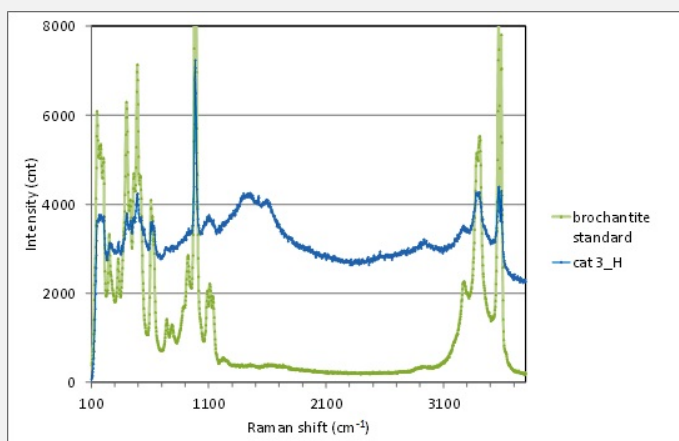
Fig. 9: Raman spectrum of the green outer corrosion layer (CP1) of the external side (cat3_H) compared to a brochantite standard spectrum. Settings: laser wavelength 532nm, acquisition time 100s, one accumulation, filter D2 (0.75-0.8 mW), hole 500, slit 80, grating 600. The peak indicated with an arrow on the cat3_H spectrum is due to fluorescence. Method of analysis: Raman spectroscopy, Lab Swiss National Museum, Affoltern a. Albis ZH,

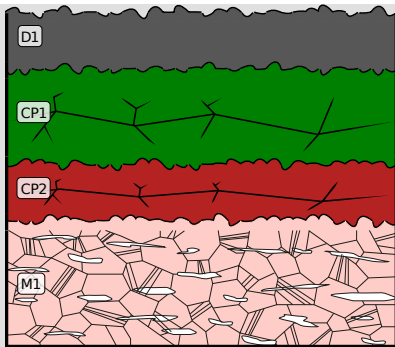
Fig. 10: Stratigraphic representation of the sample taken from the shingle in cross-section (dark field) using the MiCorr

application. The characteristics of the strata are only accessible by clicking on the drawing that redirects you to the search tool by stratigraphy representation. This representation can be compared to Fig. 6, Credit HE-Arc CR.
