SHINGLE OF A ROOF – CU ALLOY – MODERN TIMES – SWITZERLAND

Artefact name	Shingle of a roof
Authors	Marianne. Senn (EMPA, Dübendorf, Zurich, Switzerland) & Christian. Degriigny (HE-Arc CR, Neuchâtel, Neuchâtel, Switzerland)
Url	/artefacts/892/

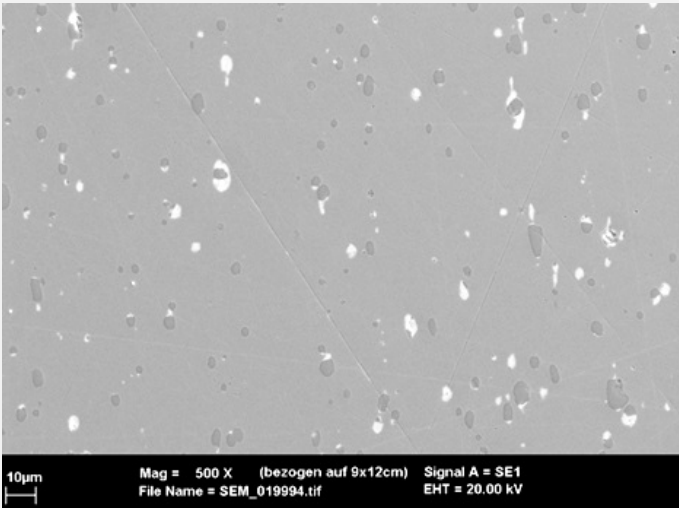
The remaining metal is a copper alloy (Table 1). The evenly distributed inclusions observed under SEM, SE-mode, are either light-grey or white (Fig. 4). The oval shape of the light-grey inclusions is due to deformation, probably by hot rolling (a common technique in the 18th century). Under polarised light they look red (Fig. 6) and their analysis reveals a composition similar to cuprite/Cu₂O (Table 2). The white inclusions are rich in Pb and are remnants of the refining process (Table 2). The etched copper shows a structure of polygonal and twinned grains (Fig. 5). The grain size is variable. The average hardness of the metal is about HV1 70.

Fig. 4: SEM image, SE-mode, of the metal sample from Fig. 3 (detail). Light-grey and white inclusions are distributed evenly,

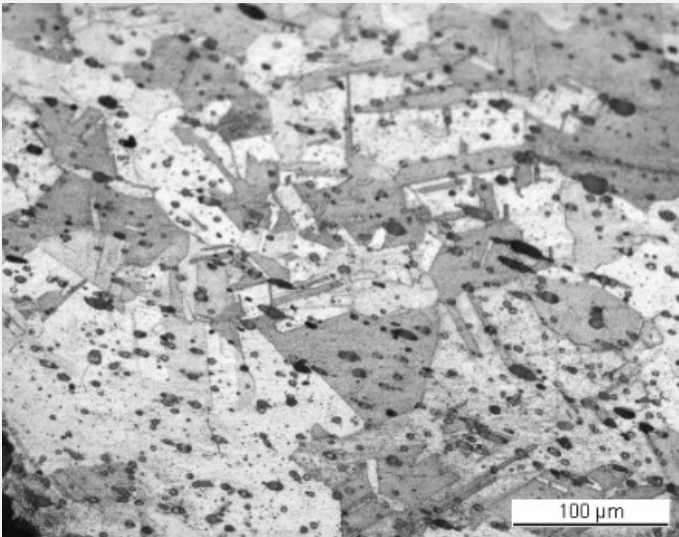
Fig. 5: Micrograph of the metal sample from Fig. 3 (detail), etched, bright field. The metal shows a structure of polygonal and twinned grains. Cuprite inclusions appear as dark spots,

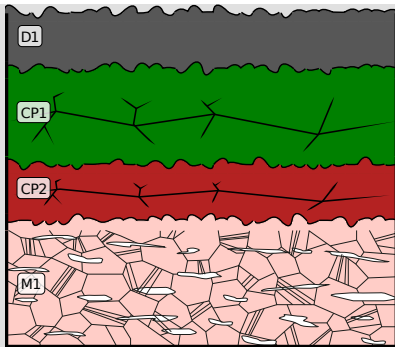
Fig. 10: Stratigraphic representation of the sample taken from the shingle in cross-section (dark field) using the MiCorr

application. The characteristics of the strata are only accessible by clicking on the drawing that redirects you to the search tool by stratigraphy representation. This representation can be compared to Fig. 6, Credit HE-Arc CR.
