# CORRODED METAL SHEET FN 655.13.01 – FE ALLOY – MODERN TIMES – SWITZERLAND

**Artefact name** Corroded metal sheet FN 655.13.01

**Authors** Marianne. Senn (Empa, Dübendorf, Zurich, Switzerland) & Christian. Degrigny (HE-Arc CR, Neuchâtel, Neuchâtel, Switzerland)

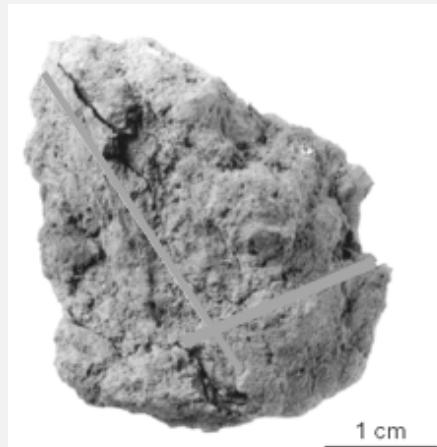
Fig. 1: Metal sheet (after Senn Bischofberger 2005, 137),

**Description of the artefact** Metal (iron-based) sheet with middle rib. The shape is no longer discernible (Fig. 1). The metal is covered by a thick corrosion crust. Dimensions: L = 4.5cm; WT = 35g.

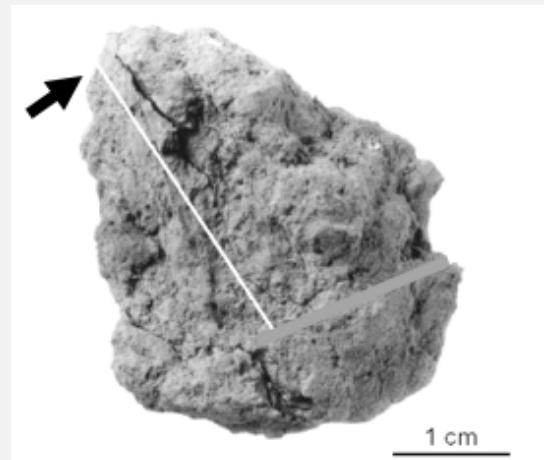
Fig. 2: Location of sampling area,

A longitudinal cut has been made through the sheet (Fig. 2). Large parts of the corrosion crust fell off during sampling (Fig. 3).

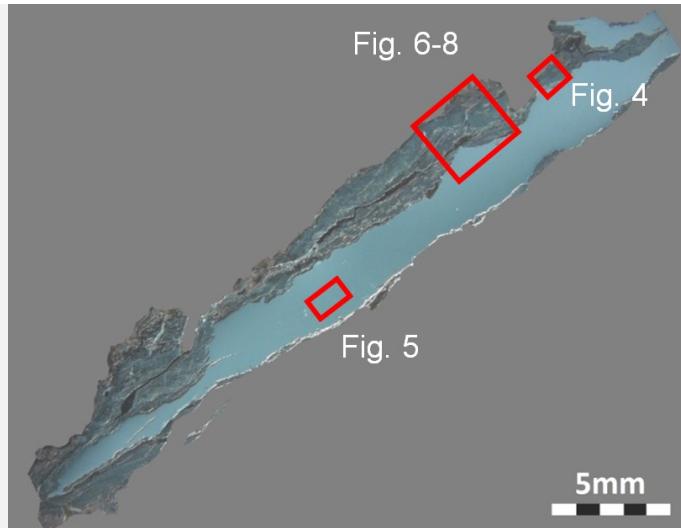
Fig. 3: Micrograph of the cross-section of the metal sheet showing the location of Figs. 4 to 8,

The corrosion is massive and large parts of the outer corrosion layers have been lost during the sample preparation. The heavily cracked corrosion crust represents about one third of the thickness of the sample (Fig. 3) and is located on one side of the metal (the rest having been lost during the cutting process). It does not show well defined layers. Despite this, three areas can be distinguished (Figs. 6 and 7). Adhering to the metal (area 1), we find an orange-red-brown layer enriched in Cl (CP3 in Fig. 9, Fig. 8 and Table 3). The dark or violet middle area 2 is richer in Fe (CP2 in Fig. 9). The outer area 3 is red-brown (CP1 in Fig. 9) and strongly contaminated by soil material (rock fragment inclusion and elements like Si, Al, P etc.). This layer is enriched in O (Fig. 9).

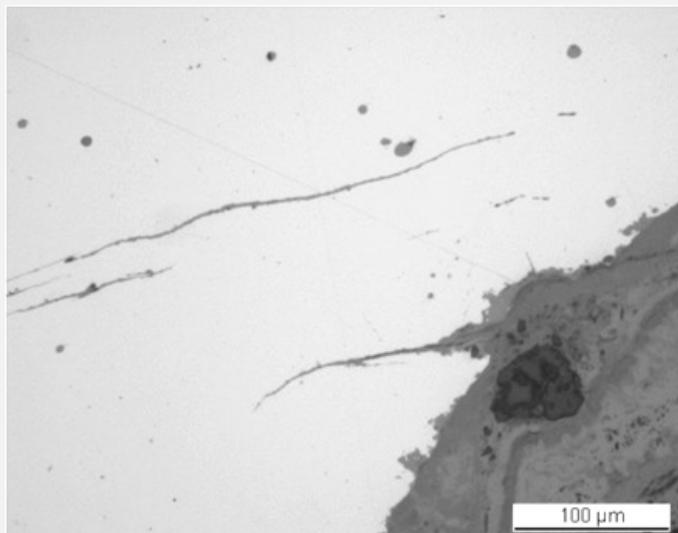
The remaining metal is an iron containing elevated (more than 1g/kg) concentrations of Co and Ni (Table 1), small round slag inclusions and cracks resulting from corrosion and deformation (Fig. 4). The composition of the round, elongated slag inclusions is similar to wüstite-FeO (Table 2). Iron reduced in the direct smelting process never contains such pure compounds and only FeO inclusions. In modern steels FeO occurs in low carbon alloys and Armco-iron (Schumann 1991, 474). After etching, the cross-section shows a heavily deformed ferritic microstructure from cold working (Fig. 6). The cracks have the same orientation as the deformation. The average hardness of the metal is HV1 195.

Fig. 4: Micrograph of metal sample from Fig. 3 (inverted picture, detail), unetched, bright field. In white the metal with round slag inclusions as well as cracks filled with corrosion products,

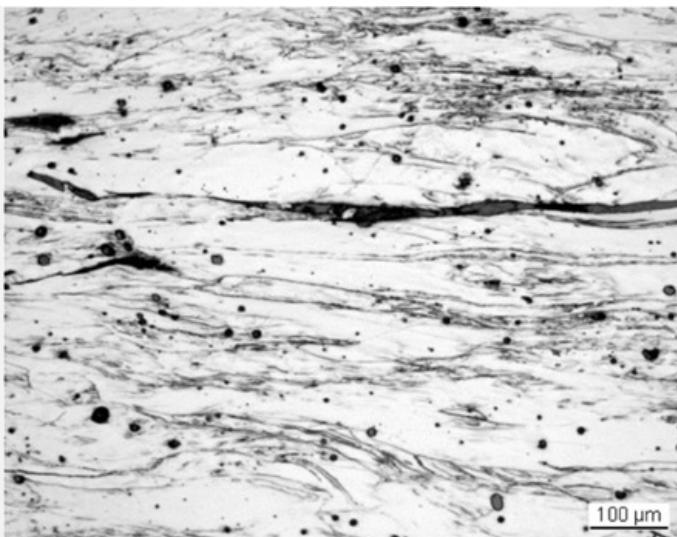
Fig. 5: Micrograph of metal sample from Fig. 3 (detail), etched, bright field. The heavily cold worked metal shows elongated grains with nearly invisible grain boundaries and cracks parallel to the grains,

**Microstructure** Heavily deformed ferritic microstructure

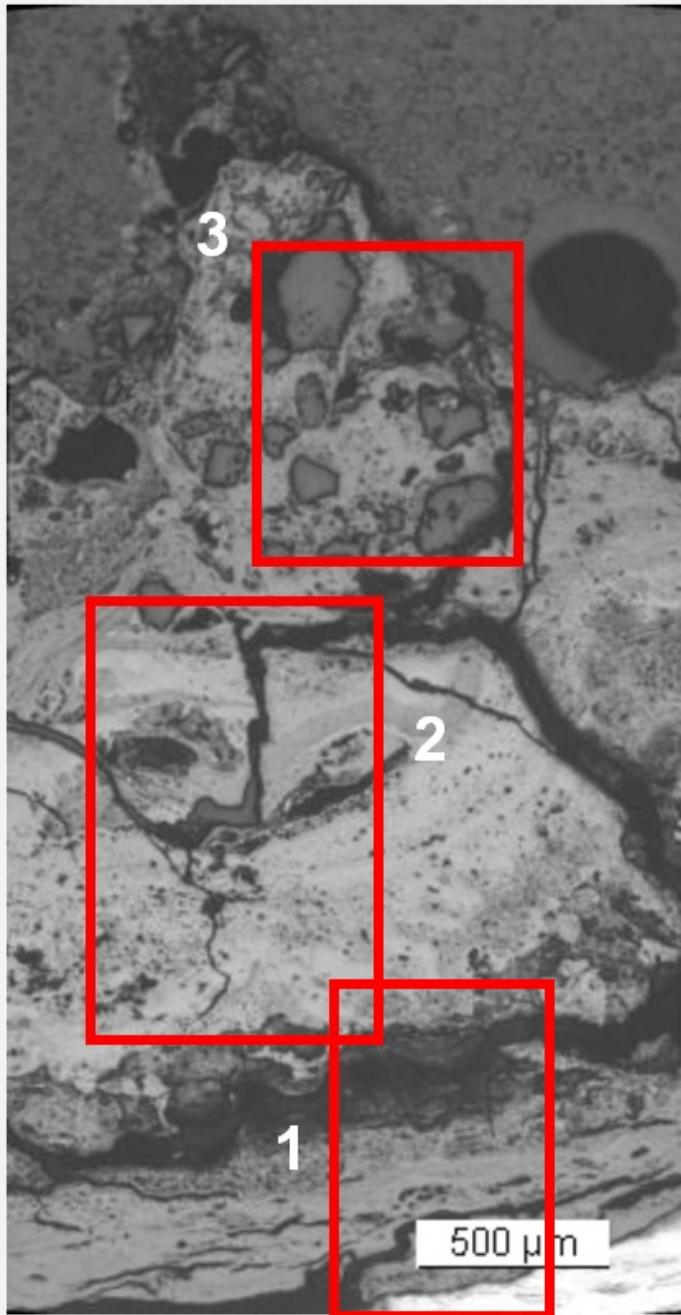
Fig. 6: Micrograph of the corrosion layer from Fig. 3 showing the metal - corrosion crust interface (detail, rotated by 45°) and corresponding to the stratigraphy of Fig. 9, unetched, bright field. The areas 1 (for CP3), 2 (for CP2) and 3 (for CP3) selected for elemental chemical distribution (Fig. 8) are marked by red rectangles,

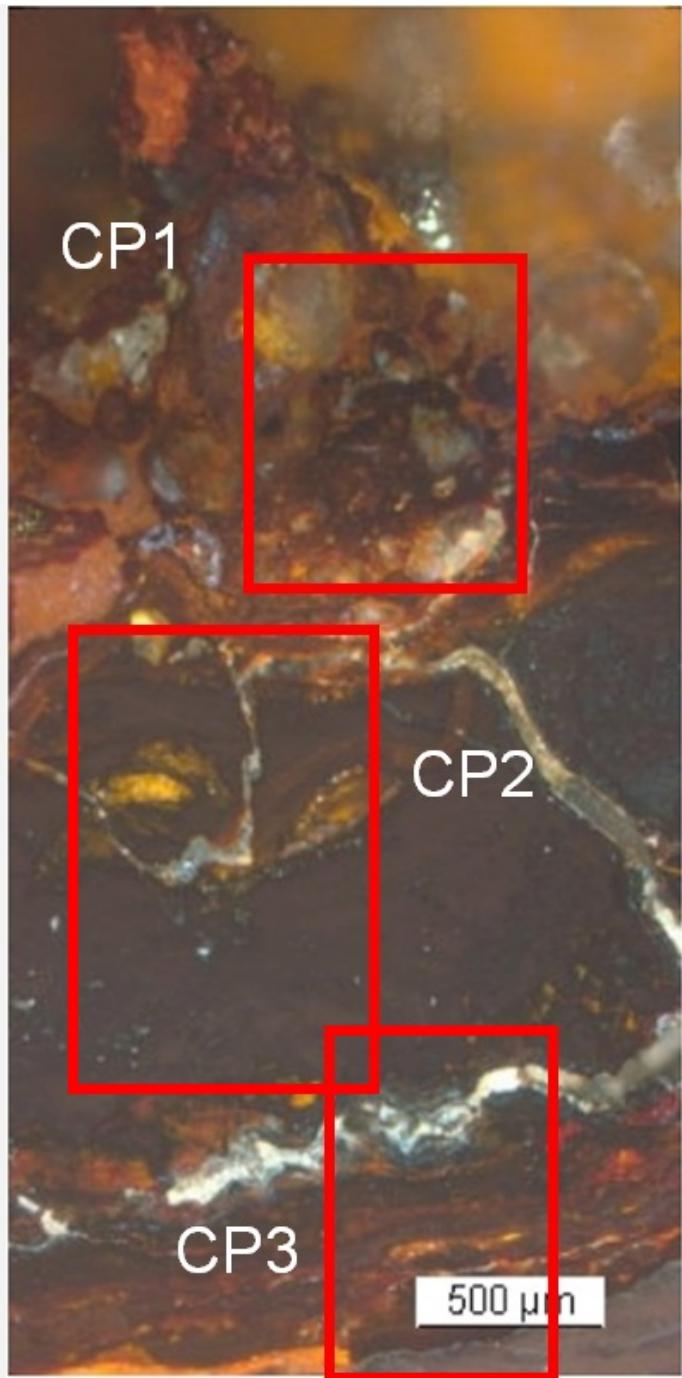
Fig. 7: Micrograph (same as Fig.6) and corresponding to the stratigraphy of Fig. 9, polarised light. The inner layer (CP3) is red-brown, area 2 is brown-violet (CP2) and the outer brown area contains rock fragment inclusions (CP1),

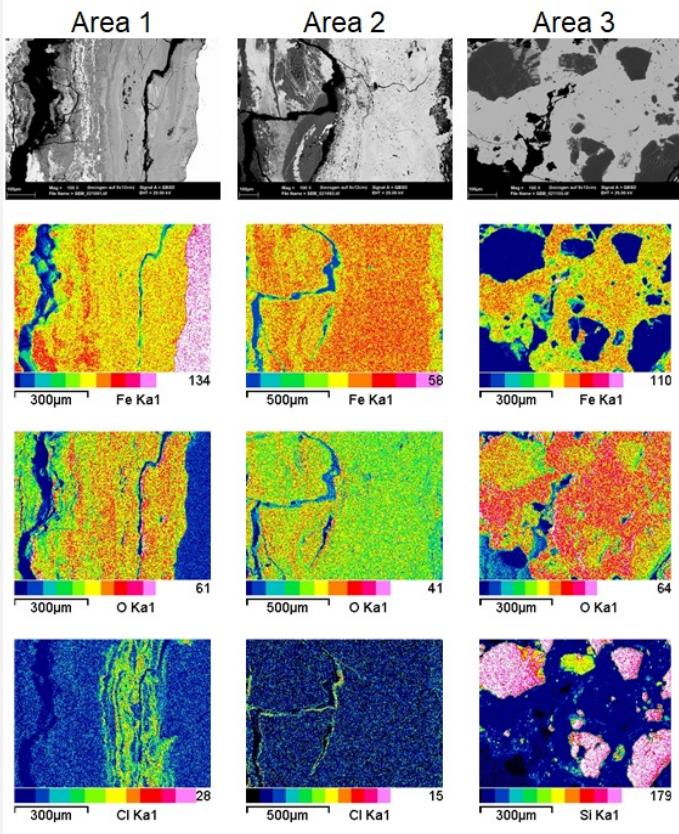
Fig. 8: SEM images, BSE-mode, and elemental chemical distribution of the selected areas from Figs. 6 and 7 (reversed picture rotated by 270°, details). First column: mapping on area 1 (CP3) where an inner layer enriched in Cl appears near the metal surface. 2nd column: area 2 (CP2) where iron oxides prevail. 3rd column: area 3 (CP1) where the outer O-rich layer includes rock fragments rich in Si. Method of examination: SEM/EDS, Lab. Anal. Chem. Empa,

This iron-based sheet is entirely cold worked and hard compared to an annealed metal. The corrosion is massive and masks the shape of the object. The presence of Cl adjacent to the metal surface indicates that the corrosion front is potentially active. The very thick top corrosion layers may have slowed down the corrosion. The object was mentioned as being Roman in Senn Bischofberger 2005, however the chemical composition of the slag inclusions shows that it is a product of the 20<sup>th</sup> century AD which has been accidentally introduced into a Roman layer.

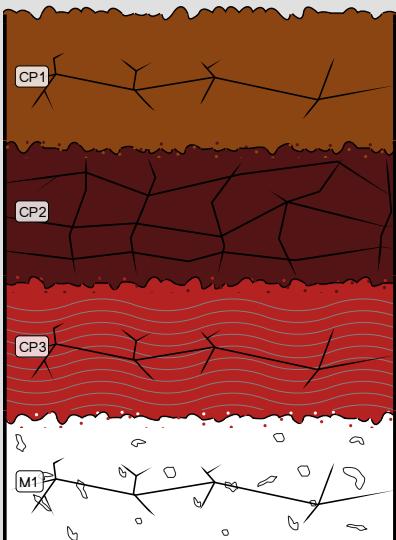
Fig. 9: Stratigraphic representation of the iron-based sheet in cross-section (dark field) using the MiCorr application. The characteristics of the strata are only accessible by clicking on the drawing that redirects you to the search tool by stratigraphy representation. This representation can be compared to Figs. 7, Credit HE-Arc CR.
