# CORRODED METAL SHEET FN 655.13.01 – FE ALLOY – MODERN TIMES – SWITZERLAND

Artefact name	Corroded metal sheet FN 655.13.01
Authors	Marianne. Senn (Empa, Dübendorf, Zurich, Switzerland) & Christian. Degriigny (HE-Arc CR, Neuchâtel, Neuchâtel, Switzerland)
Url	/artefacts/894/

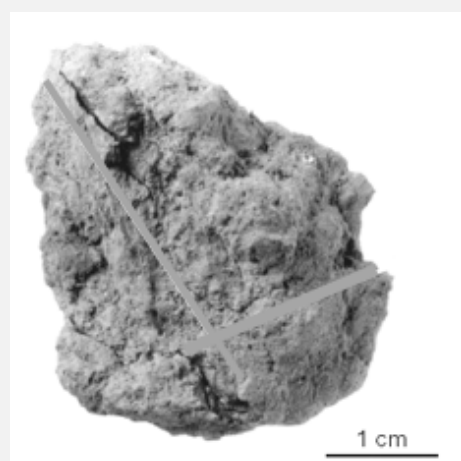
Fig. 1: Metal sheet (after Senn Bischofberger 2005, 137),

Description of the artefact	Metal (iron-based) sheet with middle rib. The shape is no longer discernible (Fig. 1). The metal is covered by a thick corrosion crust. Dimensions: L = 4.5cm; WT = 35g.
Type of artefact	Metal sheet
Origin	Steinmöri, Neftenbach / Dorf Neftenbach, Zurich, Switzerland
Recovering date	Excavation of the Roman villa, 1986-1990, phase S2, StbII.2 (2nd/3rd century AD)
Chronology category	Modern Times
chronology tpq	1900 A.D. ▼
chronology taq	2000 A.D. ▼
Chronology comment	Product of the 20th century AD introduced accidentally into a Roman layer

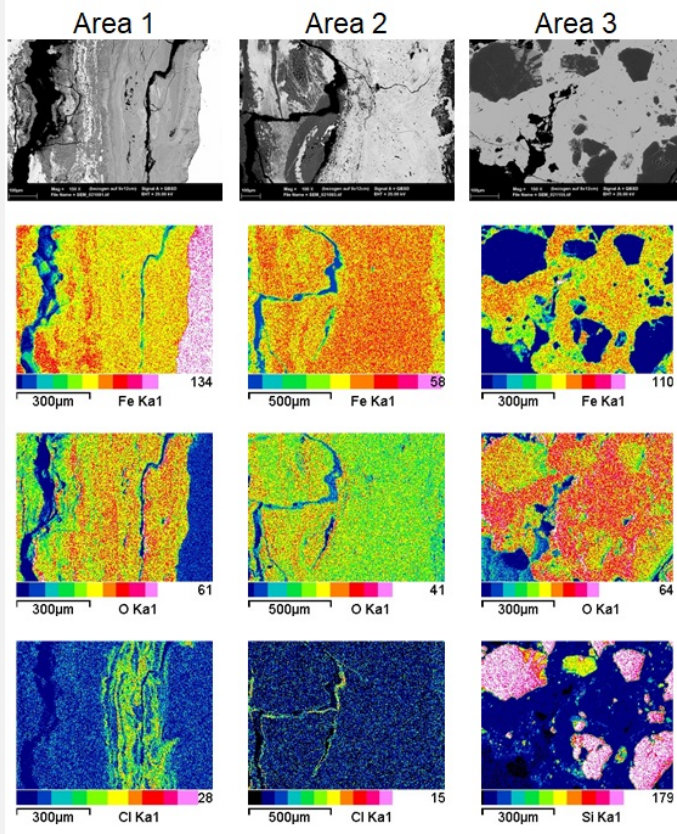
Fig. 8: SEM images, BSE-mode, and elemental chemical distribution of the selected areas from Figs. 6 and 7 (reversed picture rotated by 270°, details). First column: mapping on area 1 (CP3) where an inner layer enriched in Cl appears near the metal surface. 2nd column: area 2 (CP2) where iron oxides prevail. 3rd column: area 3 (CP1) where the outer O-rich layer includes rock fragments rich in Si. Method of examination: SEM/EDS, Lab. Anal. Chem. Empa,

This iron-based sheet is entirely cold worked and hard compared to an annealed metal. The corrosion is massive and masks the shape of the object. The presence of Cl adjacent to the metal surface indicates that the corrosion front is potentially active. The very thick top corrosion layers may have slowed down the corrosion. The object was mentioned as being Roman in Senn Bischofberger 2005, however the chemical composition of the slag inclusions shows that it is a product of the 20<sup>th</sup> century AD which has been accidentally introduced into a Roman layer.

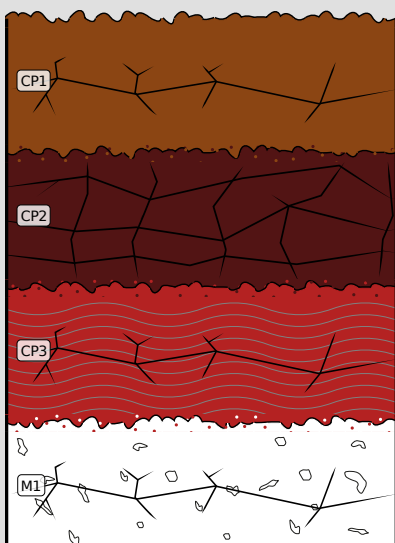
Fig. 9: Stratigraphic representation of the iron-based sheet in cross-section (dark field) using the MiCorr application. The characteristics of the strata are only accessible by clicking on the drawing that redirects you to the search tool by stratigraphy representation. This representation can be compared to Figs. 7, Credit HE-Arc CR.
