CORRODED METAL SHEET FN 655.13.01 – FE ALLOY – MODERN TIMES – SWITZERLAND

Artefact name	Corroded metal sheet FN 655.13.01
Authors	Marianne. Senn (Empa, Dübendorf, Zurich, Switzerland) & Christian. Degriigny (HE-Arc CR, Neuchâtel, Neuchâtel, Switzerland)
Url	/artefacts/894/

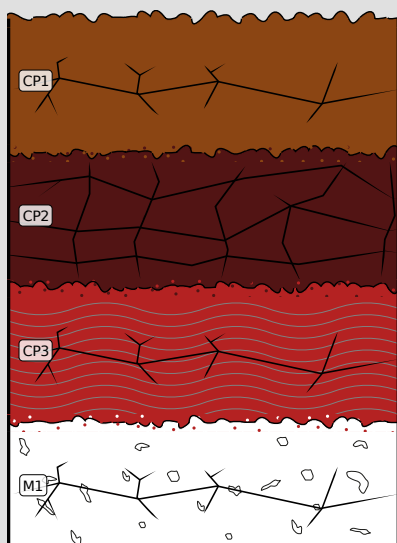
Fig. 9: Stratigraphic representation of the iron-based sheet in cross-section (dark field) using the MiCorr application. The characteristics of the strata are only accessible by clicking on the drawing that redirects you to the search tool by stratigraphy representation. This representation can be compared to Figs. 7, Credit HE-Arc CR.

This iron-based sheet is entirely cold worked and hard compared to an annealed metal. The corrosion is massive and masks the shape of the object. The presence of Cl adjacent to the metal surface indicates that the corrosion front is potentially active. The very thick top corrosion layers may have slowed down the corrosion. The object was mentioned as being Roman in Senn Bischofberger 2005, however the chemical composition of the slag inclusions shows that it is a product of the 20th century AD which has been accidentally introduced into a Roman layer.
