CHISEL POINT DEV 995 1069 PR – EUTECTOID TO HYPEREUTECTOID STEEL – EARLY MEDIEVAL TIMES – SWITZERLAND

Artefact name	Chisel point DEV 995 1069 PR
Authors	Marianne. Senn (Empa, Dübendorf, Zurich, Switzerland) & Christian. Degriigny (HE-Arc CR, Neuchâtel, Neuchâtel, Switzerland)
Url	/artefacts/900/

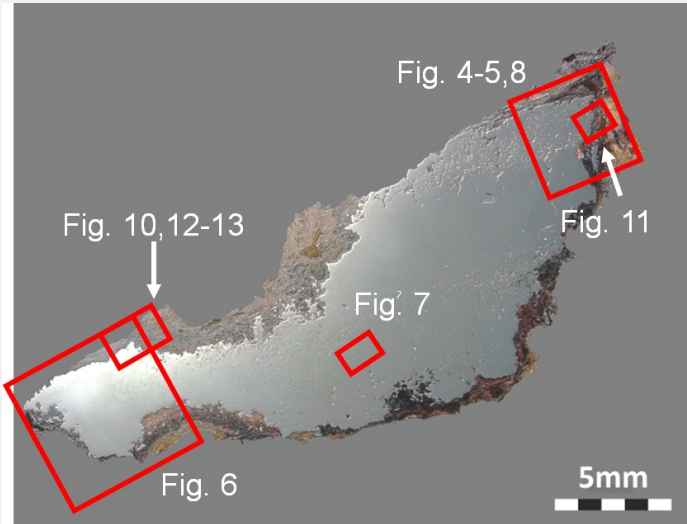
Fig. 3: Micrograph of the cross-section of the chisel point showing the location of Figs. 4 to 8 and 10 to 13,

Description of sample	A longitudinal cut from a chisel point (Figs. 2 and 3) after restoration. Dimensions: L = 30mm; W = 11mm (approximately).
Alloy	Eutectoid to hypereutectoid steel
Technology	Quench hardened
Lab number of sample	DEV1069
Sample location	HE-Arc CR, Neuchâtel, Neuchâtel
Responsible institution	Office de la Culture, Porrentruy, Jura
Date and aim of sampling	2000, metallography and chemical composition of the metal

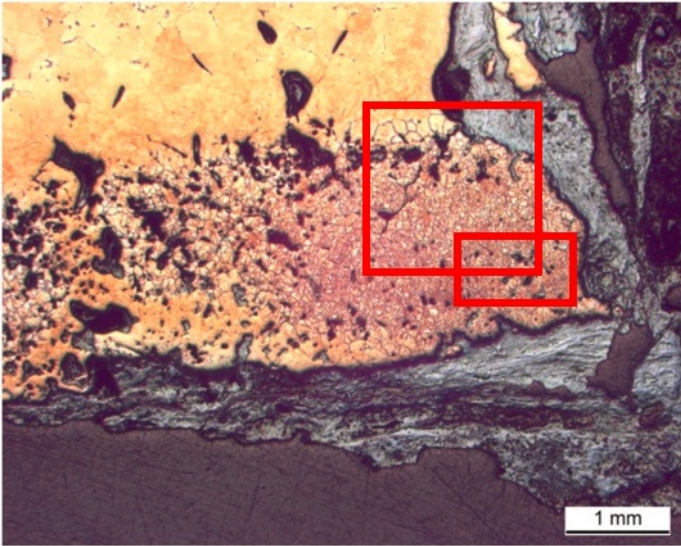
The remaining metal is a eutectoid to hypereutectoid steel (C 0.8-1 mass%) with cracks and porosity (Figs. 4 and 5). Its composition is given in Table 1 (except Fe). Of the trace elements, only Ni reaches a medium concentration (Ni 0.07 mass%). The composition and the high Ni/Co ratio are atypical for iron worked in smithies of the settlement at Develier-Courtételle JU, CH. The few slag inclusions and their chemical composition confirm this (Table 2). The slag is rich in CaO whereas the pisolithic or bean ore worked in the Central Jura smelting district is rich in Al₂O₃. The slag inclusions cannot be smithing slag because the artefact is formed from one piece of metal. The slag probably incorporated while refining the bloom or during the bloom smelting process. The ore from which this metal was smelted cannot yet be identified. Intergranular corrosion has developed, penetrating into the metal structure (Fig. 5). The etched metal shows a dominant martensitic structure, typical of quench hardened steel (Figs. 4, 6, 7 and 8). The characteristic forms of the martensite are non-organised needles (Fig. 7). In restricted areas bainite nodules occur (Figs. 6 and 7). In the centre of the point, hypereutectoid steel is composed of cementite in the grain boundaries and in needle like shapes within the grains (Fig. 9). Hypereutectoid regions also occur in the centre of the shaft and on its left surface (Fig. 4). Here the hypereutectoid steel is composed of martensite and cementite in the grain boundaries and in needle form within the grains (Figs. 5 and 8). Nevertheless, most of the chisel is dominated by eutectoid steel. The average hardness of the quench hardened eutectoid steel is about HV1 690. In the bainite nodules the average hardness drops to about HV1 350, the martensite has an average hardness of HV1 750.

Fig. 4: Micrograph of the metal sample from Fig. 3 (inverted picture, detail), etched, bright field. The metal contains porosity and cracks (in black). The micrographs of Figs. 5 and 8 are marked by the top and bottom rectangles respectively,

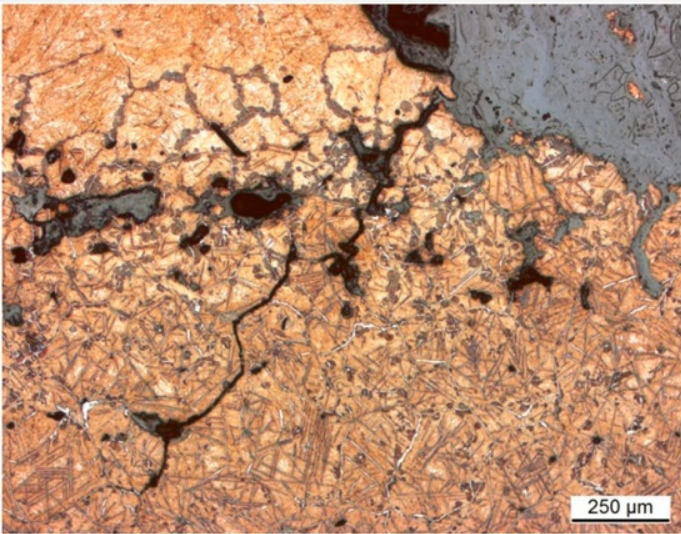
Fig. 5: Micrograph of the metal sample, detail from Fig. 4, etched, bright field. We observe martensite (in orange), cementite (in grey), porosity and intergranular cracks (in black) and corrosion,

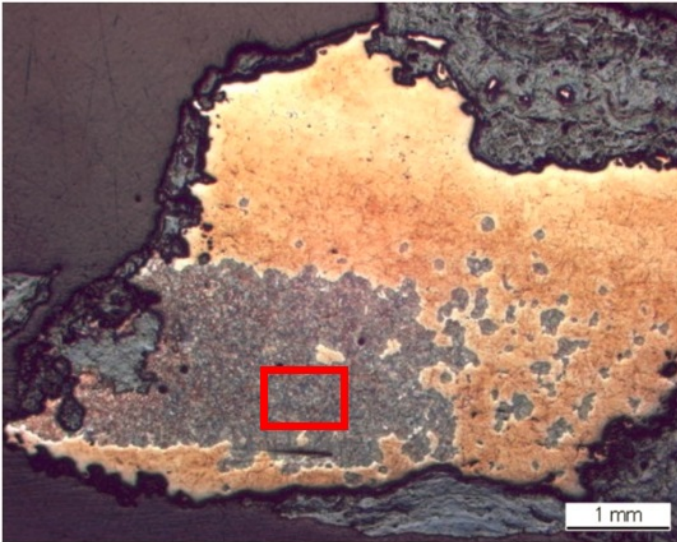
Fig. 6: Micrograph of the metal sample from Fig. 3 (inverted picture, detail), etched, bright field. We observe the metal with martensite (orange) and bainite nodules (blue). The micrograph of Fig. 9 is marked by a rectangle,

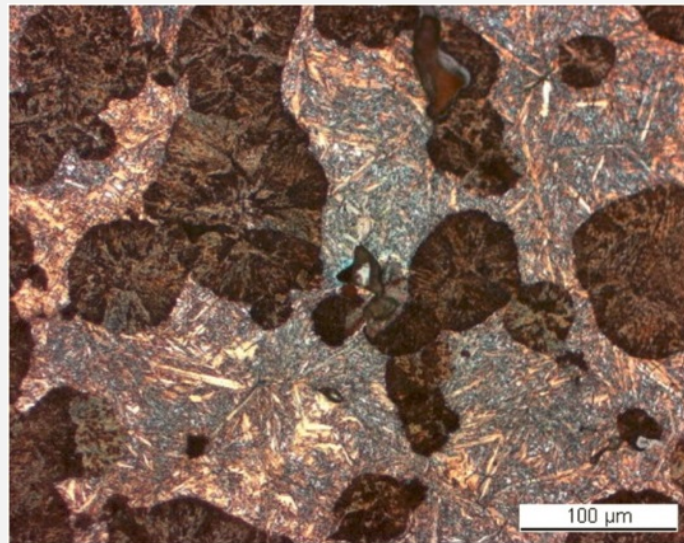
Fig. 7: Micrograph of the metal sample from Fig. 3 (detail), etched, bright field. We observe dark bainite nodules combined with martensite needles,

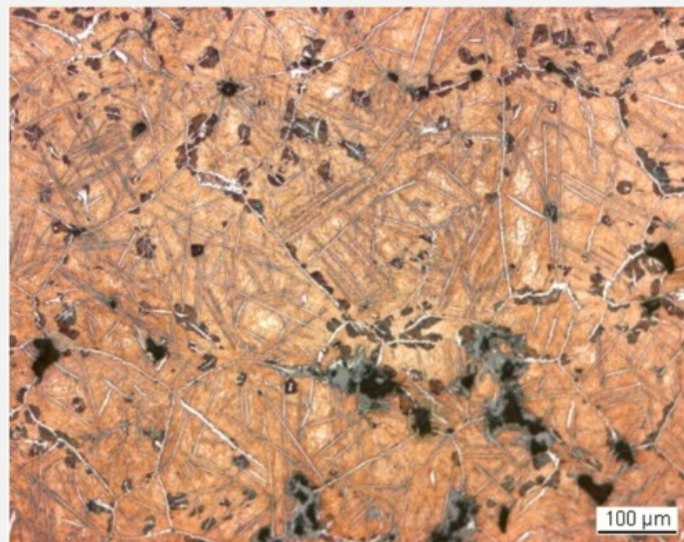
Fig. 8: Micrograph of the metal sample, detail from Fig. 4, etched, bright field. Hypereutectoid steel with a structure of cementite in white in the grain boundaries and in needle form combined with martensite (pink). Some bainite occurs around the grain boundaries,

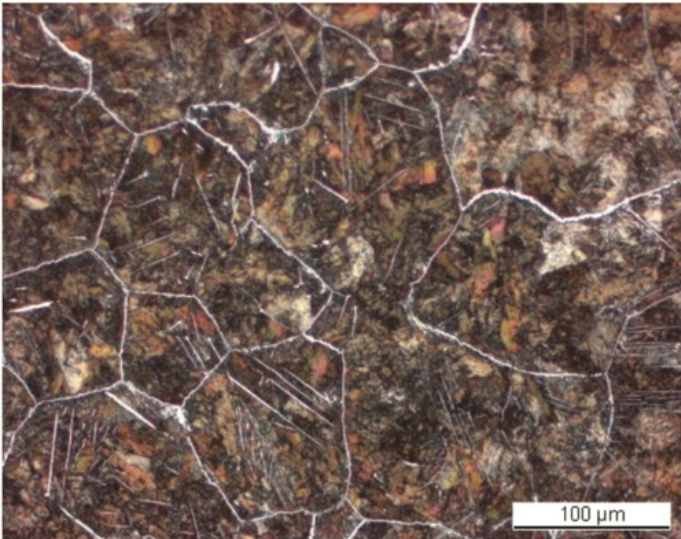
Fig. 9: Micrograph of the metal sample, detail from Fig. 6, etched, bright field. Hypereutectoid steel with a structure of cementite in white in the grain boundaries and in needle form combined with bainite (dark),

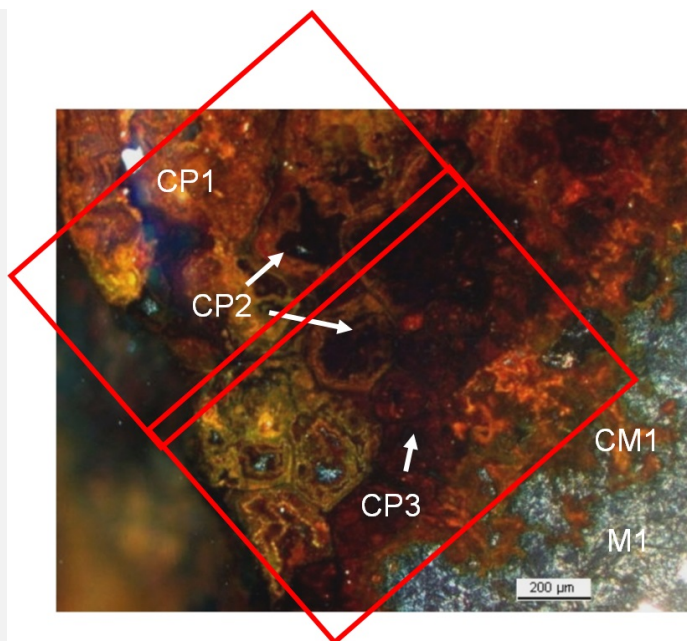
The metal is heavily corroded and the thickness of the corrosion crust is irregular, but averages about 0.5mm. The corrosion products enclose different ghost structures: the corrosion crust has preserved the shape of polygonal grains (Figs. 10 and 12) and cementite needles (Fig. 11). Under polarised light, the corrosion products at the metal - corrosion crust interface are dark-red and form an inner S-rich layer (CP3, Figs. 10 and 12). Cl occurs locally (CP3) and C is present in layers CP2 and CP3 (Fig. 12). The outer layer of the corrosion products (CP1) is orange and contains more O than the inner layer CP3 (Figs. 10 and 13).

Fig. 10: Micrograph showing the metal - corrosion crust interface from Fig. 3 (rotated by 270°, detail) and corresponding to the stratigraphy of Fig. 14, unetched, polarised light. Polygonal grains are visible as ghost structure in the corrosion crust. The selected areas for elemental chemical distribution (Figs. 12 and 13) are marked by two rectangles (bottom: Fig. 12 and top: Fig. 13),

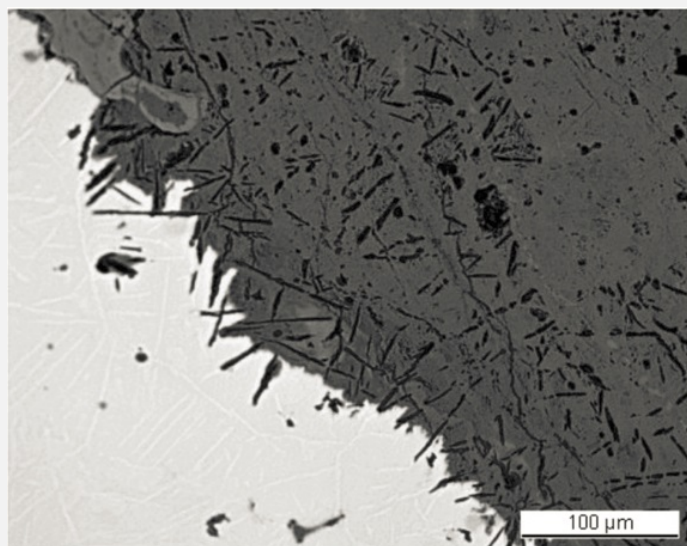
Fig. 11: Micrograph showing the metal - corrosion crust interface from Fig. 3 (detail), unetched, bright field. The cementite is visible as white needles in the metal and its ghost structure as black needles in the corrosion crust,

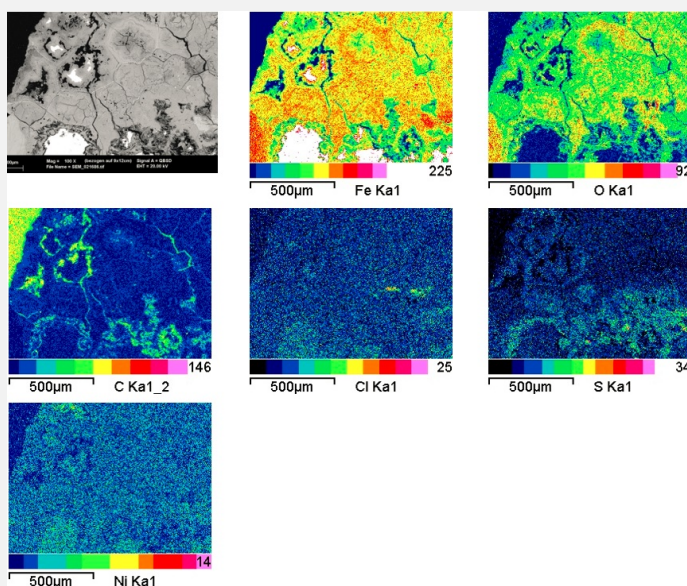
Fig. 12: SEM image, BSE-mode, and elemental chemical distribution of the selected area from Fig. 10 (rotated by 45°). Method of examination: SEM/EDS, Laboratory of Analytical Chemistry, Empa,

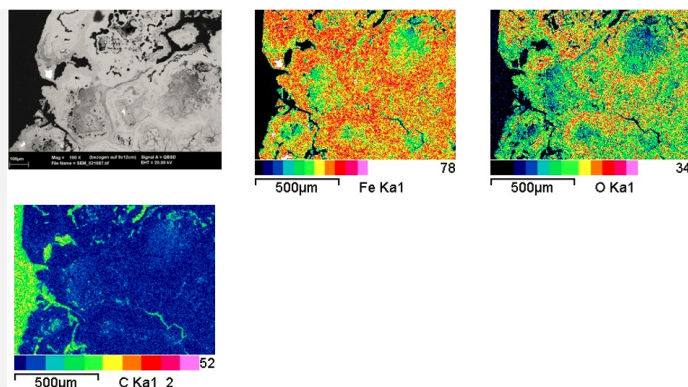
Fig. 13: SEM image, BSE-mode, and elemental chemical distribution of the selected area from Fig. 10 (rotated by 45°). Method of examination: SEM/EDS, Laboratory of Analytical Chemistry, Empa,

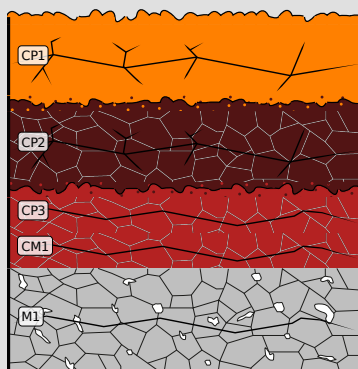
Fig. 14: Stratigraphic representation of the chisel point in cross-section (dark field) using the MiCorr application. The characteristics of the strata are only accessible by clicking on the drawing that redirects you to the search tool by stratigraphy representation. This representation can be compared to Fig. 10, Credit HE-Arc CR.
