SITULA EMT09-554.665 - TIN BRONZE - IRON AGE - SWITZERLAND

Artefact name	Situla EMT09-554.665
Authors	Christian. Degriigny (HE-Arc CR, Neuchâtel, Neuchâtel, Switzerland) & Marie-Jeanne. Scholl (HE-Arc CR, Neuchâtel, Neuchâtel, Switzerland) & Valentin. Boissonnas (HE-Arc CR, Neuchâtel, Neuchâtel, Switzerland)
Url	/artefacts/902/

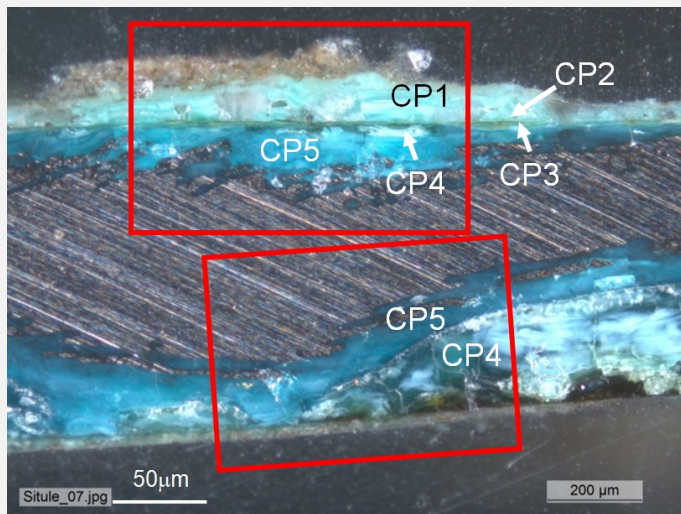
The corrosion crust is heterogeneous and has in places completely replaced the metal. The metal – corrosion products interface is irregular due to transgranular corrosion (Figs 5-6). In most cases, the corrosion crust can be divided in three main layers: first, an inner compact blue layer directly on the metal core (CP5, Figs. 8, 10 and 15 and CP3, Fig. 14). In areas of extensive corrosion this blue layer coexists with a friable light blue-green layer (CP4, Figs. 8, 10 and 15 and CP2, Fig. 14). Secondly, and depending on the area, either a very fine dark green (CP3, Figs. 8 and 15) or red corrosion layer (CP2, Figs. 10 and 15) marks the limit of the original surface. Finally, there is a fourth outer layer, consisting of friable and sometimes curly pale green corrosion products, interspersed with soil products (CP1, Figs. 8, 10 and 15). In heavily worked and fragile parts of the object a cleavage between the inner layers of blue and light blue-green corrosion is present, rendering the light blue-green corrosion vulnerable to loss (Fig. 9).

Fig. 8: Micrograph of the metal sample from Fig. 4, unetched, dark field, 50x. Areas of Fig. 9 (bottom, corresponding to the stratigraphy of Fig. 14) and Figs. 10 and 11 (top, corresponding to the stratigraphy of Fig. 15) are marked by a rectangle. Codes are those of Fig. 15,

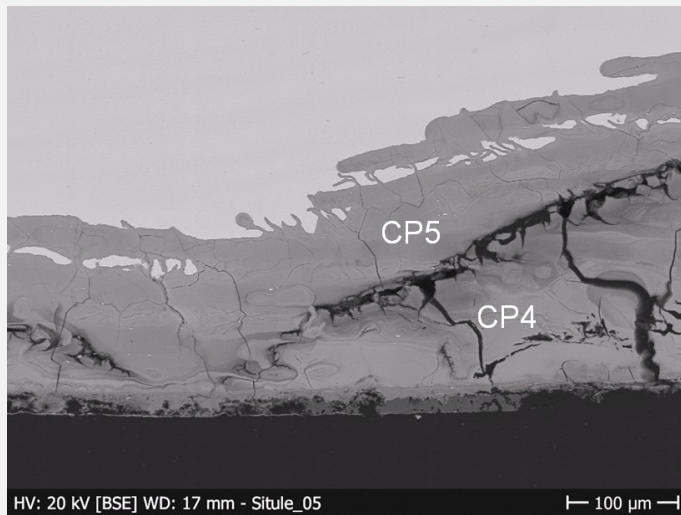
Fig. 9: SEM image, BSE-mode of the metal sample from Fig. 8 (detail) showing cleavage between the inner blue (CP5) and green (CP4) layers of Fig. 15,

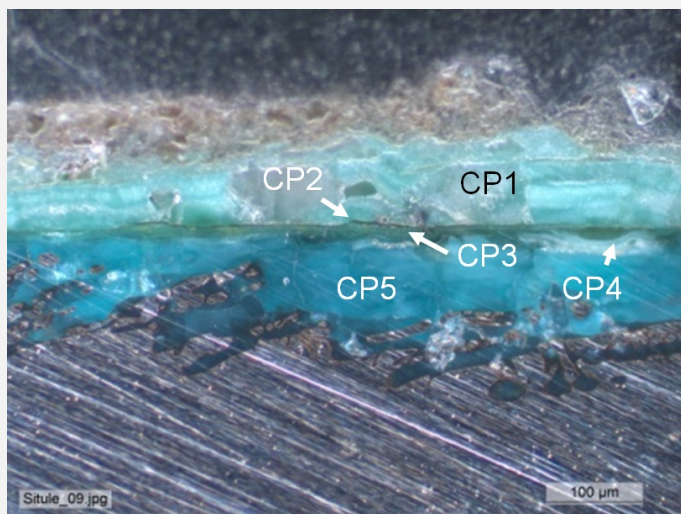
The limit of the original surface is well defined (interface of CP1 and CP2) but due to the fragility of the inner corrosion layers it was difficult to uncover.

Fig. 10: Micrograph of the metal / corrosion interface (detail of Fig. 8) unetched, dark field, 100x. The outer layer (CP1 of Fig. 15) incorporates soil material and the thin dark layer (CP2 of Fig. 15) highlights the limit of the original surface,

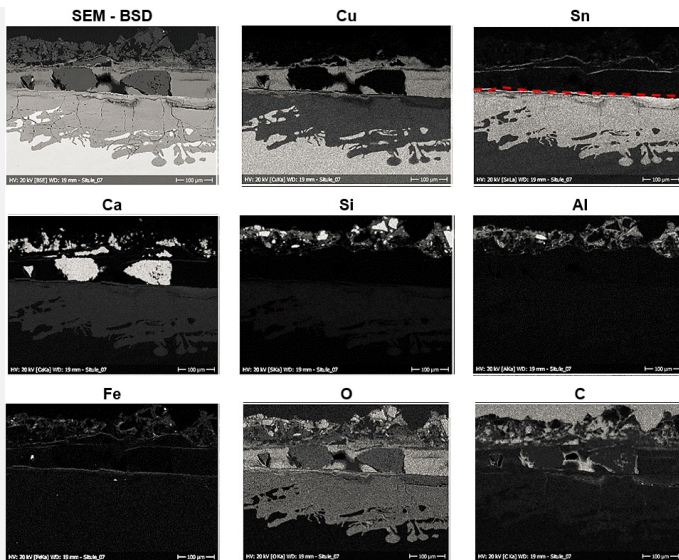
The inner layers (CP3-CP5) are Sn and O-rich and depleted in Cu (Table 2). The outer layers (CP1 and CP2) are Cu and O-rich, contain no Sn, and are contaminated with Ca, Si, Al and Fe coming from the soil (Fig. 11). The colour of the corrosion crust varies according to the content of Sn (the more Sn, the darker green or blue the corrosion). FTIR on the inner blue (CP5 and Fig. 12) and outer green (CP1 and Fig. 13) layers were difficult to interpret. Only malachite could be identified in both cases. XRD spectra could not be interpreted because of the deficiency of peaks.

Fig. 11: SEM image, SE-mode, and elemental chemical distribution of Fig. 10. In red: the limit of the original surface highlighted by the enriched tin layer. Method of examination: SEM-EDS, Lab of Electronic Microscopy and Microanalysis, IMA (Néode), HEI Arc,

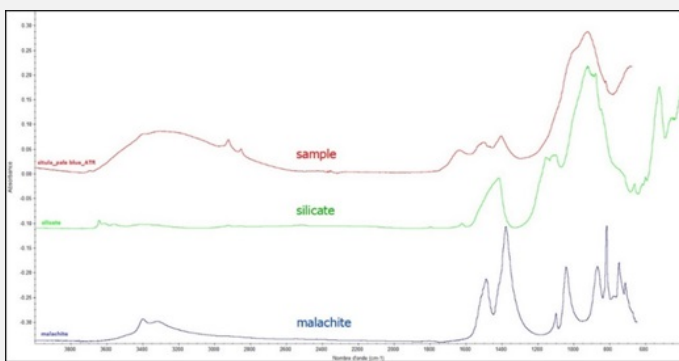
Fig. 12: FTIR spectrum (ATR mode) of the inner blue layer (CP5) compared to the silicate and malachite standard spectrum. Method of analysis: FTIR spectroscopy, HE- Arc CR,

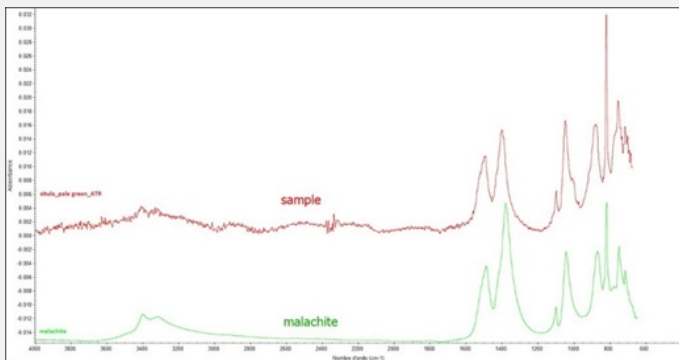
Fig. 13: FTIR spectrum (ATR mode) of the outer green layer (CP1) compared to the malachite standard spectrum. Method of analysis: FTIR spectroscopy, HE-Arc CR,

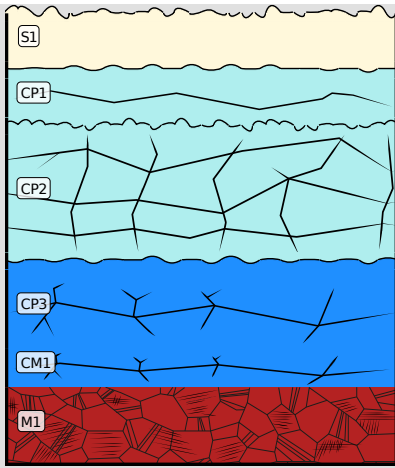
Fig. 14: Stratigraphic representation of the sample taken from the detached fragment of the situla in cross-section (dark field) using the MiCorr application. The characteristics

of the strata are only accessible by clicking on the drawing that redirects you to the search tool by stratigraphy representation. This representation shows the interior face and can be compared to Fig. 8 (bottom red rectangle), Credit HE-Arc CR, M-J.Scholl.

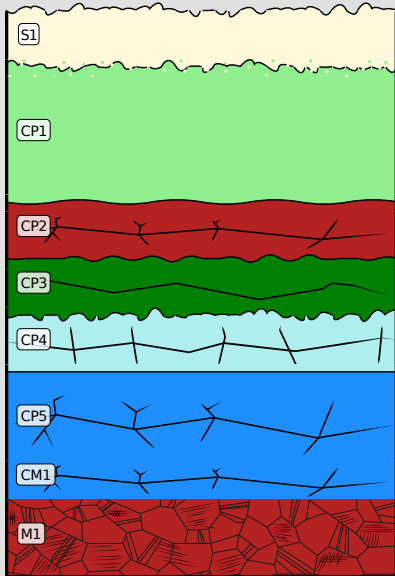
There are 2 stratigraphies (Fig. 14 corresponding to the interior face of the situla and Fig. 15 to its exterior face). The strata are similar in composition but their coding is different: CP1 to CP3 in Fig. 14 correspond to CP3 to CP5 in Fig. 15. Since the stratigraphy of Fig. 15 is more complete, the composition of each of its strata is given below.

Fig. 15: Stratigraphic representation of the sample taken from the detached fragment of the situla in cross-section (dark field) using the MiCorr application. The characteristics of the strata are only accessible by clicking on the drawing that redirects you to the search tool by stratigraphy representation. This representation shows the exterior face and can be compared to Fig. 8 (top red rectangle), Credit HE-Arc CR, M-J.Scholl.
